Town: 178 - READSBORO

IDENTIFICATION	
(1) State Names	50 - Vermont
(8) Structure Number	200102002502092
(5) Inventory Route	1
(2) Highway Agency District	1 - District 1
(3) County Code	3 - BENNINGTON

(4) Place Code	58525
(6) Features Intersected	DEERFIELD RIVER
(7) Facility Carried	VT 00100 ML
(9) Location	5.2 MI N JCT. VT.8
(11) Mile Point	0 mi
(12) Base Highway Network	No

INSPECTIONS *			
(90) Inspection Date			04/25/2023
(91) Frequency			12
(92) Critical Feature Inspection	Done	Freq. (Mon)	Date
A: Fracture Critical Detail	Yes	24	04/25/2023
B: Underwater Inspection	No		
C: Other Special Inspection			
* The inspection date and frequency information in this box contains the current NBI date and frequency information. Please refer to the report header for the date this inspection was conducted.

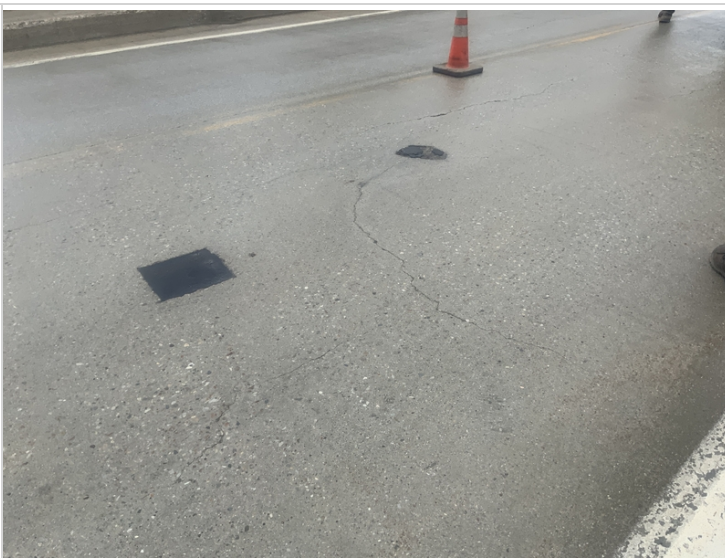
Deck

Large spalled areas and delams throughout with many areas penetrating up to and beyond the second layer of reinforcing.

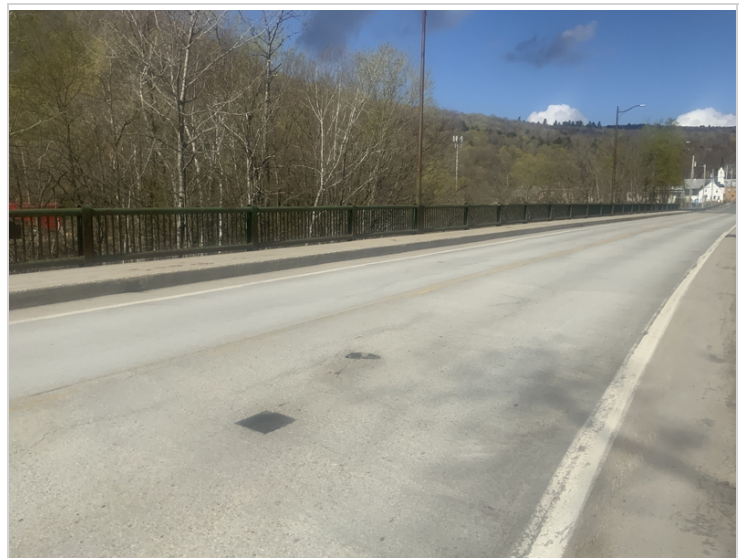
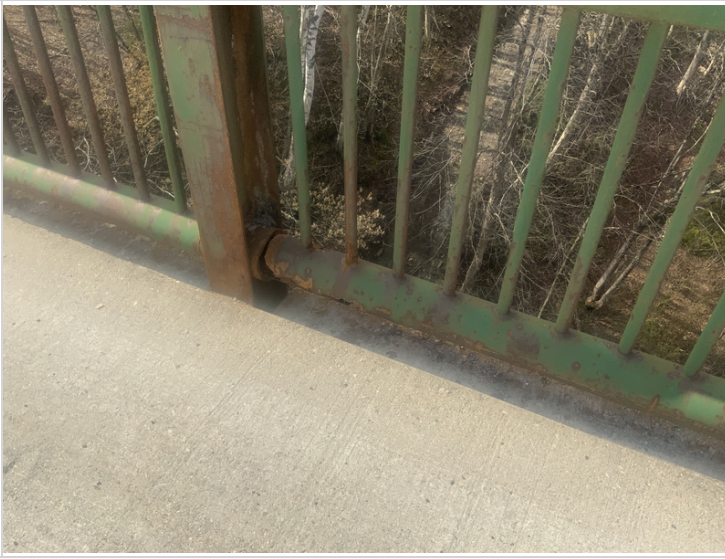
Downstream rail

Deep pitting and advanced section loss around the tube steel at the connections to the posts w/ perforations and some detached members along the bottom rail.

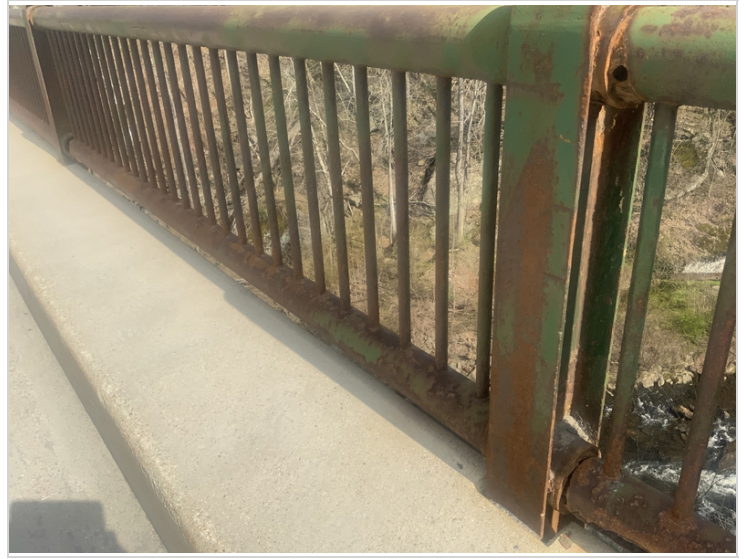
Section loss upstream rail

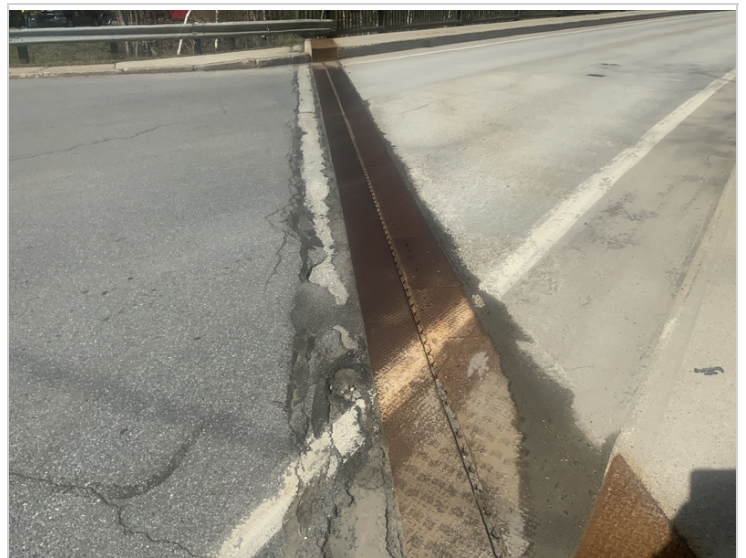
Joint 2

Welded plate steel now covers most of the joint w/ minor rust staining and pitting throughout.

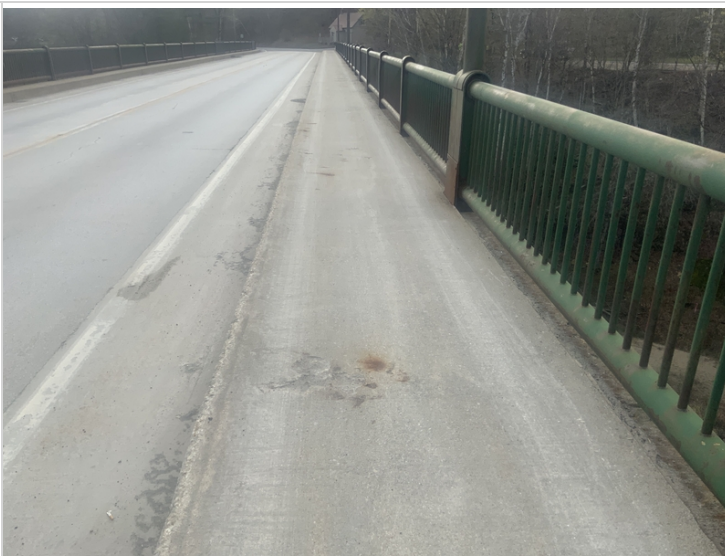
Sidewalk

Scattered map cracking w/ some minor separation

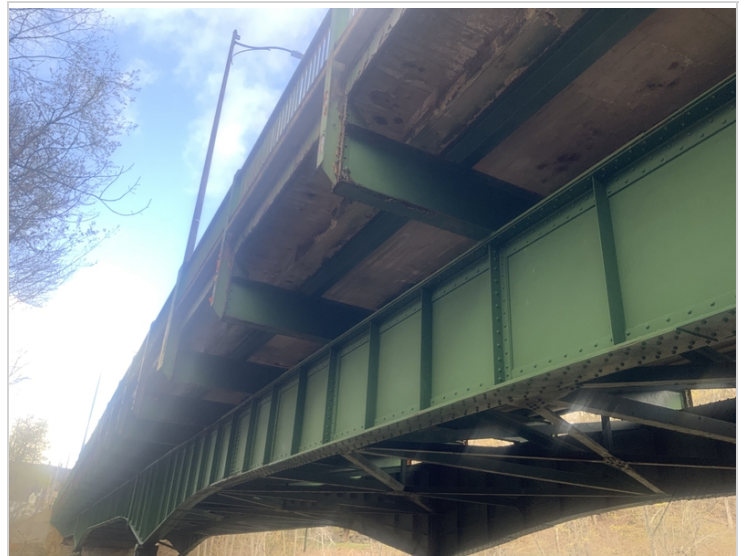
Downstream fascia/Sidewalk soffit

Scattered cracking w/ some small spalls and delams throughout.

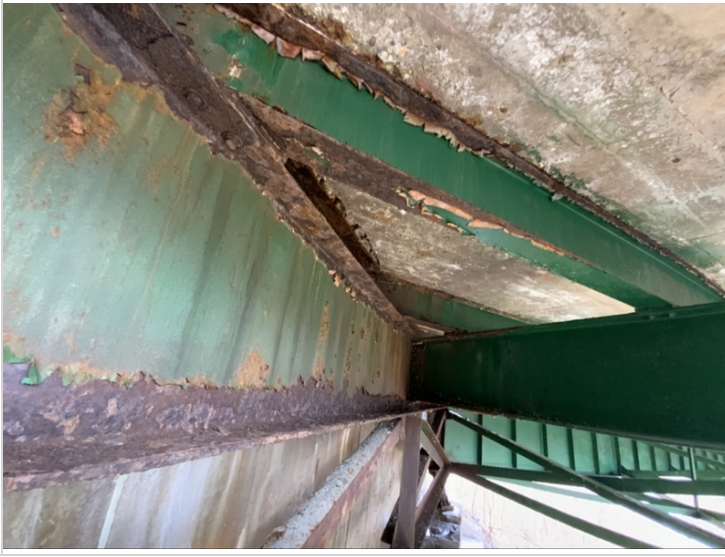
Abutment 1 floor beam and stringer ends

Beam ends have small areas of rust scale w/ deep pitting and minor section loss in the webs. The floor beams at the abutment ends have heavy rust scale throughout w/ moderate section loss, areas of section loss in the flanges are significant with minimal section remaining. The angled plate brackets of the floor beam extensions in the downstream ends of the abutment floor beams have 6"+/- cracks. The upstream floorbeam extension at abutment 2 has heavy rust scale extending down below the utility pipe with moderate section loss in the web, and minimal section remaining in the top flange.

The stringers have heavy rust scale at the abutment ends w/ small slotted perforations (1"- 3") in the webs in many areas. The upstream stringers at abutment 2 have extensive section loss. The exterior stringer has a 47" slotted perforation and 2"+/- of depth, and the first interior stringer has much of the beam end gone w/ settlement, the length of the perforation measuring 46", and what remains of the beam end now resting on the second floor beam. The upstream stringer has heavy rust scale with moderate to heavy section loss in the bottom flange at the floor beam seats. The upstream stringer at floorbeam 16 (from abutment 1) has deep pitting w/ 1/4" of section loss in the lower area of the web and a 3" perforation in the exterior of the bottom flange.

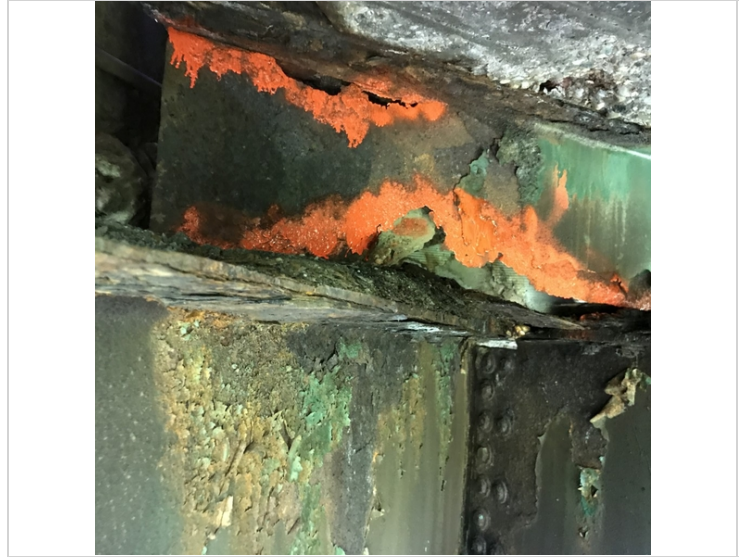
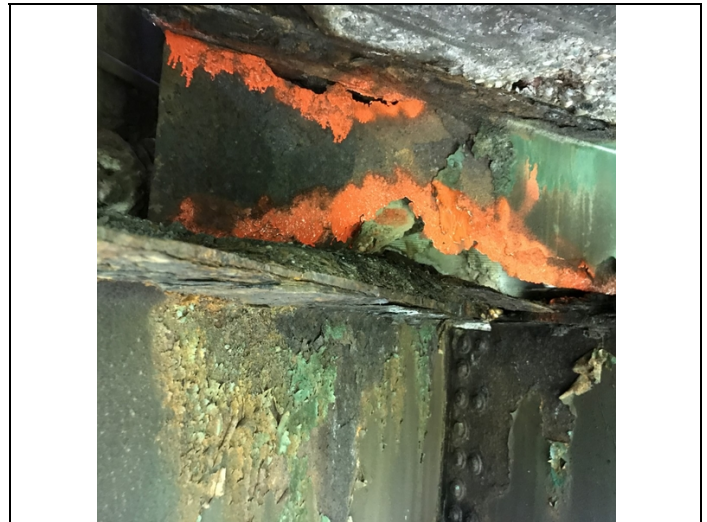
Upstream interior stringer over abutment 2

The deck continues to develop large spalled areas that penetrate up to and beyond the second layer of reinforcing with exposed rotted strands. The abutment backwalls have deep voided spalls that undermine the joints with exposed reinforcing and heavy scaling. The stringer beam ends continue to deteriorate with varying size perforations throughout with the upstream stringers at abutment 2 being the worst with 3'+/- of the ends having basically failed.

This structure should be considered for an extensive rehabilitation project or replacement.

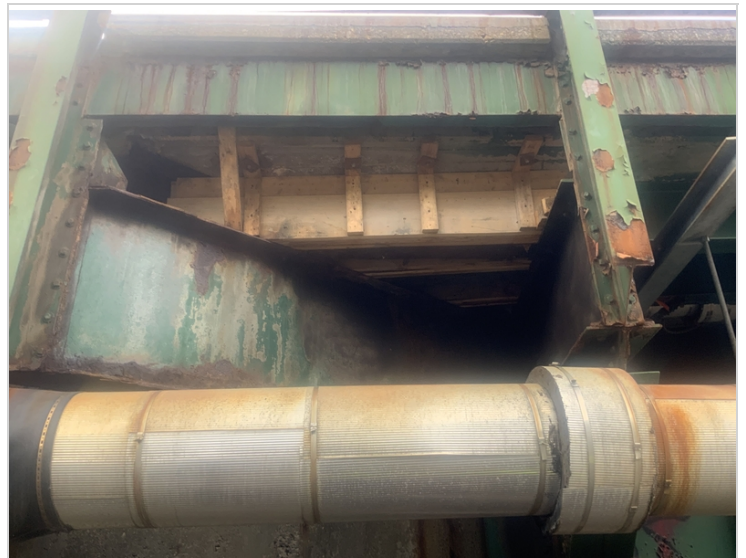
Nail/Screw laminated timber stringers (repair) over abutment 2

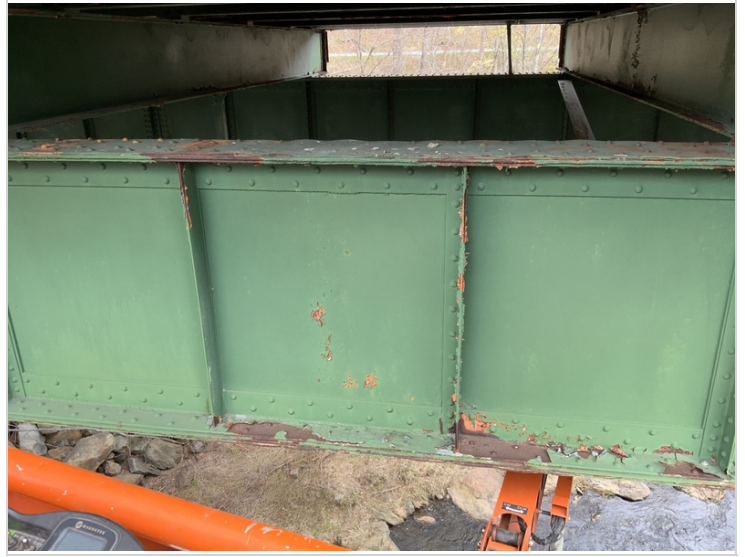
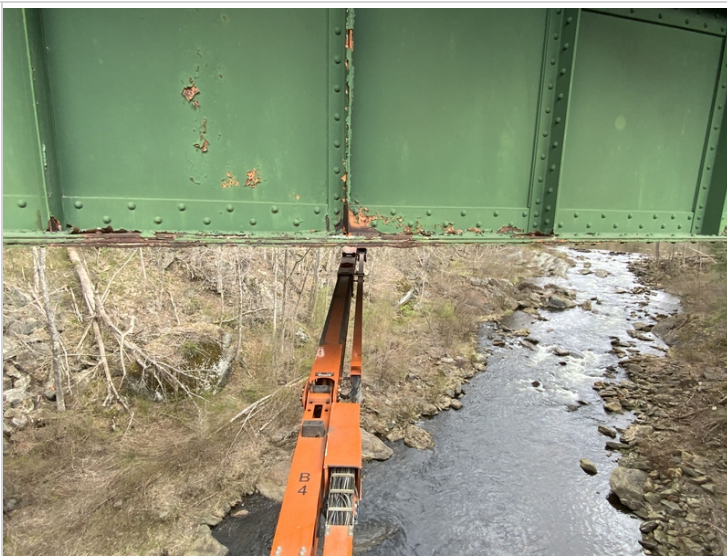
Girder flange

Riveted Girders have scattered areas of paint peel w/ exposed primer and minor rust staining/scaling. Areas along the outer edges of the flanges have pack rust inbetween the bolted/riveted plates with minor bending where saturation from the soffit above affects the beams. The beam ends at the abutments have heavy rust scale w/ minor section loss.

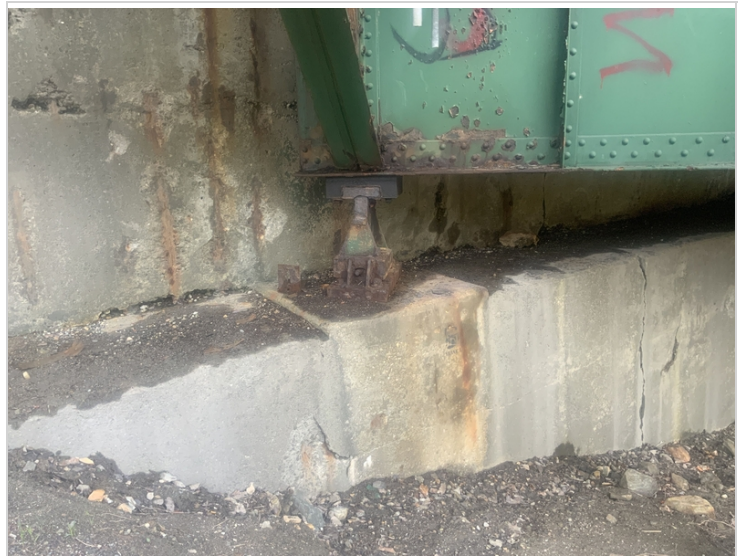
Bearing abutment 2

Heavy rust scale w/ minor to moderate section loss at the abutments. Pier bearings are in good condition.

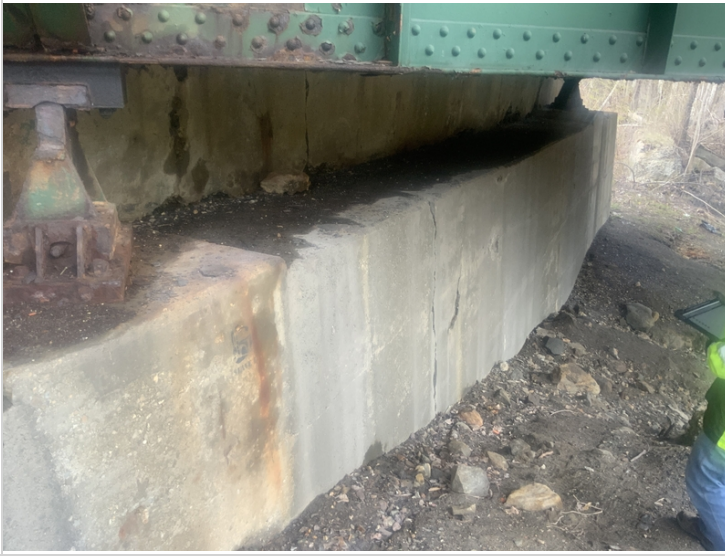
Abutment 2 has scattered small spalls throughout with small voids and exposed reinforcing. No new changes were found in the sustained full height vertical settlement crack near the upstream end.

Large areas of voided spalling below the joints with heavy saturation, scaling, and exposed reinforcing. The abutment 2 wall has scattered small spalls throughout w/ small voids and exposed reinforcing.

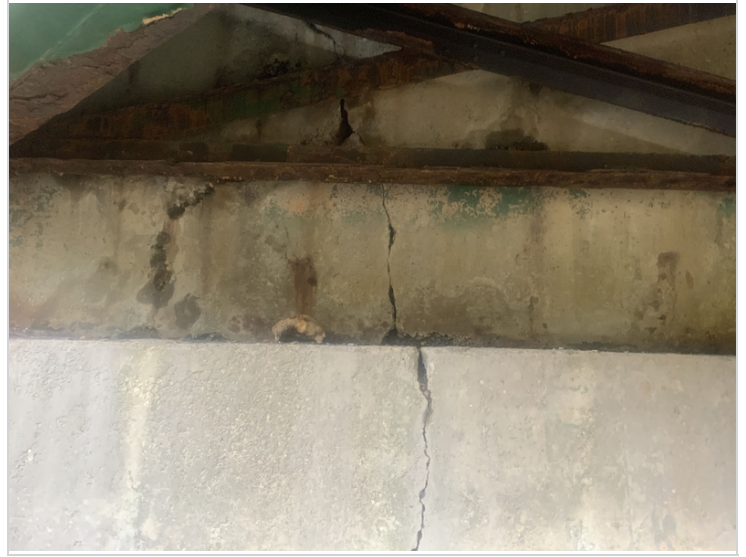
Vertical crack abutment 2

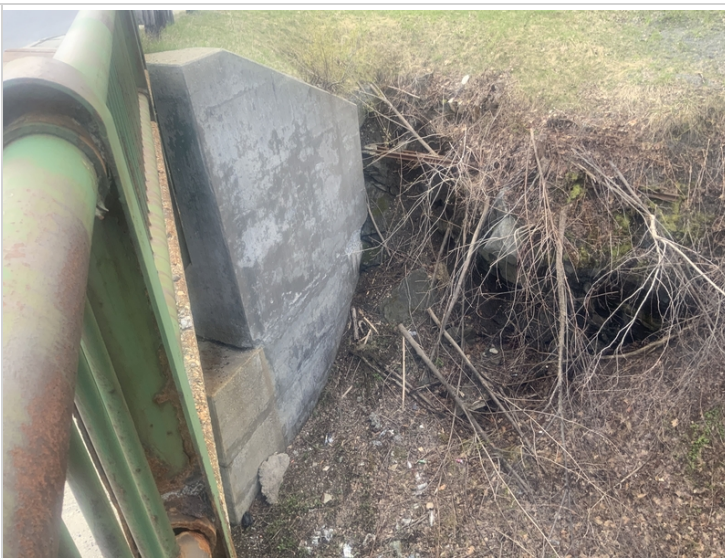
NE wing

Map cracks scattered throughout w/ areas of light to moderate saturation. The abutment 2 walls have scattered areas w/ efflorescence and rust staining.

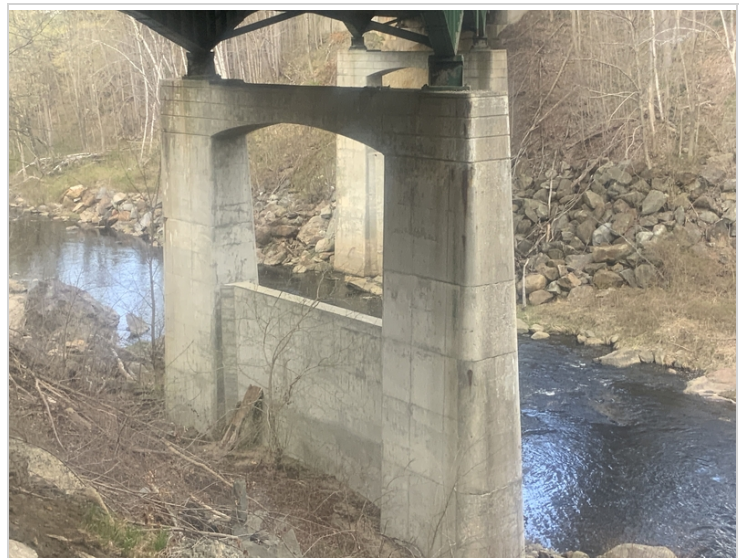
The pier 1 wall is in good condition. Pier 2 wall has a full height vertical shrinkage crack w/ minor separation.

Map cracking w/ light staining, scattered small areas of efflorescence and rust staining. The fascia ends have small lineal spalls w/ scaling and exposed reinforcing found in the pier 2 ends.

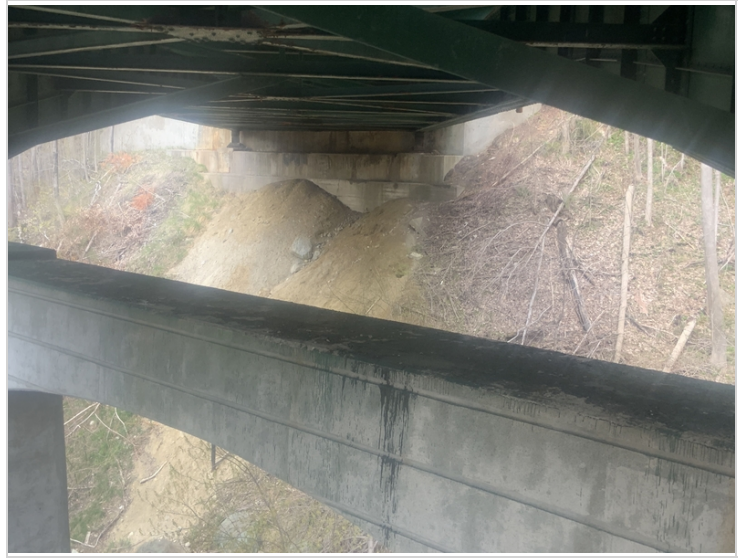
Abutment 1 has map cracks scattered throughout w/ areas of light staining. The bridge seat has scattered surface spalling w/ a large voided area near the upstream bearing.
