Scoping Report

FOR
Hartford (Quechee) NH 020-2(45)

US Route 4, BRIDGE 61 OVER OTTAUQUECHEE RIVER

January 22, 2018

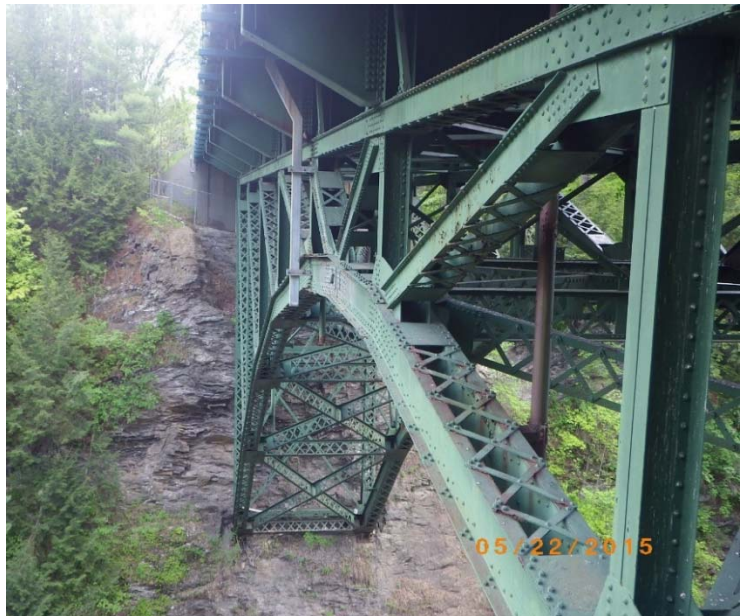
This option would include cleaning and painting the existing steel arch in place. Painting the existing members would provide a new protective coating for the bridge and extend the life of the members. Currently, the existing paint is starting to corrode in some areas, exposing the steel members underneath.

Due to the height of the bridge and complexity of the structure, it is recommended that the arch members are field painted in place.

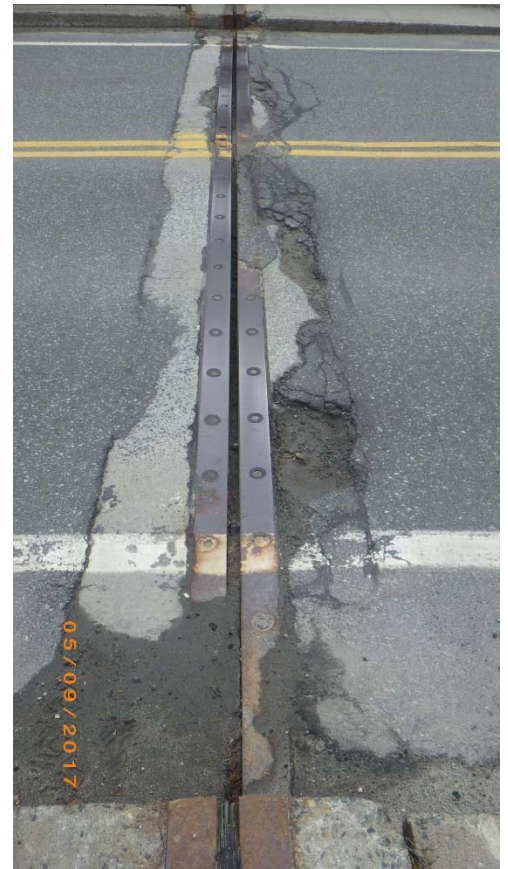
There are currently three Vermont expansion joints on the bridge that are all in poor condition and are not functioning as intended. The VTrans Maintenance and Operations section has indicated that the existing joints are a constant maintenance problem, and that welding repairs to the joints has been required on a frequent basis.

The joints are leaking water and salt onto components below causing accelerated deterioration. Leakage is evident along the backwalls with minor rust staining and efflorescence. The joint at the midspan continues to leak onto the superstructure causing advanced deterioration. Removal of this joint should be considered in design. Replacement of all three joints should be included in any rehabilitation project to extend the life of the structure. This work would require traffic to be phased during construction. Traffic would be reduced down to one lane during off peak hours, and opened up back to traffic during peak hour traffic.

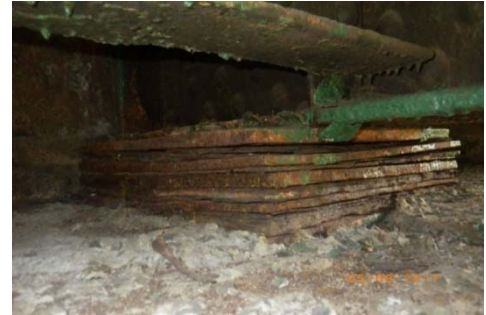
Bearing replacement at abutments:

The bearings located at the abutments are in poor condition. The steel plates at the girders have heavy rust scale and areas of extensive section loss with crushing. Additionally, rust expansion is causing the stringers/girders to lift. The bearings located at the abutments should be considered for replacement as part of the rehabilitation project.

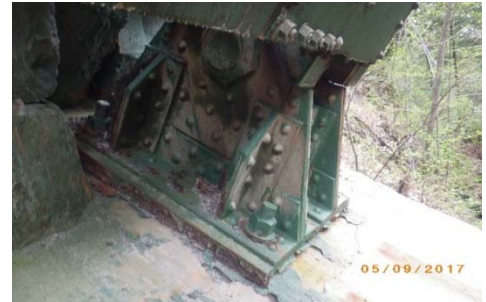
Pedestal Rockers:

The pedestal rockers of the pinned deck arch have heavy rust scale and deep pitting surrounding the pinned connections, and slotted pitting along the gusset plate connections. These bearings should be rehabilitated as part of a preventative maintenance project.

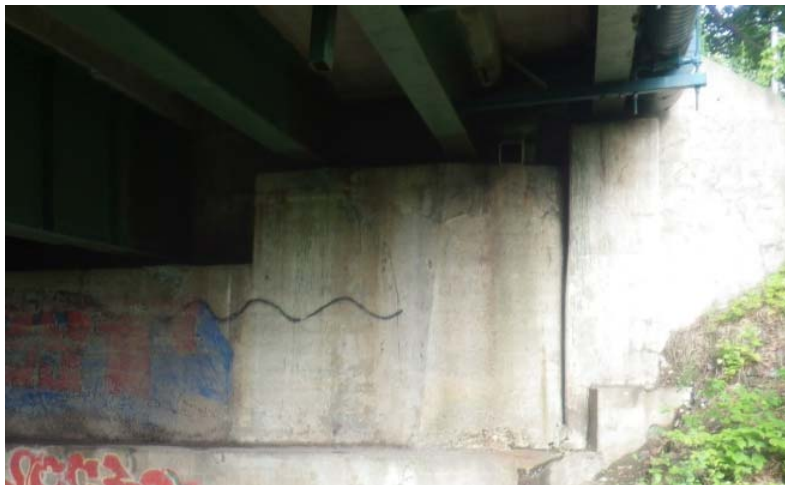
Additionally, there are localized areas of minor concrete spalling at the abutments. Consideration should be given to patching the concrete in these areas.
