STATE OF VERMONT
AGENCY OF TRANSPORTATION

Scoping Report

FOR
Springfield IM 091-1(74)

Interstate Route 91, Bridges 26 N/S over the Black River

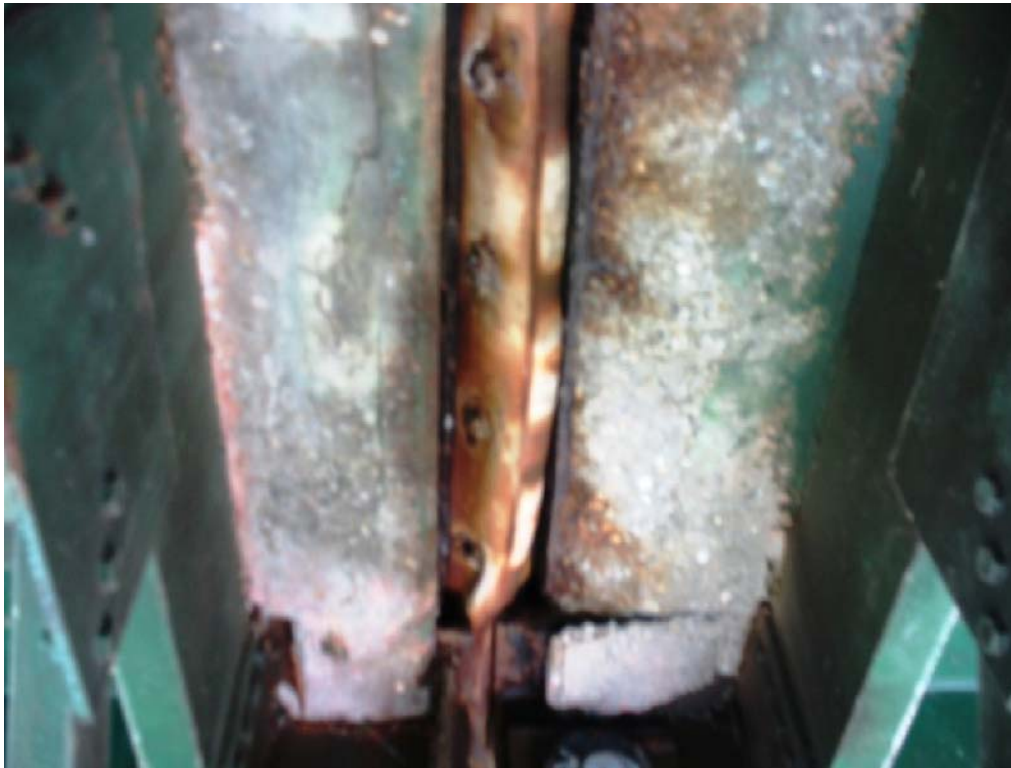
The bridge decks have been classified as Satisfactory and Fair. There is visible deterioration to the underside, particularly near the joints, and the deck cores (see Appendix) indicate that the deck has been overlaid. While deck patching appears to be a viable repair on its own, when combined with other repairs it becomes less appropriate.

Deck Condition at Expansion Finger Joint, Located above Hinges (Bridge 26S shown)

The expansion joints over the pin and hanger are leaking and should be replaced as part of every rehabilitation alternative. The calculated range of thermal movement, under a 150-degree temperature differential, is 2.34" - this can be accommodated by the Vermont Joint. A product such as Emseal Bridge Expansion Joint System (BEJS) can also be considered under this range of movement. The BEJS is a product that MassDOT has had recent success for retrofit joint

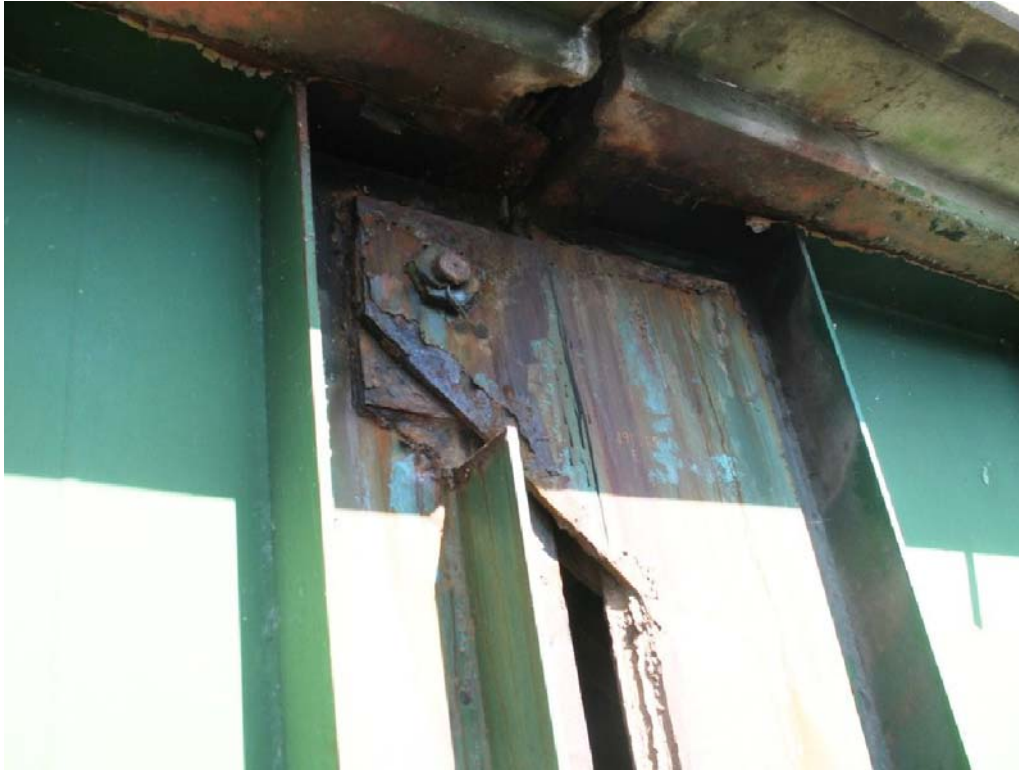
While the bridges are not coded structurally deficient, there are two existing conditions that are deficient and require immediate action: the fracture critical pin and hanger suspenders should be retrofitted, and the substandard aluminum bridge railing should be replaced. The condition of the deck, expansion joints, superstructure steel, high level bearings, and substructure were evaluated to determine additional repairs and develop appropriate combinations for rehabilitation alternatives. Additionally, a cursory seismic evaluation was performed to understand the anticipated performance and vulnerability of the structure for the design earthquake and the outcome of a seismic retrofit strategy.

Pin Condition (Bridge 26S shown)

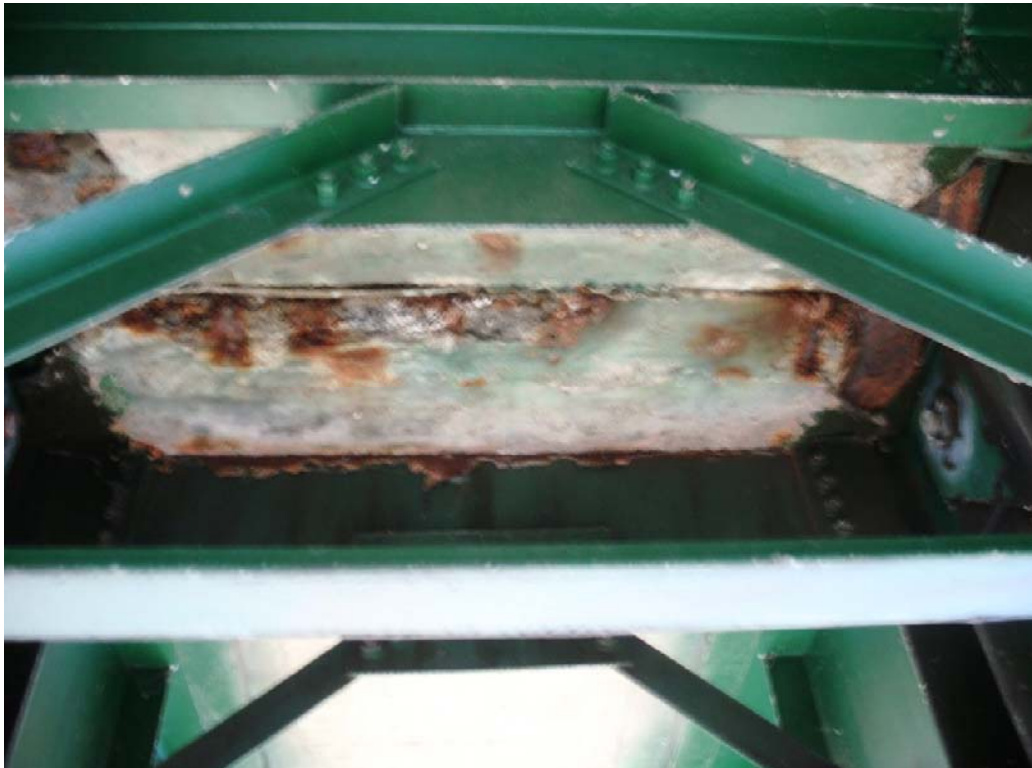
Deck Condition above Pin (Bridge 26S shown)

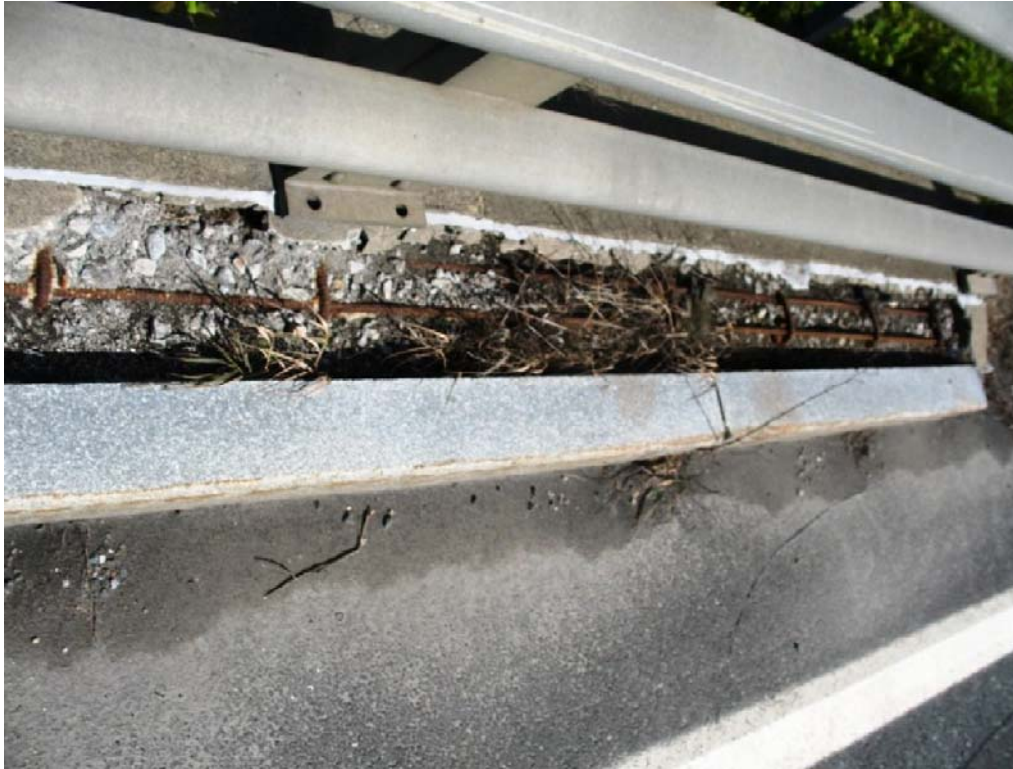
For example, the severely deteriorated curb cannot receive a new steel railing, and it is likely that the deck below the curb will be inadequate to structurally support a new curb. Thus, it is anticipated, that to replace the substandard aluminum railing with a TL-4 steel railing, a full depth

Bridge Curb Deterioration (Bridge 26S shown)

section of deck along each fascia will need to be removed and replaced to receive a new concrete curb. Additionally, if the expansion joints are to be replaced (as discussed in Section 2.4), a section of deck (full depth by full bridge width) on either side of the joint will need to be removed and replaced. It does not seem practical, from a life-cycle cost perspective, to perform extensive full-depth repairs and patching to a deck from 1965 that has been previously patched and overlaid.

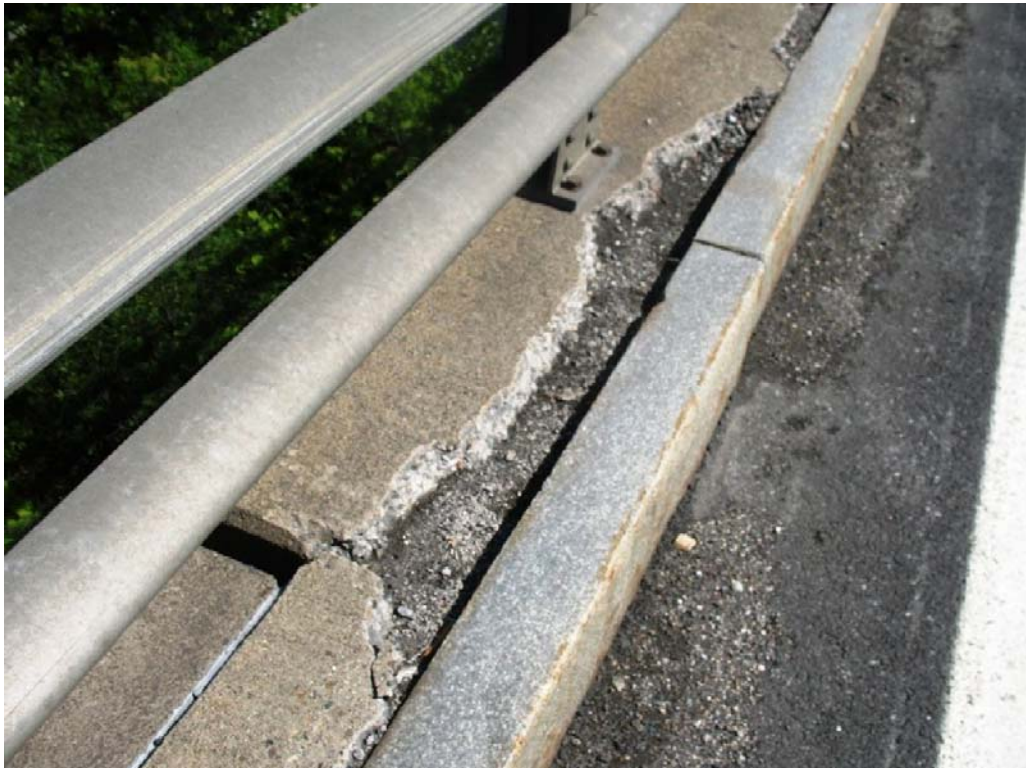
Bridge Curb Deterioration (Bridge 26S shown)

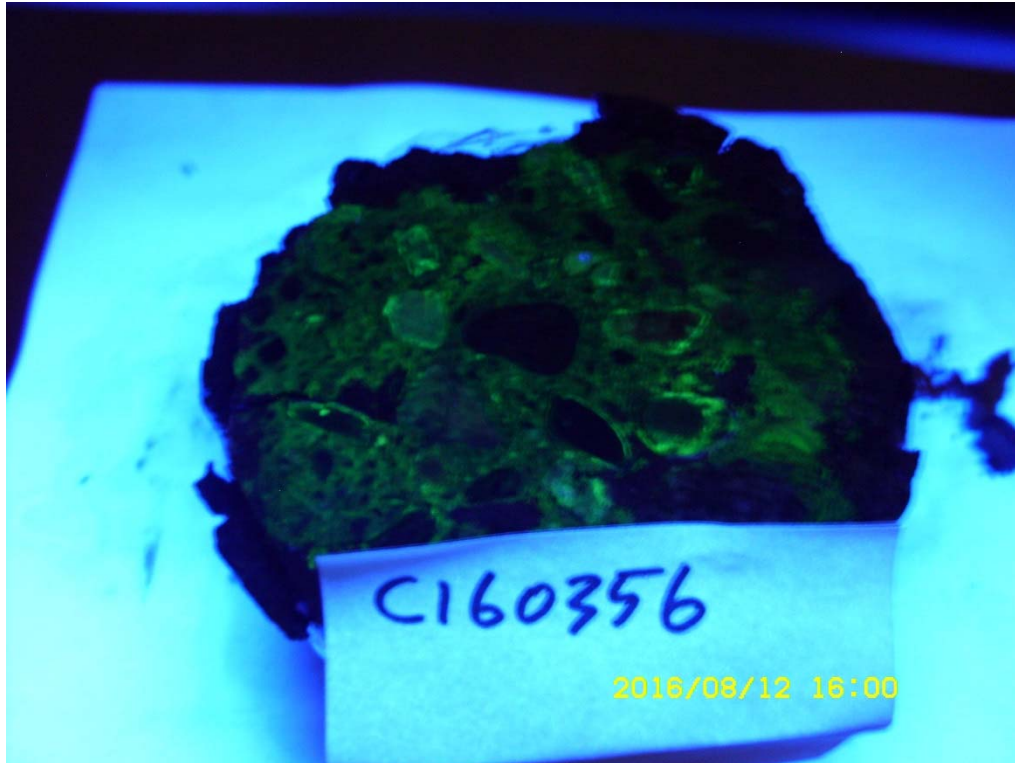
Core 1A from sample area 1, rated moderate ASR activity

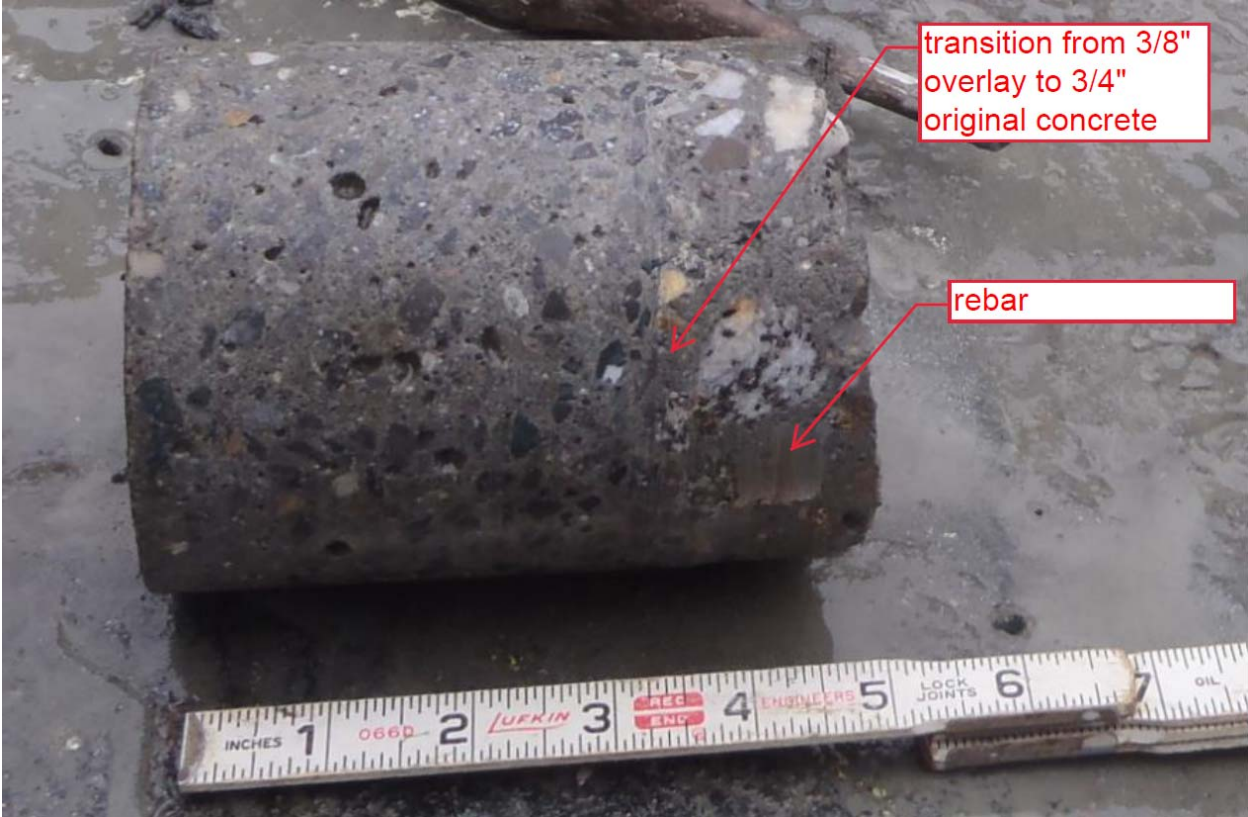
Core 1B showing interface of 3/8" aggregate concrete to 3/4" concrete.

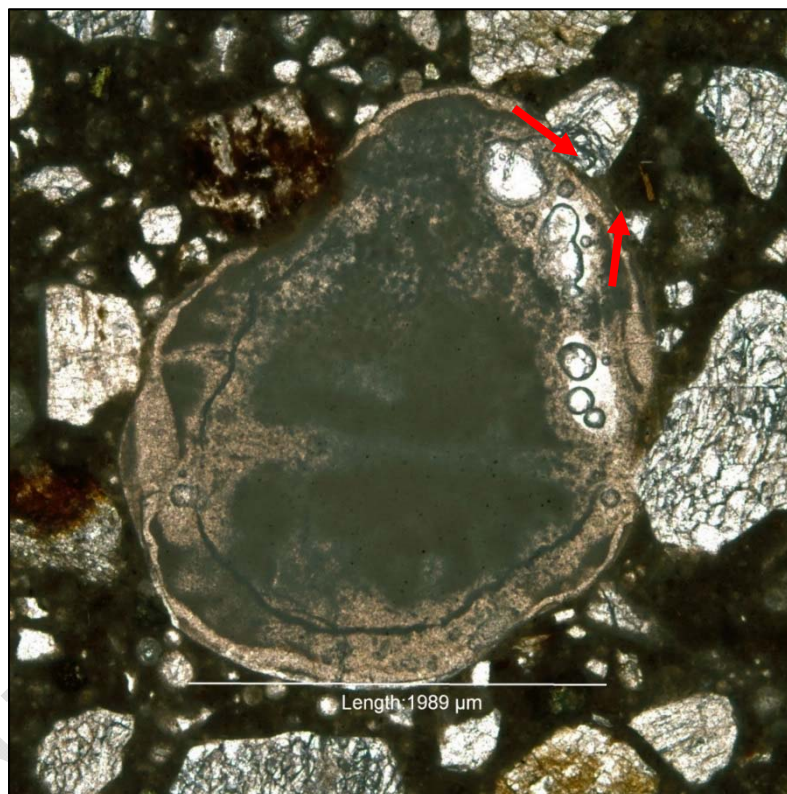
Figure 1: Photomicrograph of Thin Section #C160364B showing large ASR gel filled void. Red arrows show ASR gel filled cracks extruding into adjacent aggregate grain. Photo taken at 4X under plane polarized light.

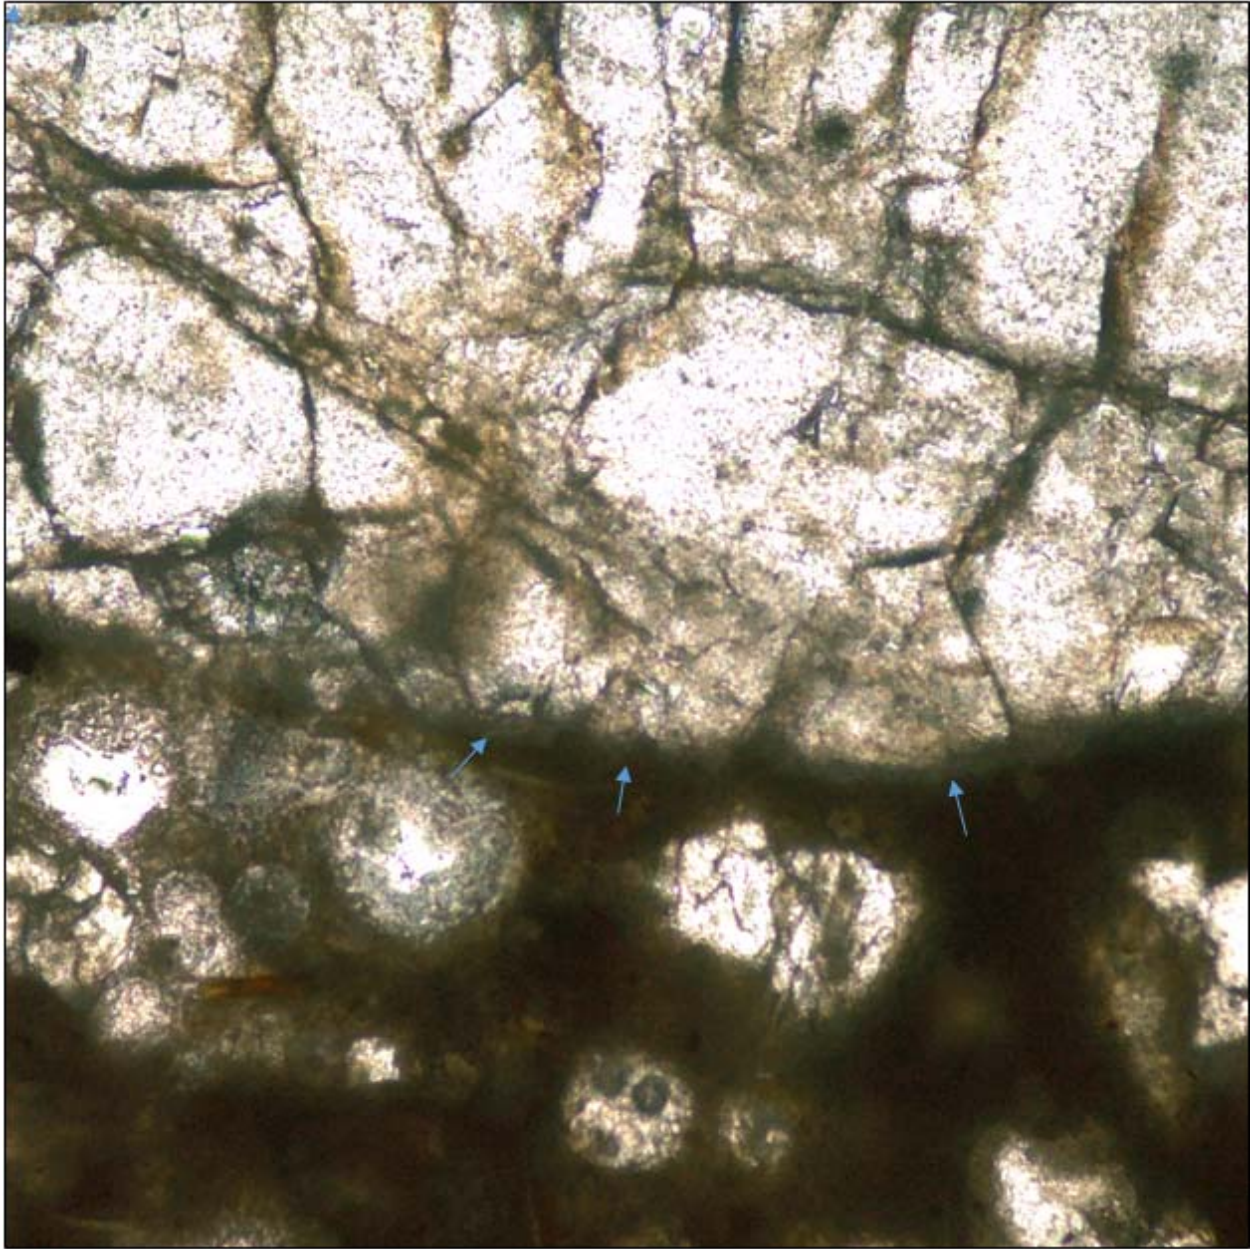
C160358B: Faint reaction rims around aggregate (blue arrows). View is with 10x magnification and with plane polarized light.

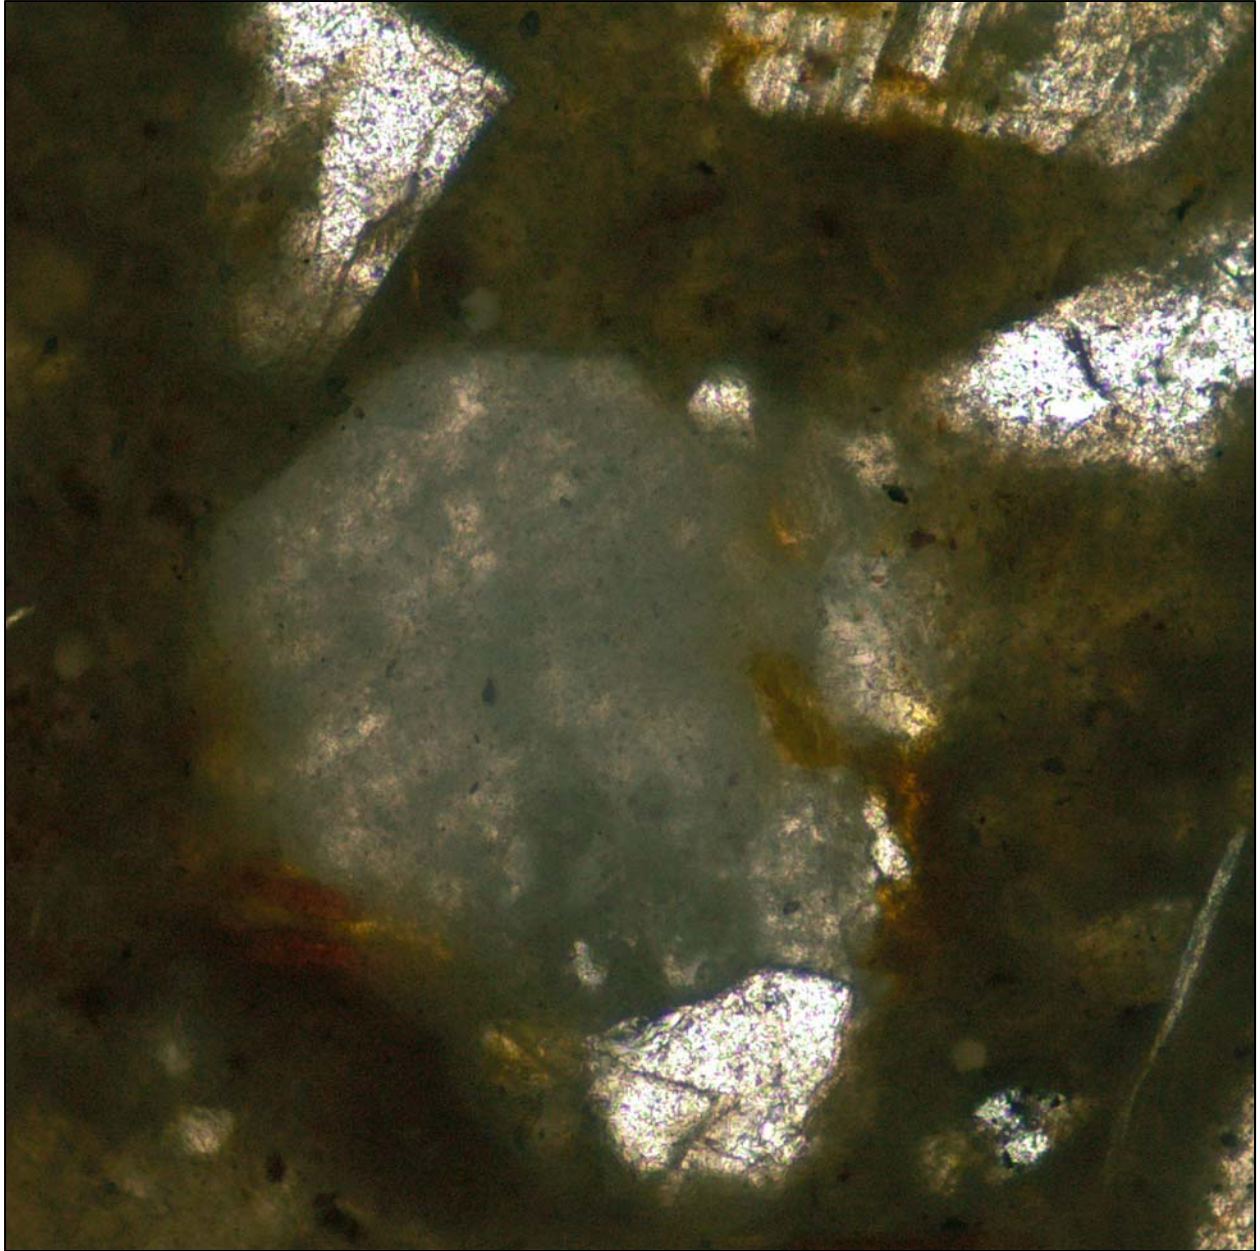
C160364T: ASR gel filled void in paste. View is with 20x magnification and with plane polarized light.

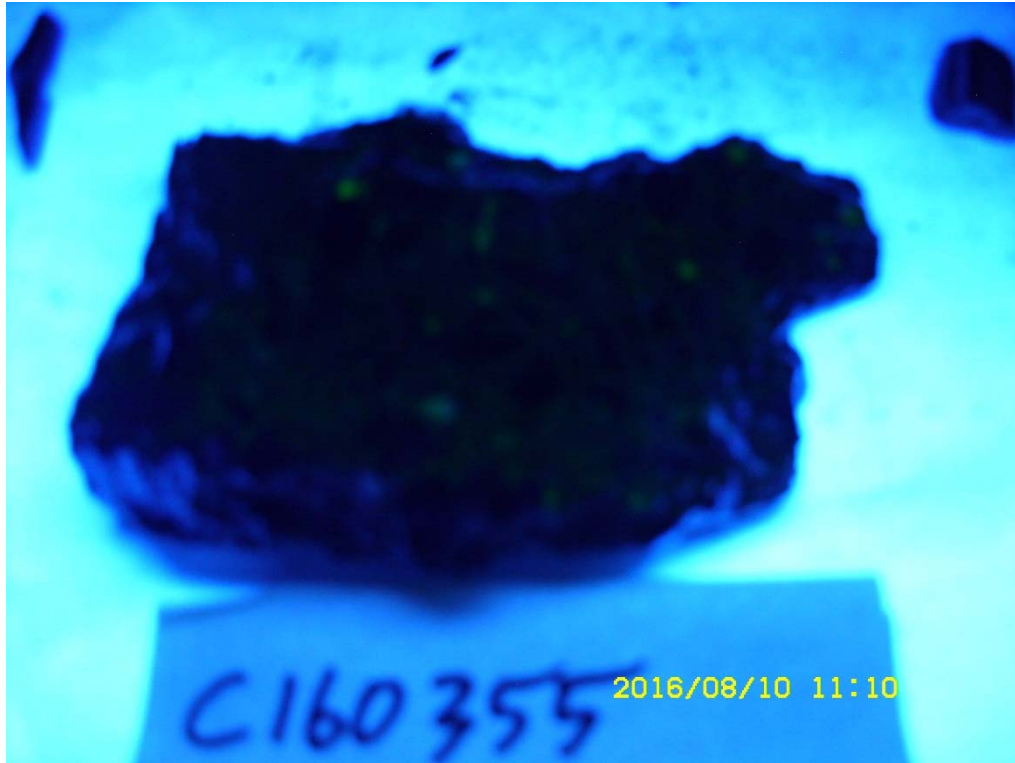
Core 1A from sample area 1, rated low ASR activity

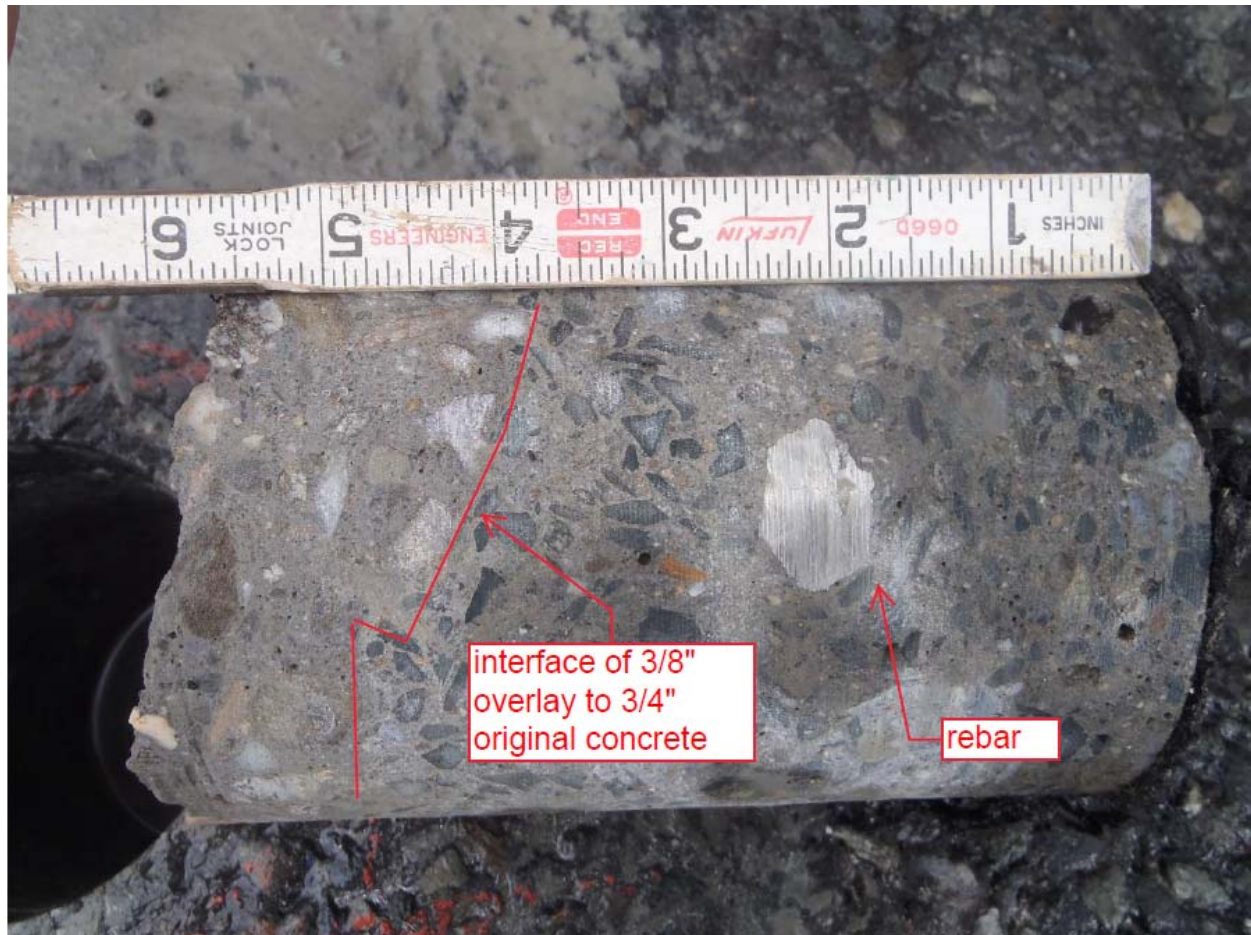
Core 2C showing interface of 3/8" aggregate concrete to 3/4" concrete.

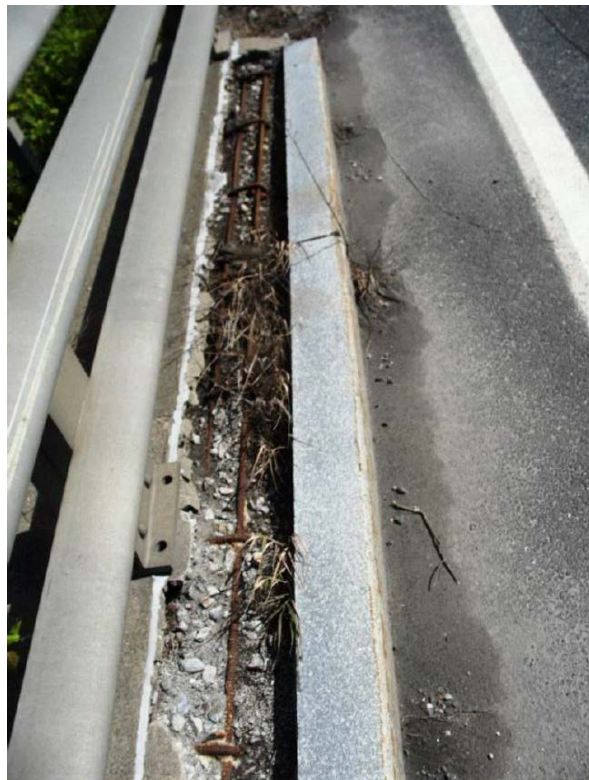
Figure 2: BR 26 S Curbing Requiring Patchwork

Based on the latest bridge inspection report from June 2012, the curbs, structure, and joint areas in the soffit should be cleaned and patched. Additionally, the bridge railing and transitions do not meet federal standards. The northbound bridge substructure was rated as very good and the southbound substructure was rated as good. Photos from the 2012 inspection show curbing requiring patchwork as seen in Figure 2.
