STATE OF VERMONT  
AGENCY OF TRANSPORTATION

**Scoping Report**

**Springfield IM 091-1(83)**  
**I-91 Bridges 28 N&S over US Route 5**

August 25, 2020

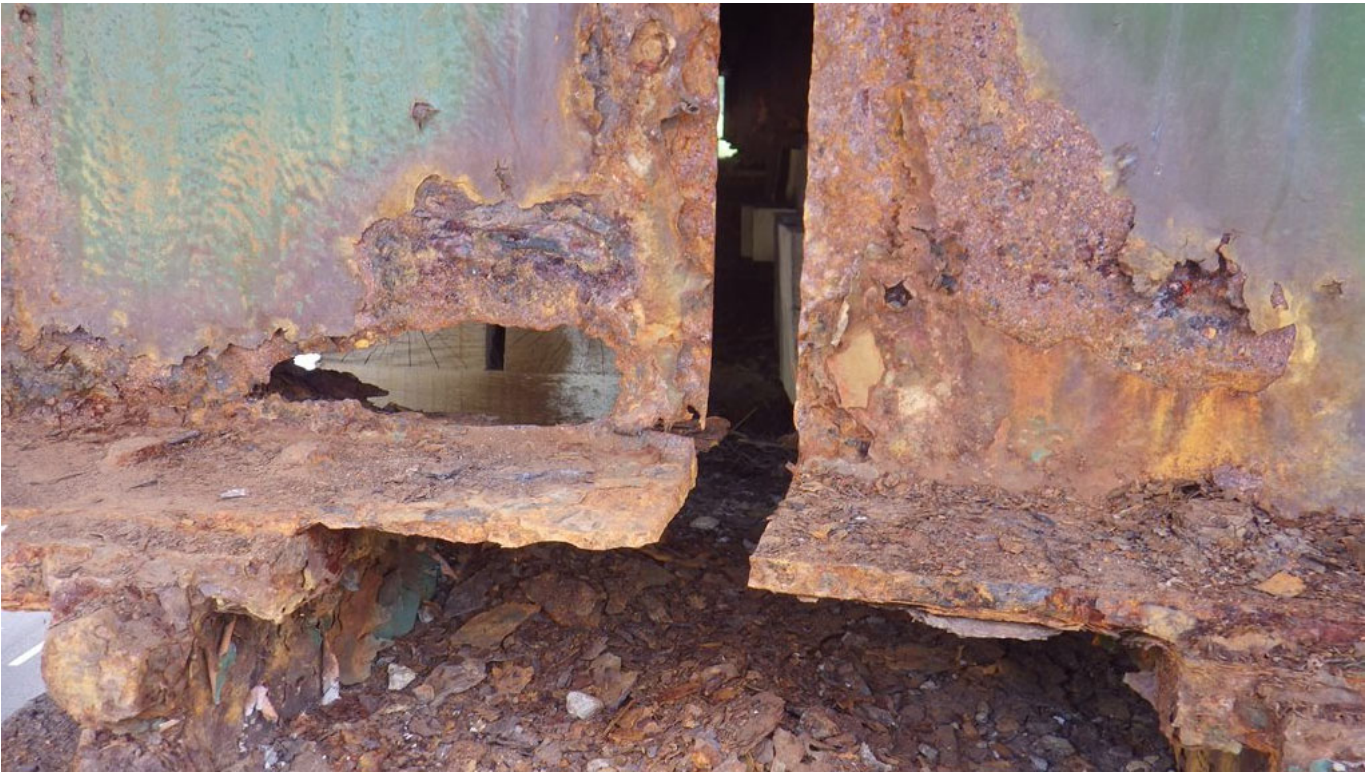
Rolled beam deterioration at joint

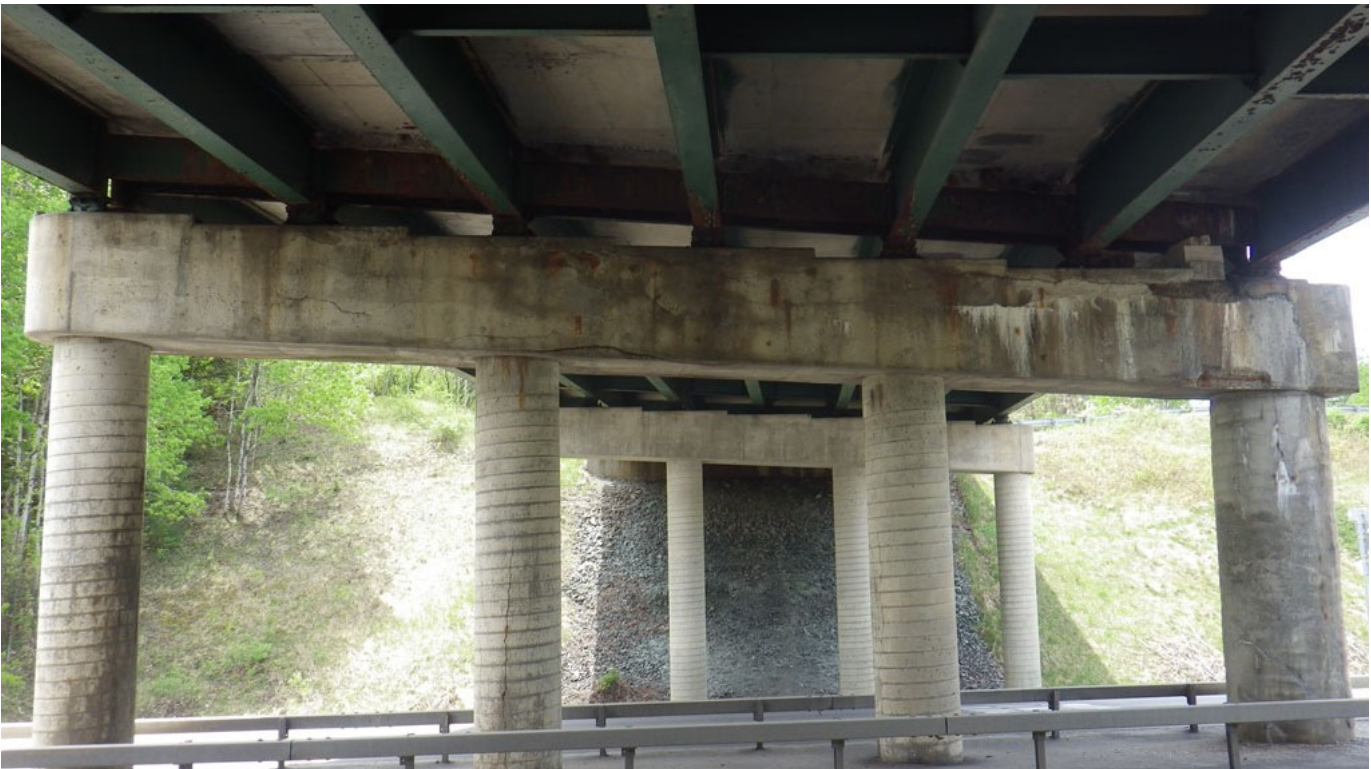
Pier column and cap condition

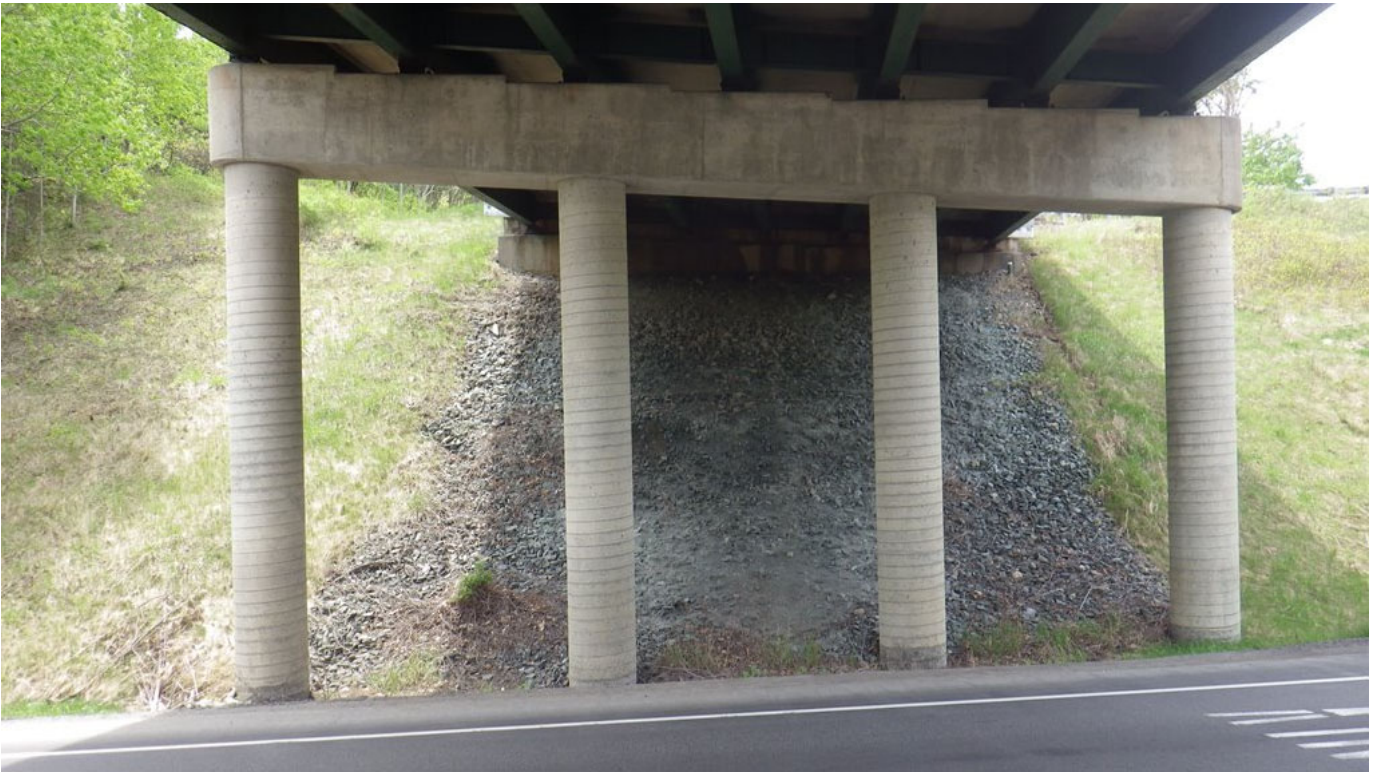
Pier column and cap condition

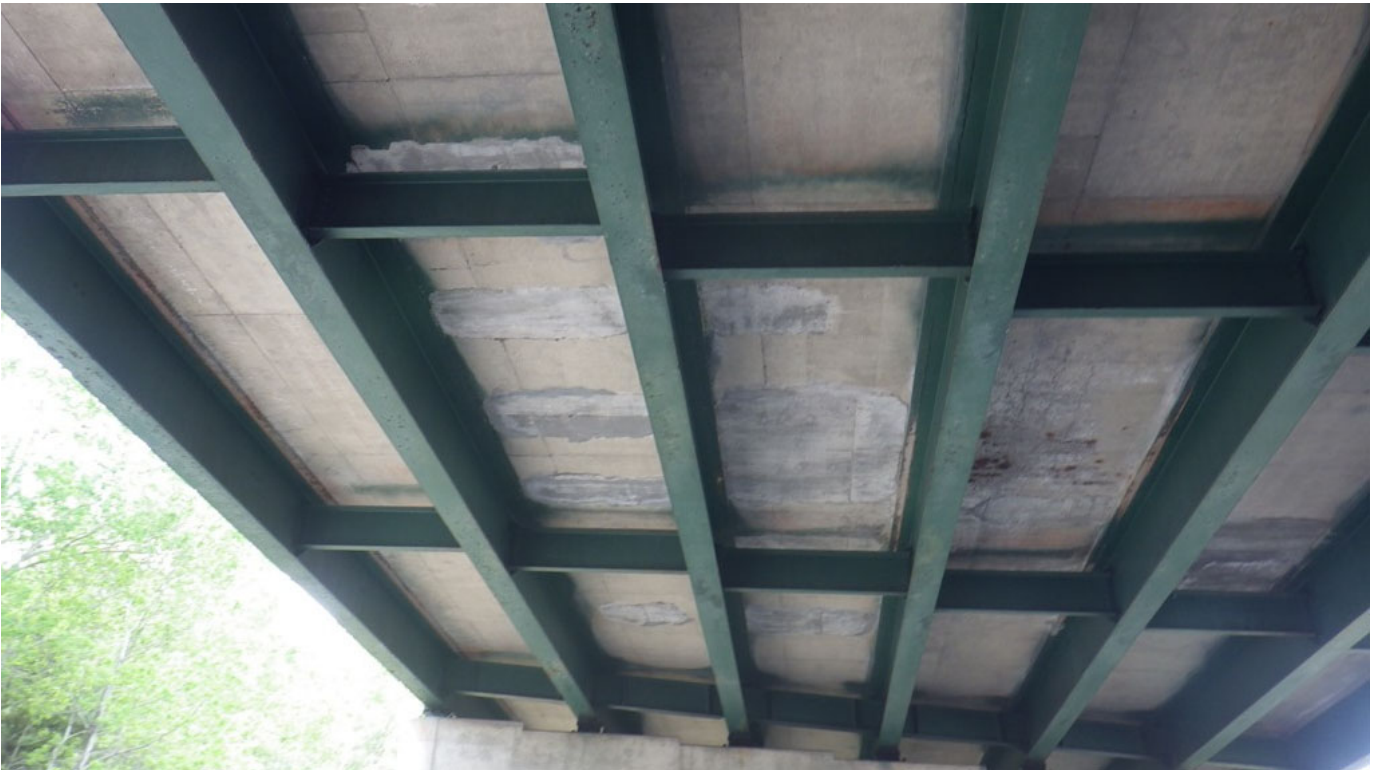
Deck and superstructure condition

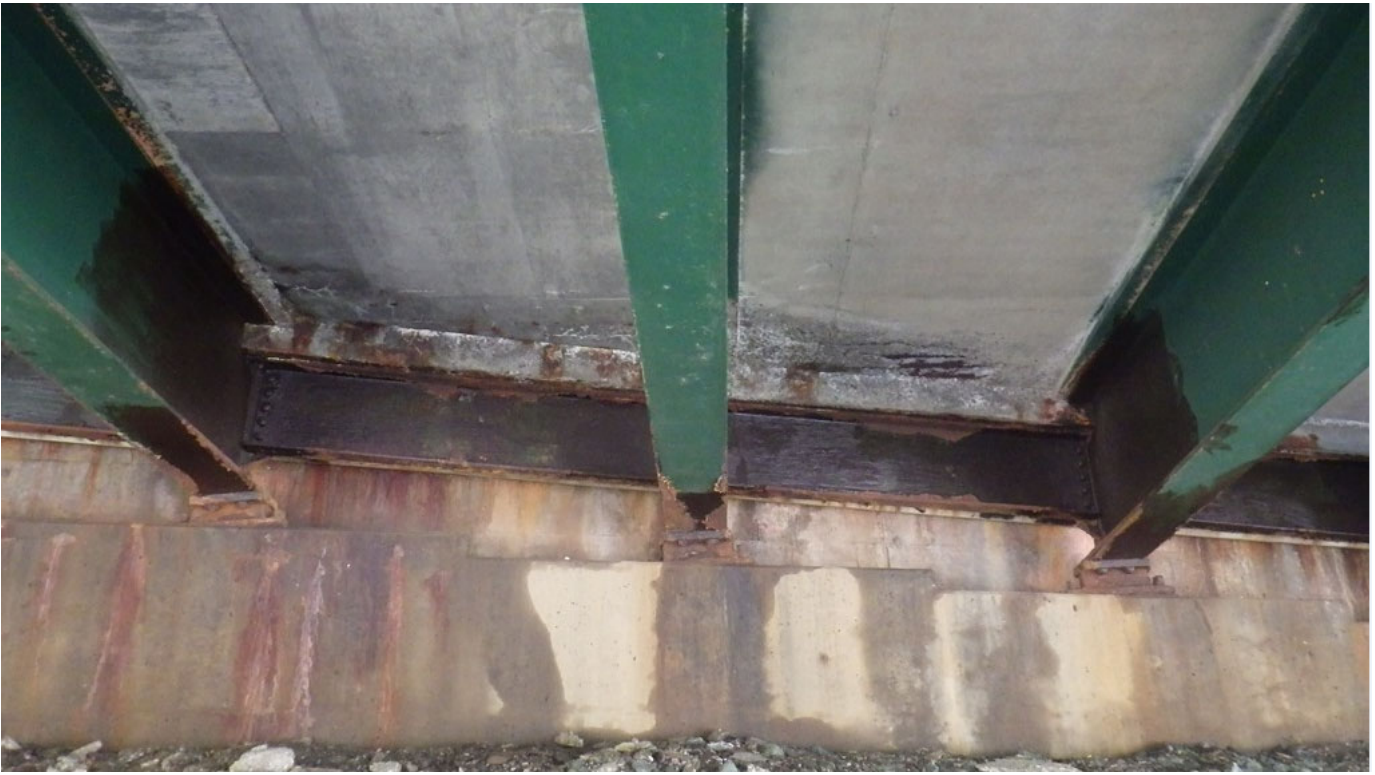
Abutment Condition (Note saturation due to leaky joint)

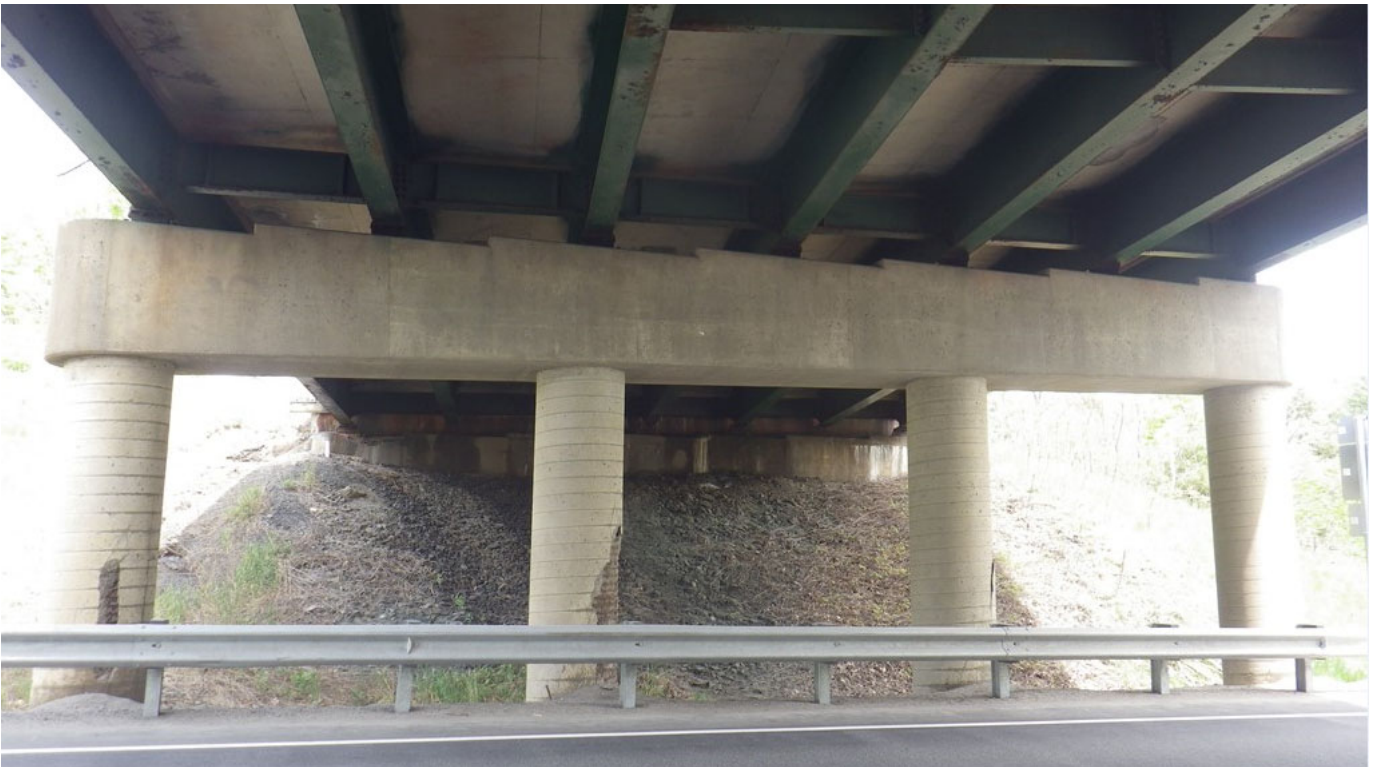
Pier Condition

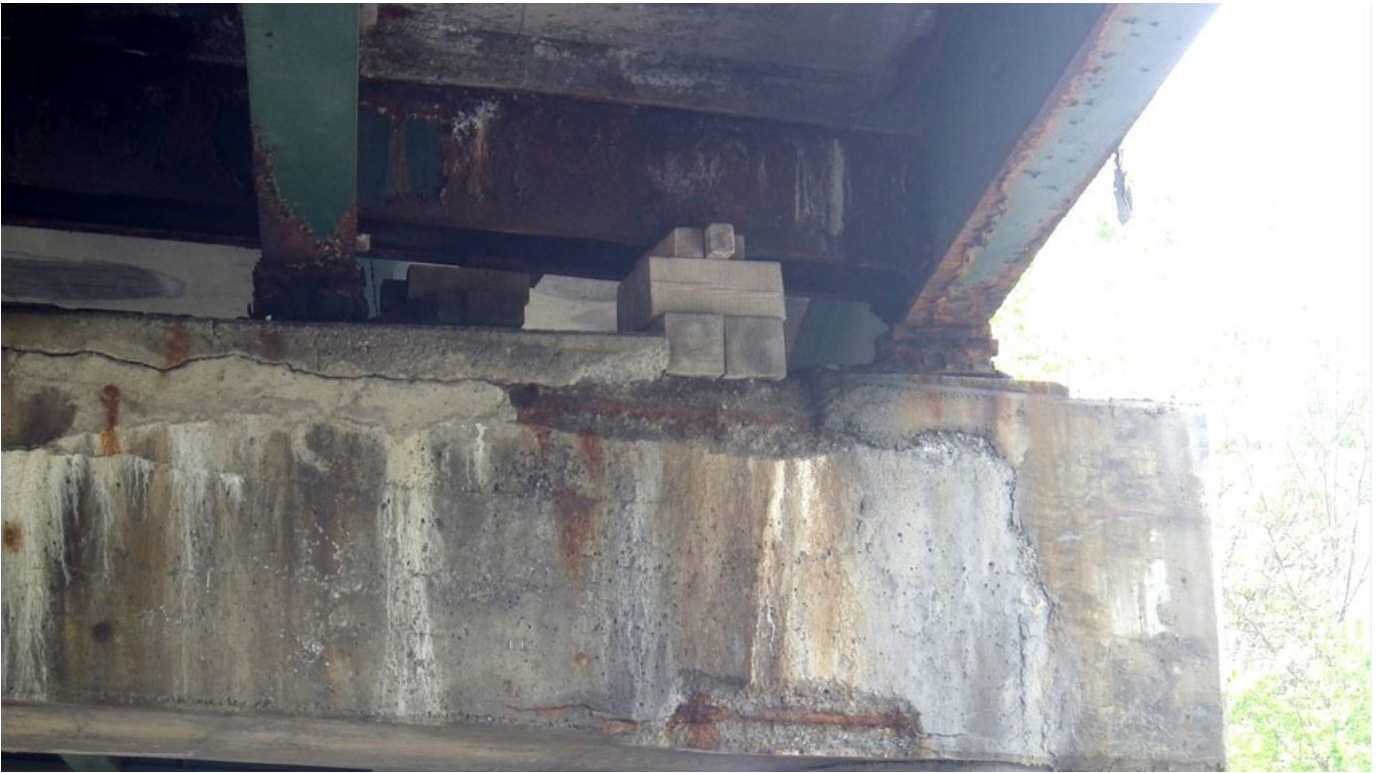
Abutment Condition

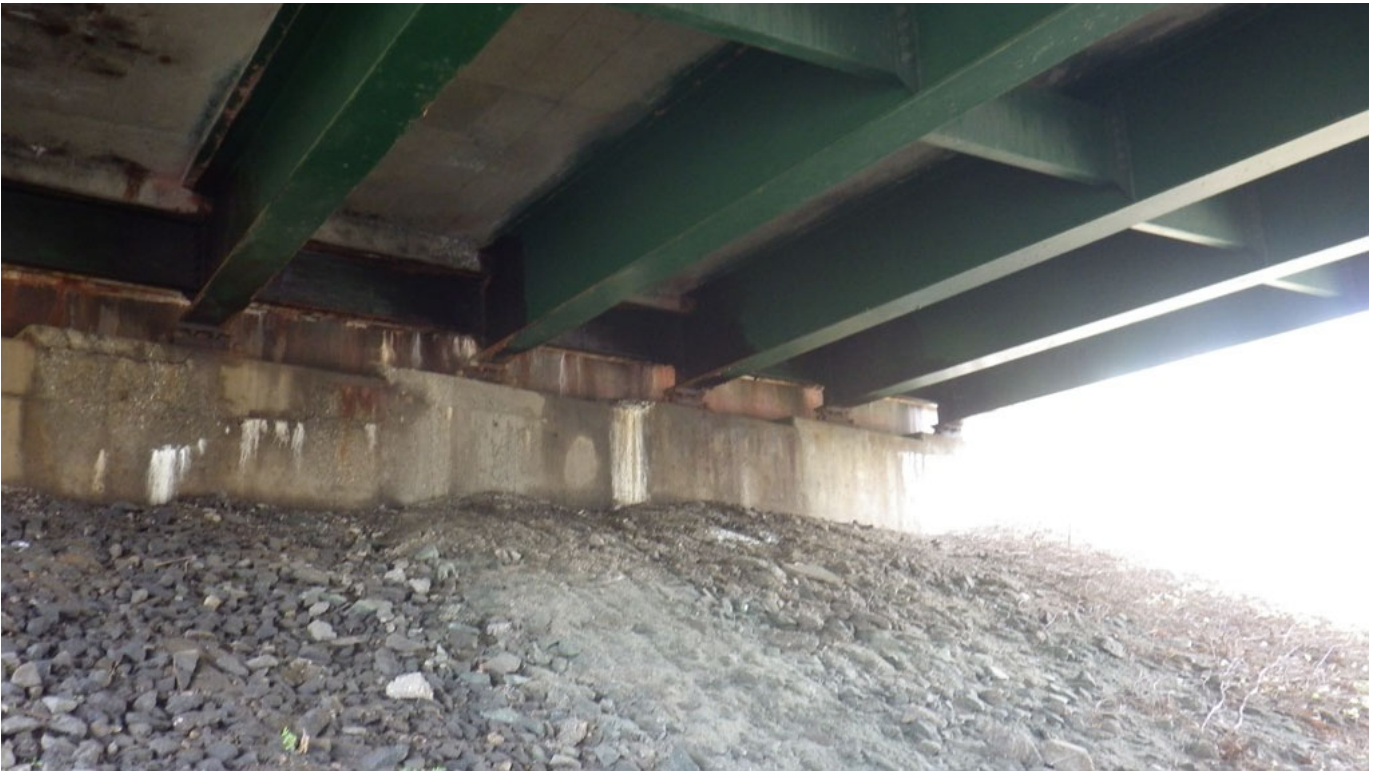
Abutment Condition

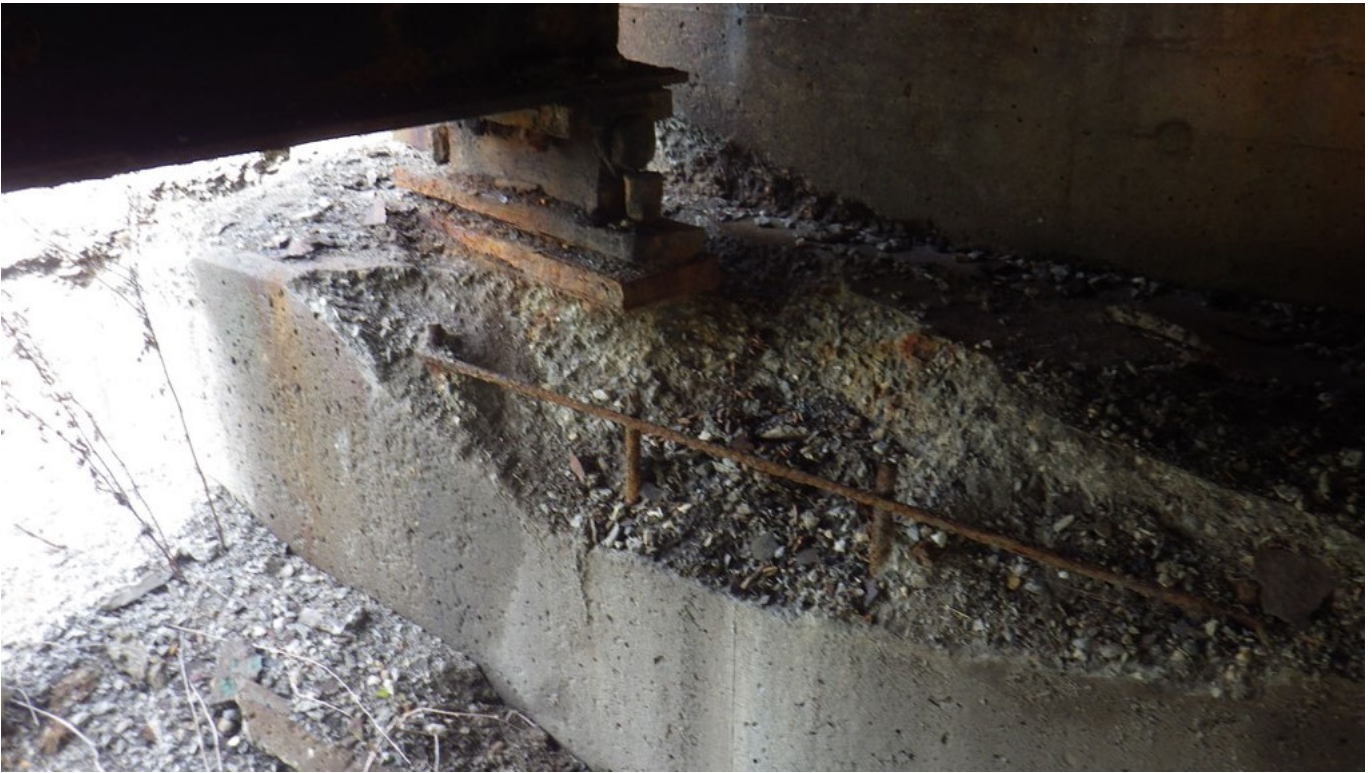
Abutment Condition

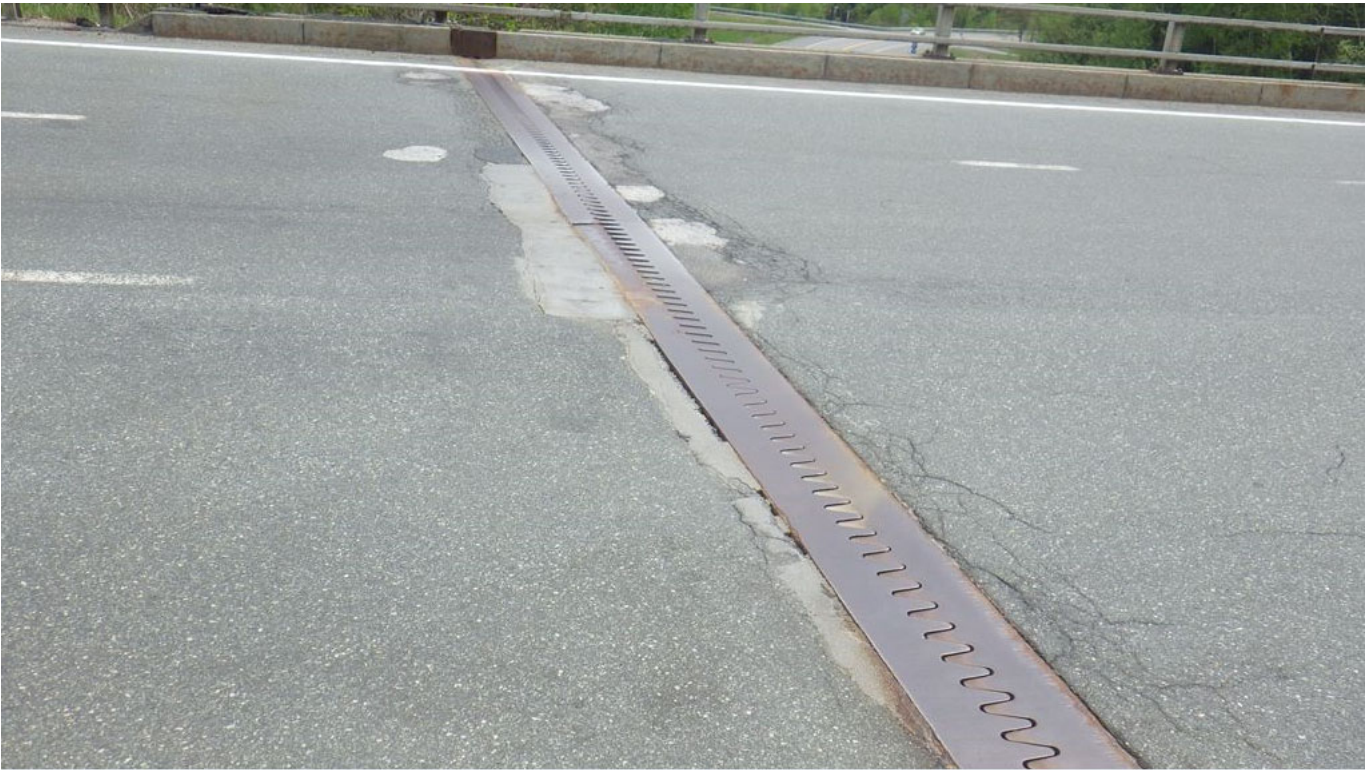
Deterioration around bridge joints

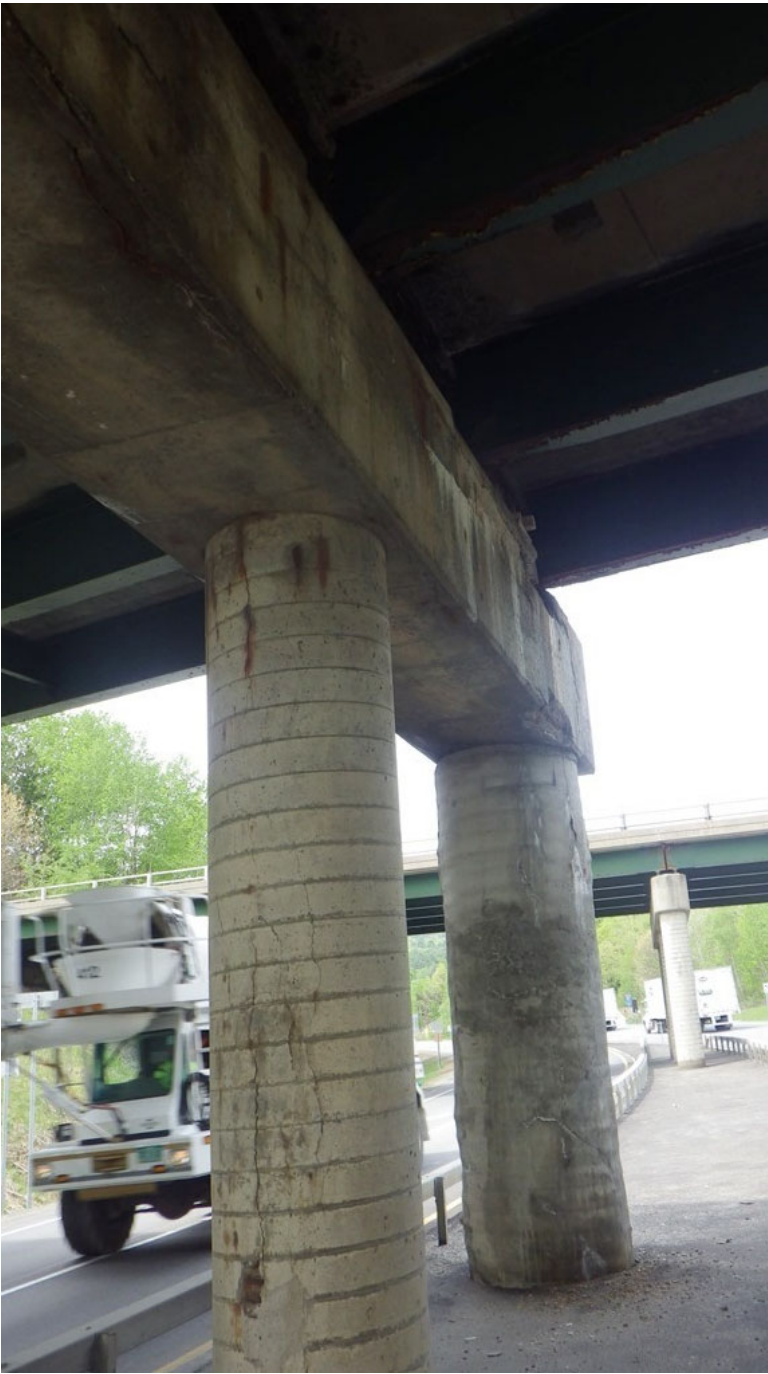
Pier Condition

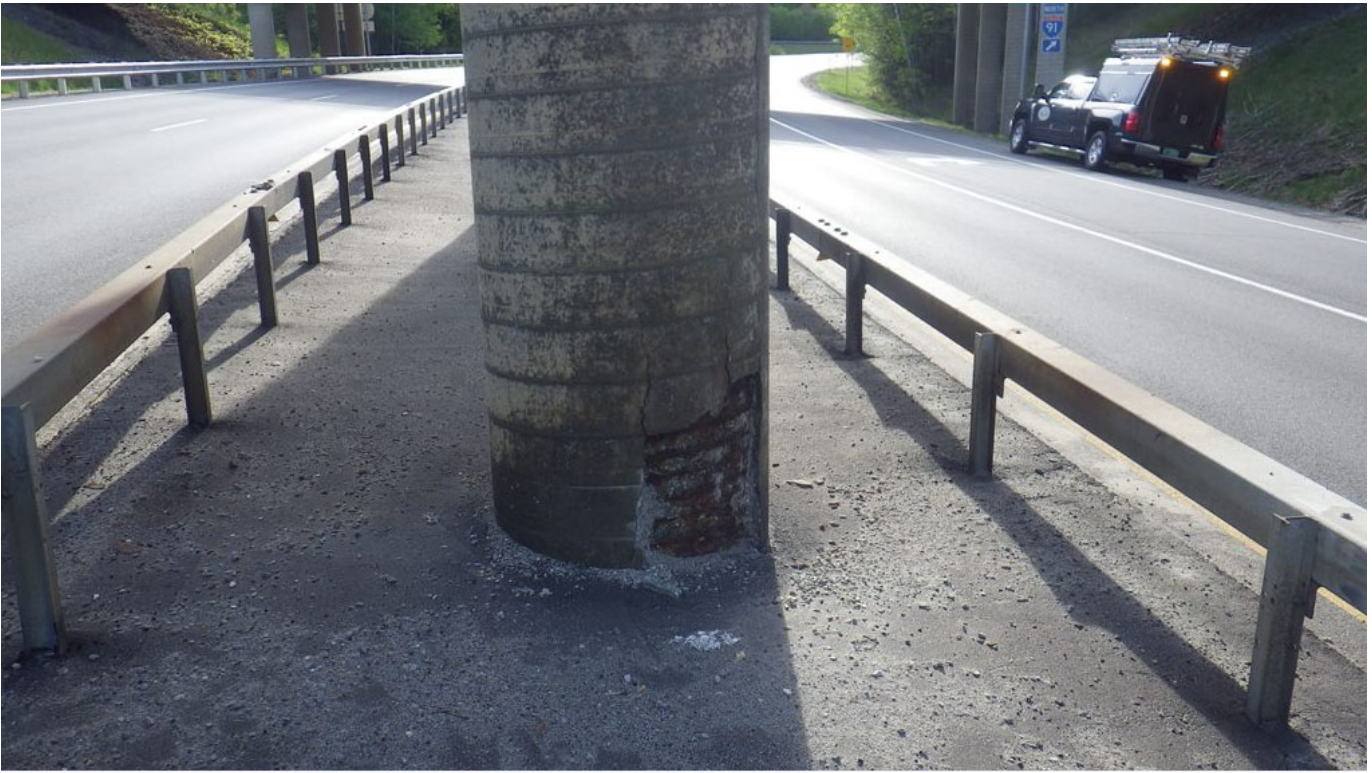
Pier column condition

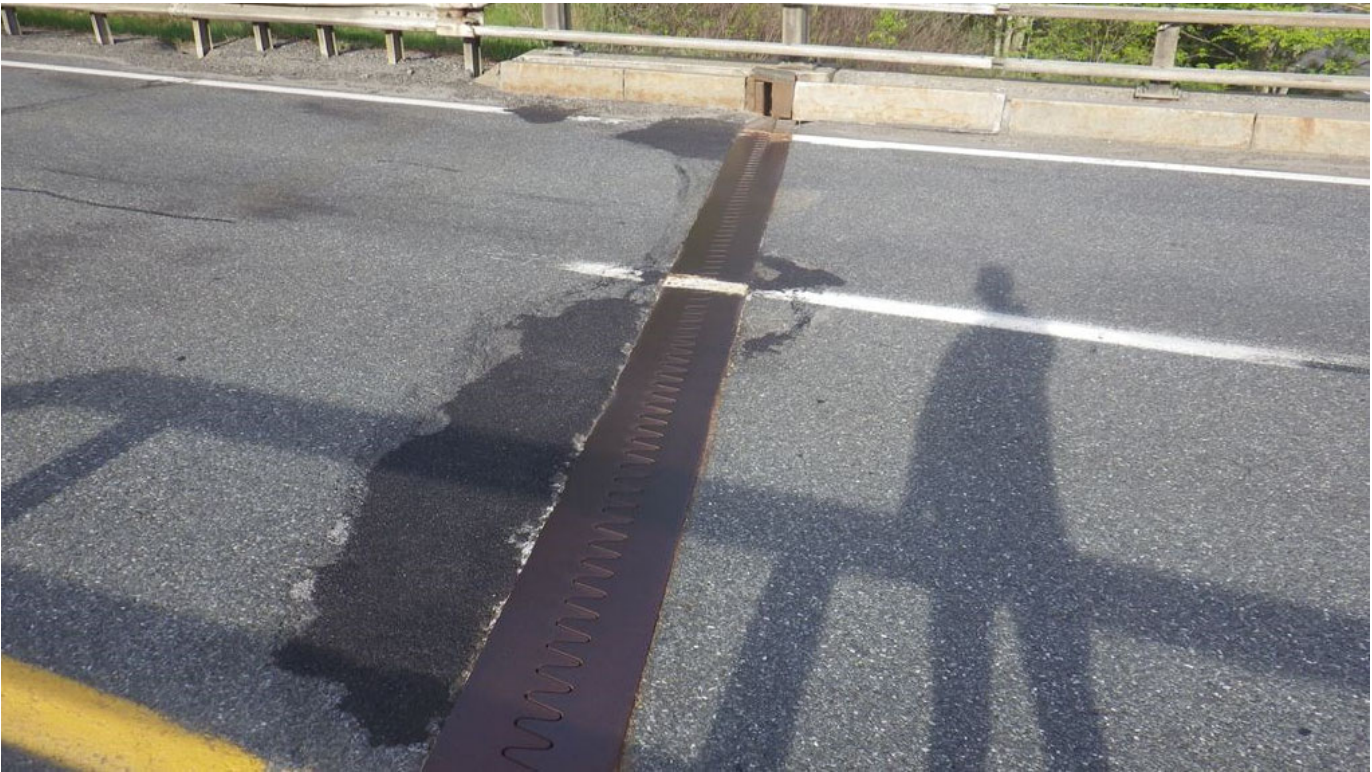
Deterioration around bridge joint

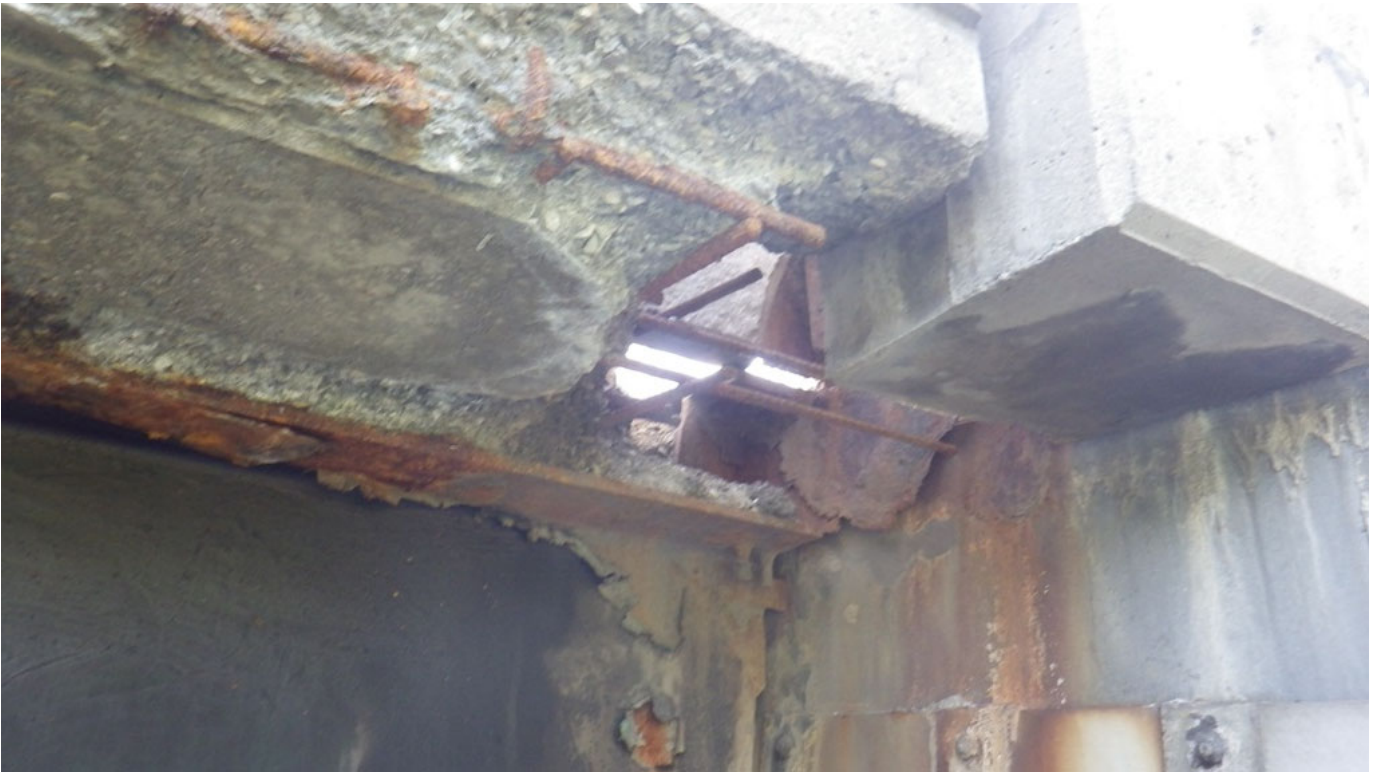
Deterioration at fascia and joint

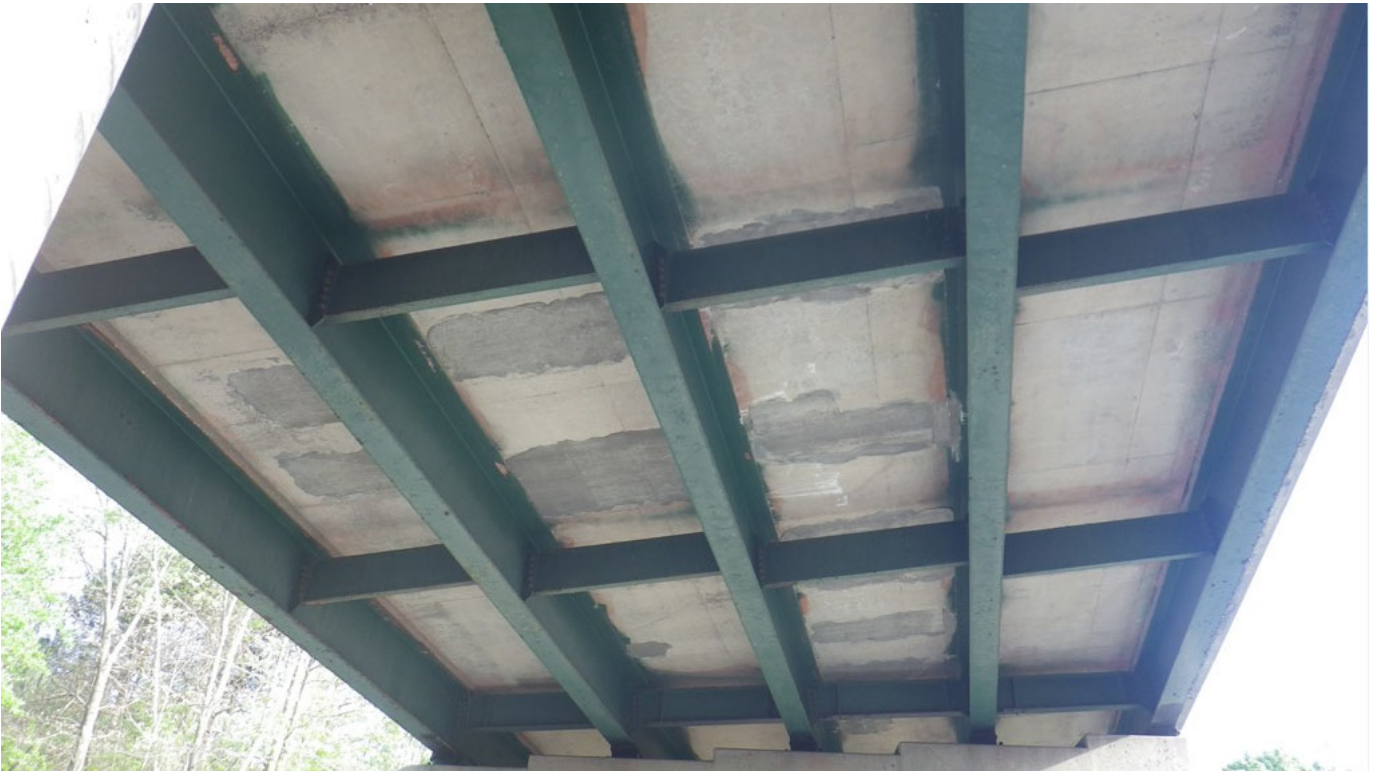
Bridge deck and superstructure condition

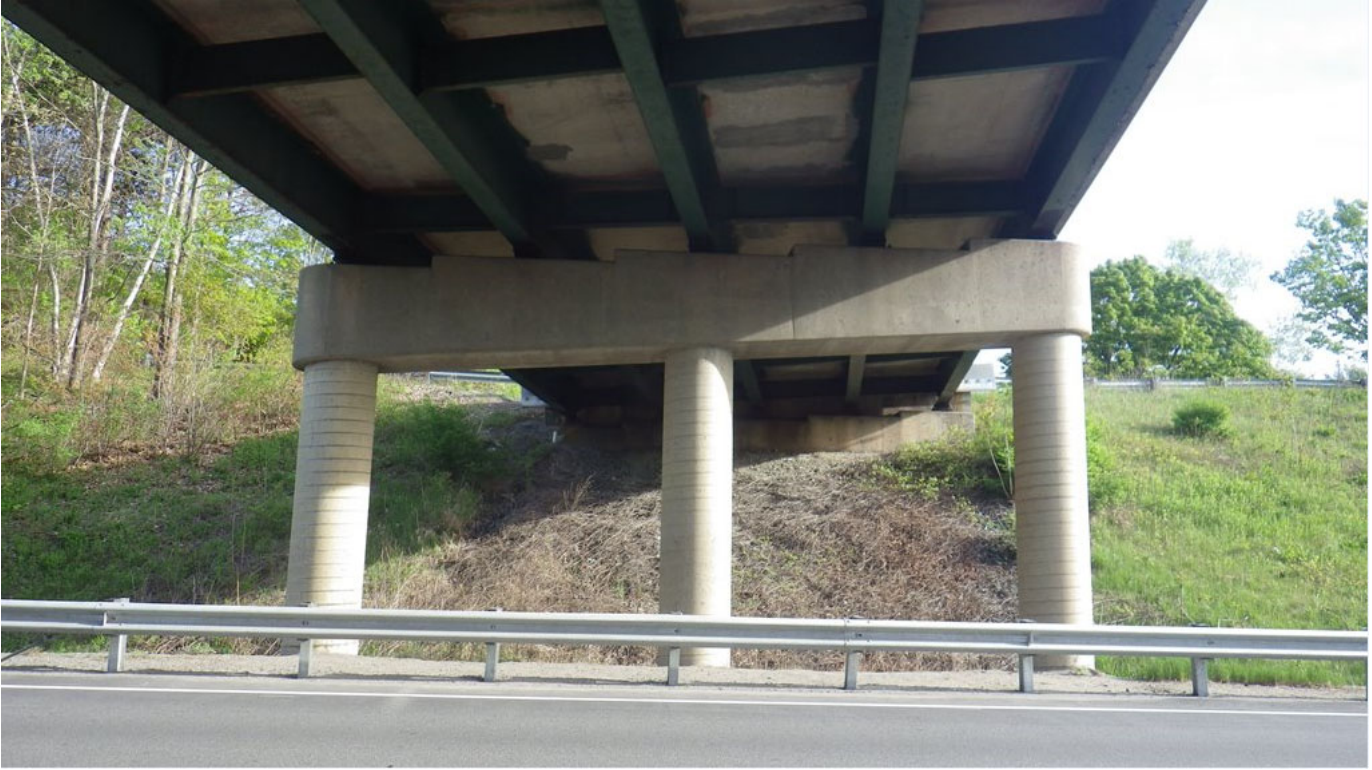
Pier condition

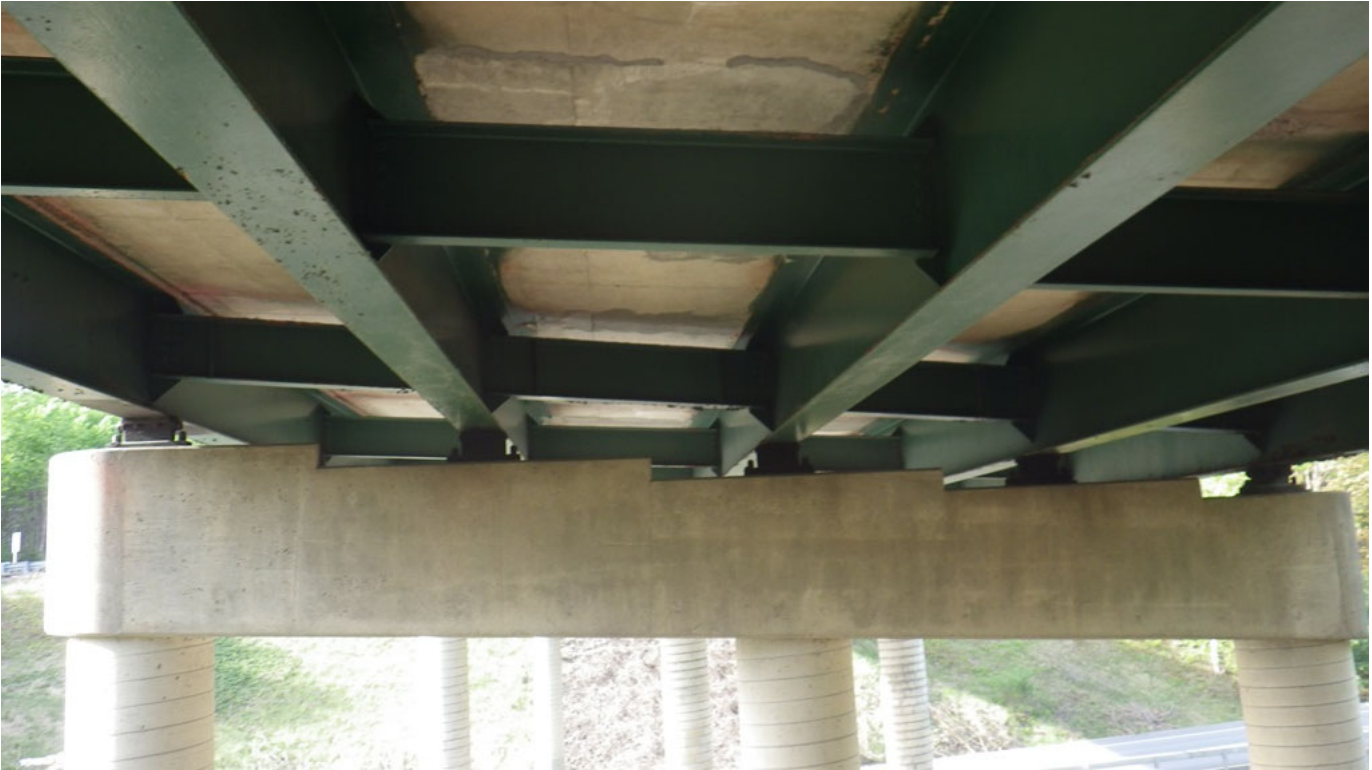
Pier cap condition

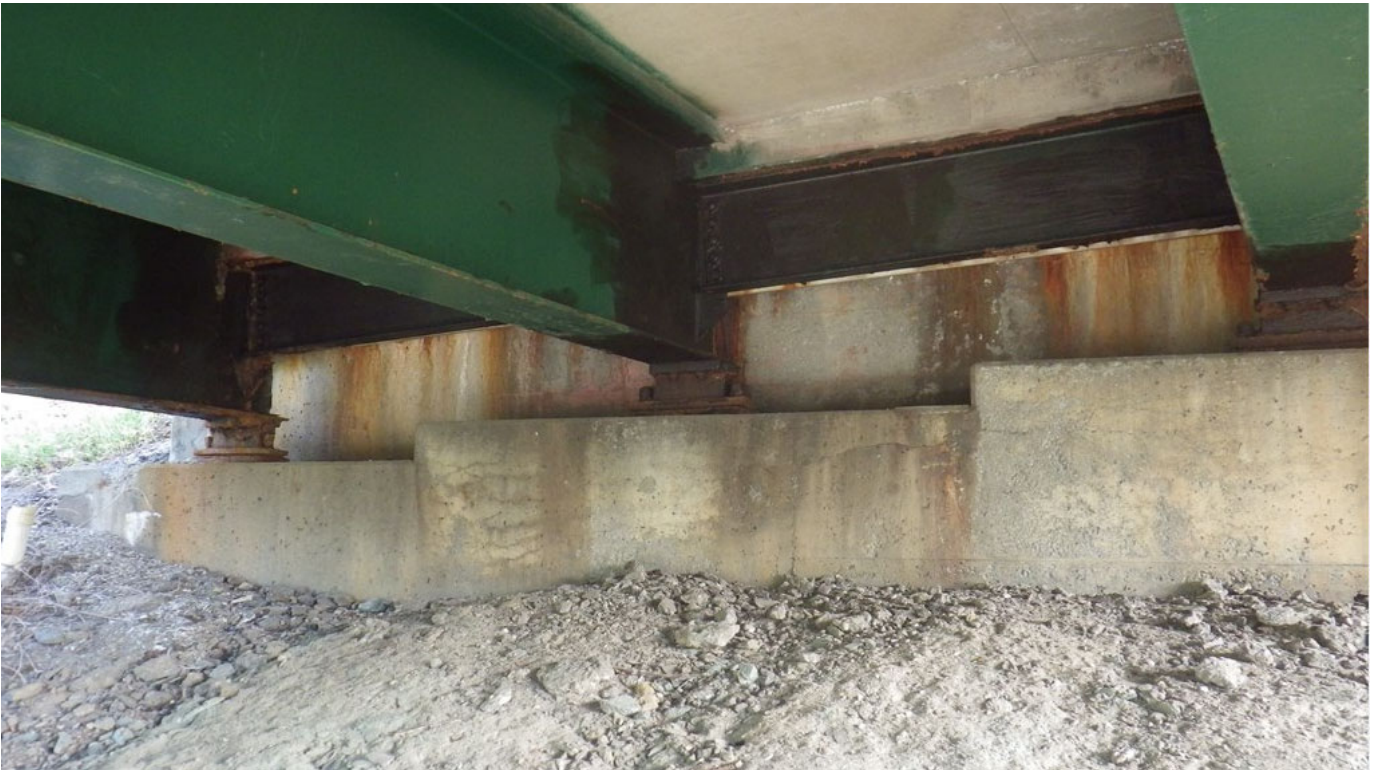
Abutment condition

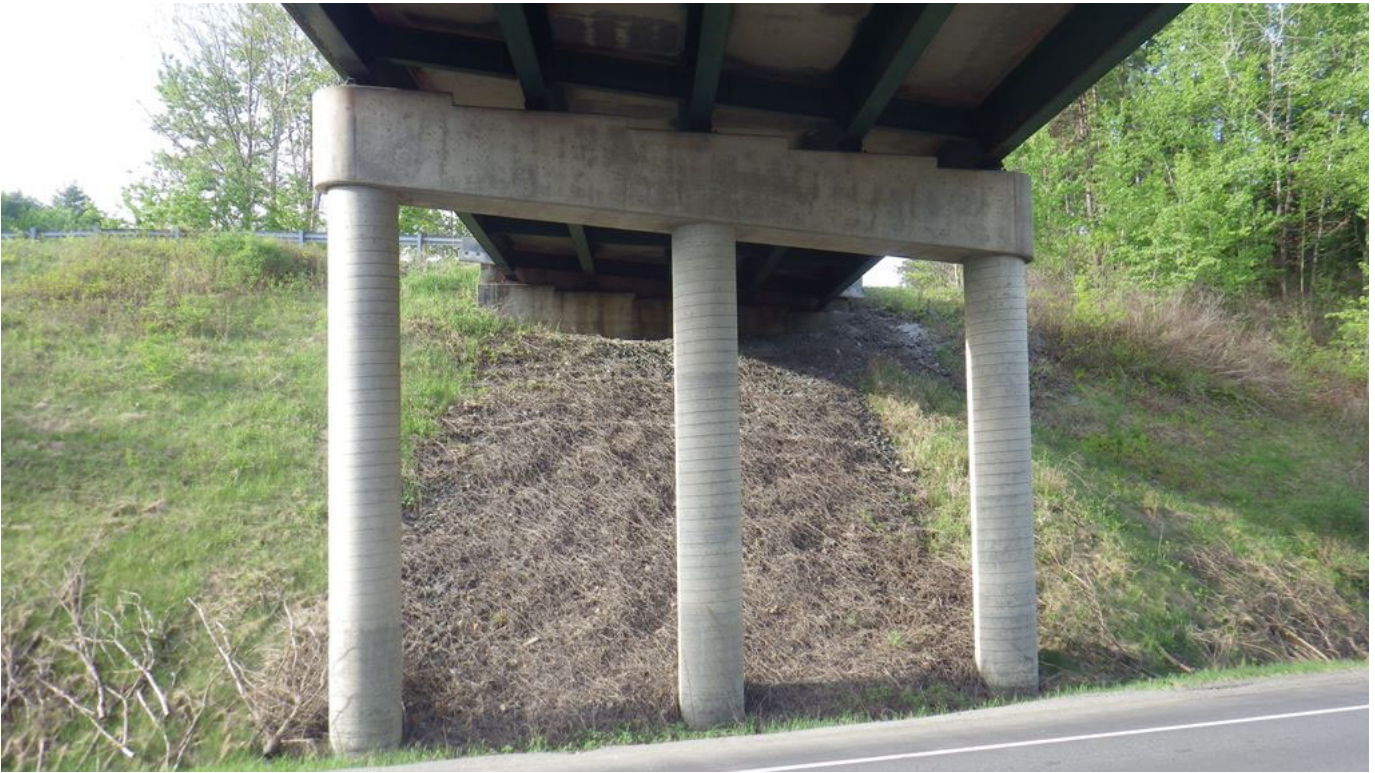
Pier condition

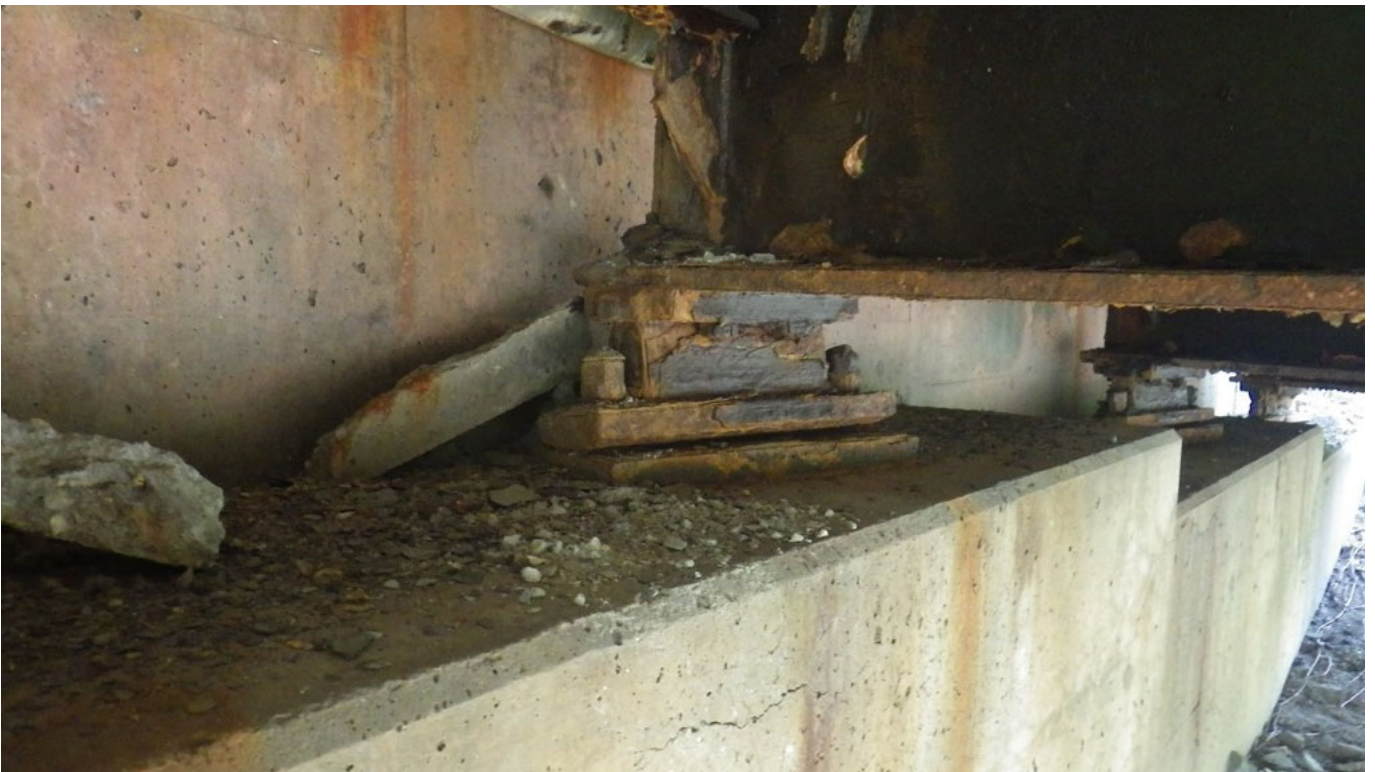
Bridge seat and bearing condition

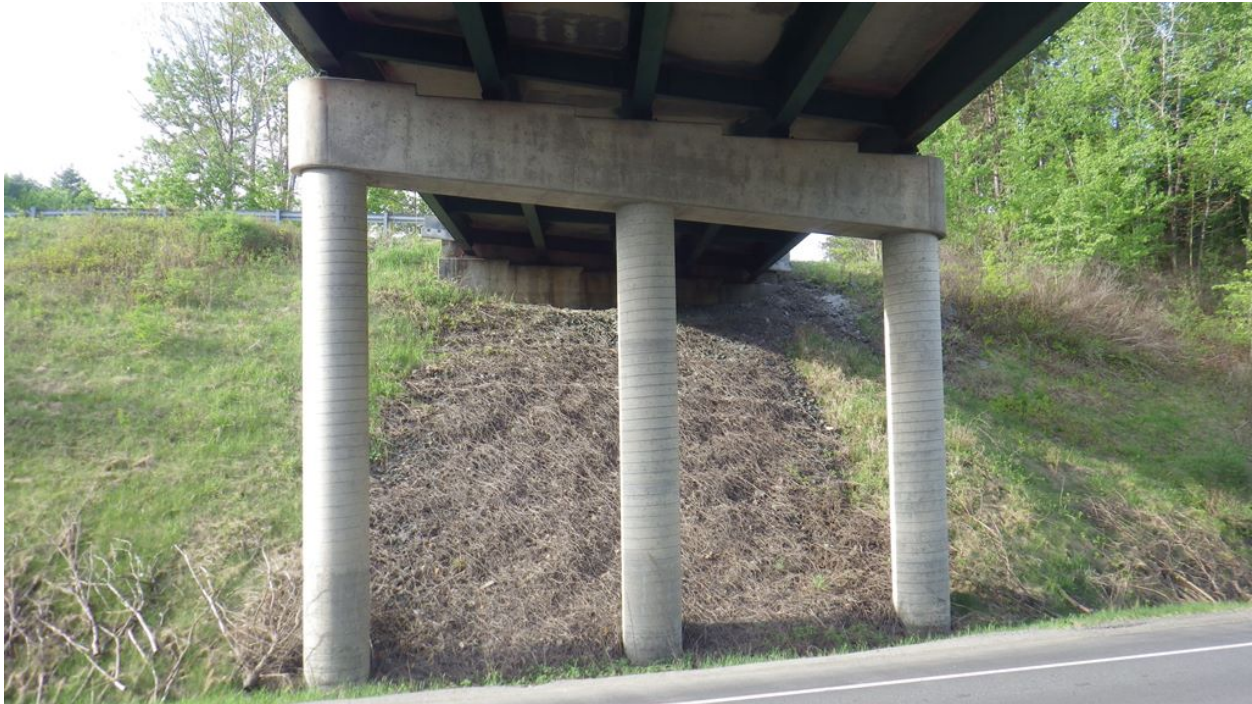
**Figure 3.1:** *Stone fill armoring at bridge abutment underneath Interstate 91 Bridge 28 Southbound. [Inspection photo dated 2018]*
