Town: 206 - SPRINGFIELD

IDENTIFICATION	
(1) State Names	50 - Vermont
(8) Structure Number	200091028S14182
(5) Inventory Route	1
(2) Highway Agency District	2 - District 2
(3) County Code	27 - WINDSOR

(4) Place Code	69550
(6) Features Intersected	I 91 OVER US 5
(7) Facility Carried	I 00091 ML
(9) Location	I 91 EXIT 7
(11) Mile Point	41.681 mi
(12) Base Highway Network	Yes

Team Lead: Martin Kelley, Inspection Date: 05/25/2022

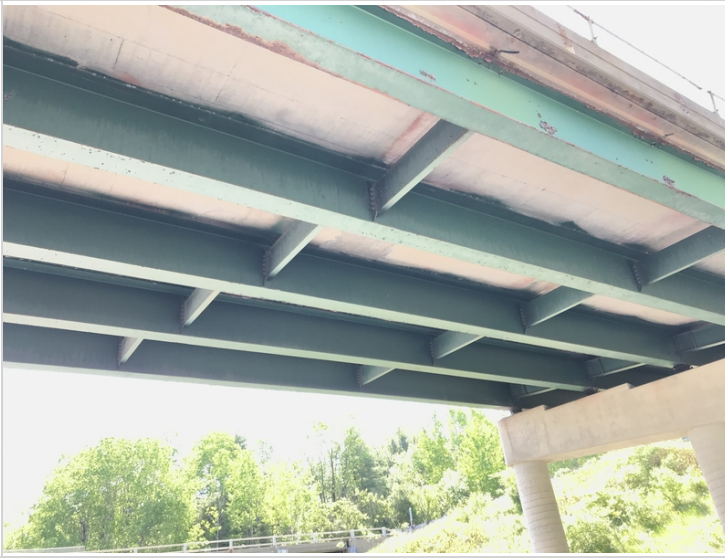
Span #2 Protective Coating

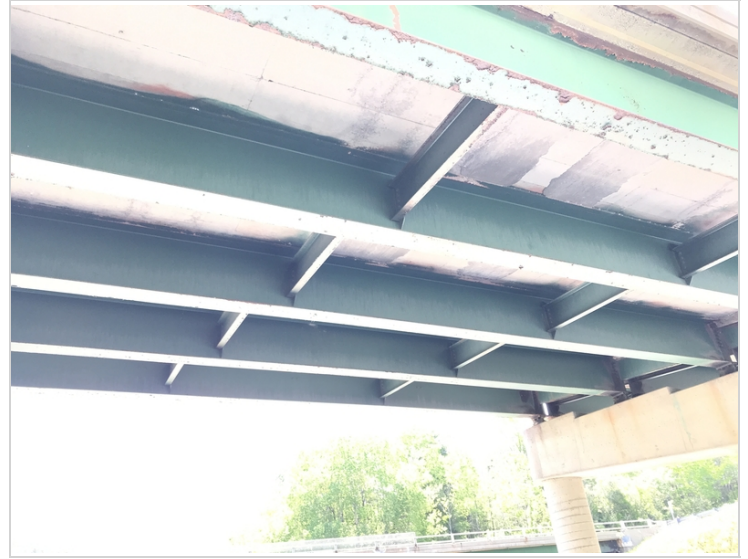
Span #3 Protective Coating

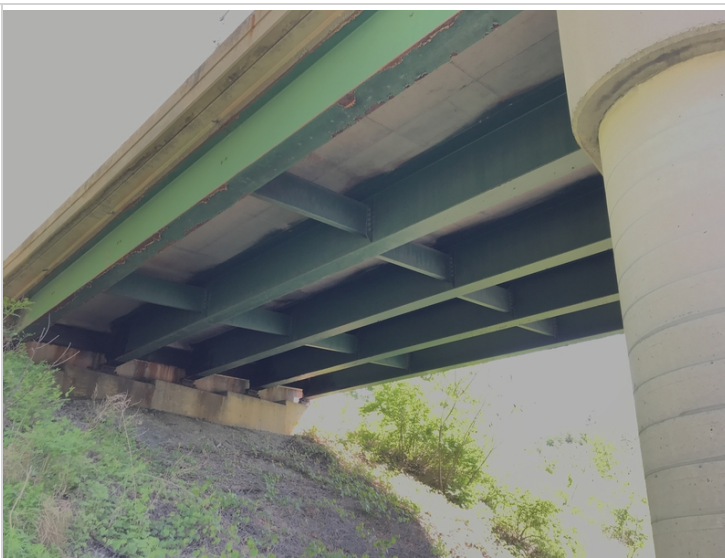
Span #4 Protective Coating

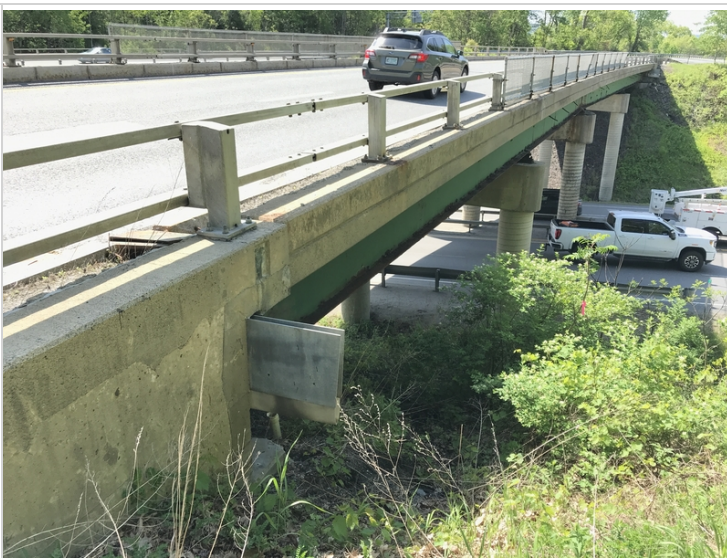
Western Fascia

Concrete fascia is in fair to poor condition having heavy spalling exposing thinning steel reinforcing at each joint along the fascias. Other minor cracking with rust stains and efflorescence leakage are scattered throughout.

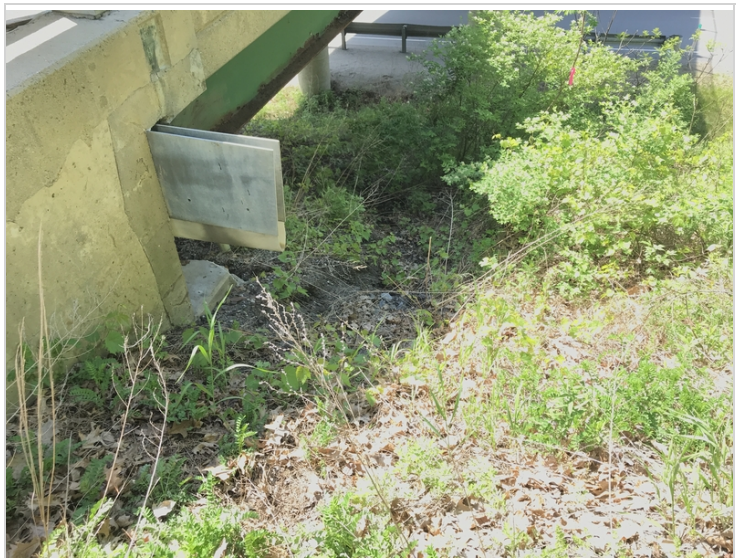
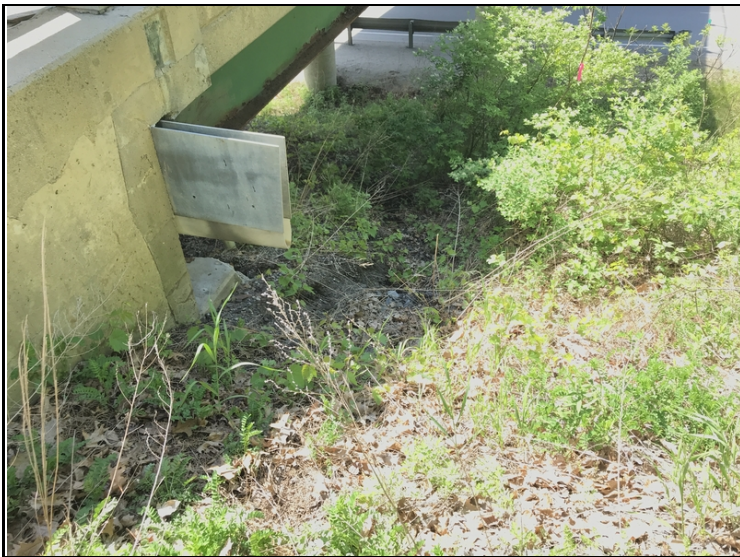
Erosion along Northwest Embankment

Erosion along embankments should be repaired

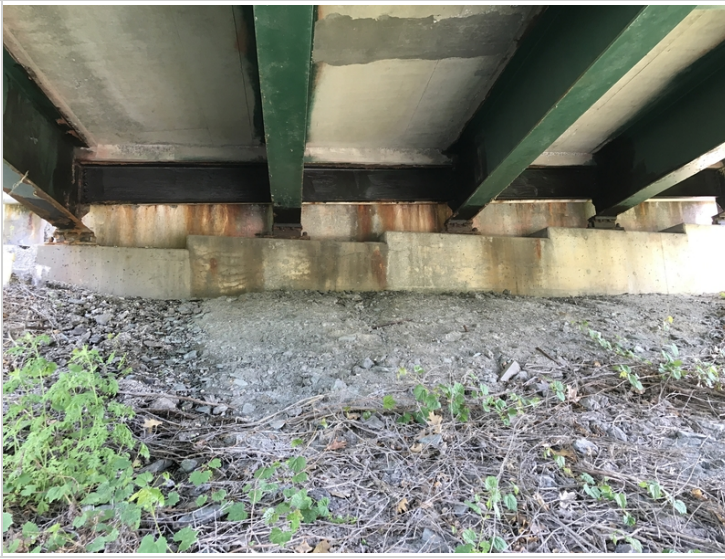
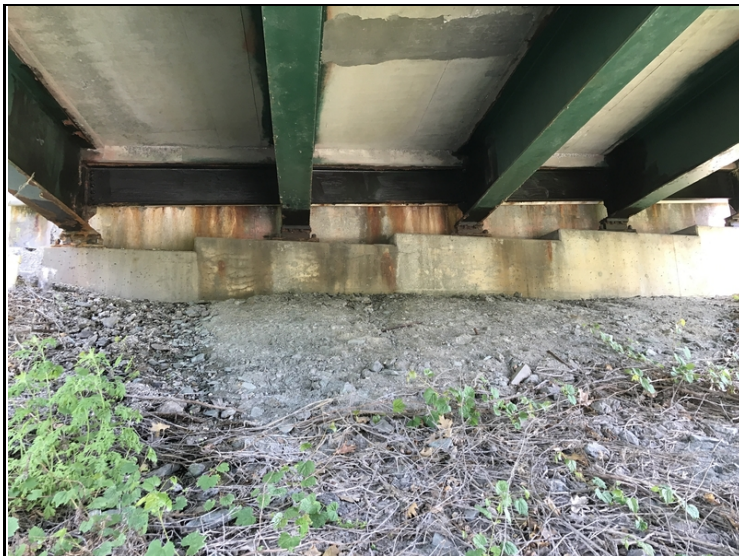
Abutment #2

Reinforced concrete abutment #2 is in satisfactory condition having minor cracking with rust stains scattered throughout the stem face. Outer portions of abutment stem / bridge seat have areas of concrete scaling / spalling. Minor sediment build up is present along bridge seat.

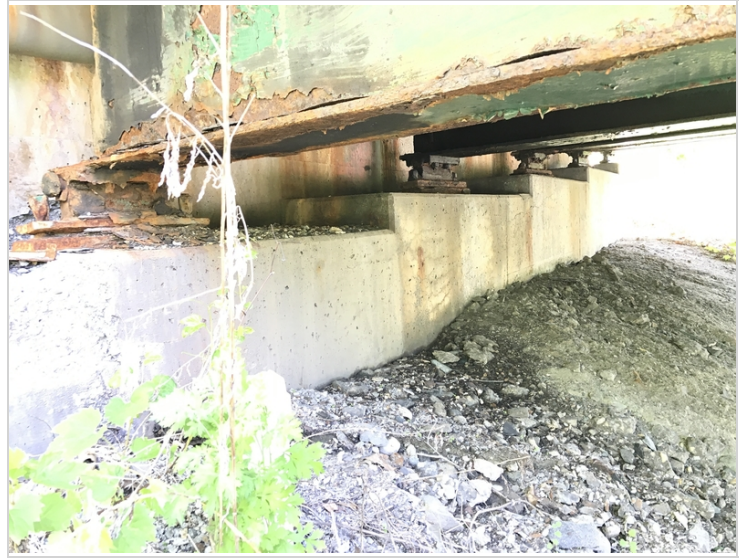
Bearings at Abutment #2

Rocker bearings are present over both abutments and piers #1 and #3. Pier #2 has fixed bearings. Both abutments and pier #2 have joints present allowing leakage with bearings having moderate to heavy rust scaling and anchor bolts thinning. Rockers over abutments and pier #1 and #3 have allowable rotation.

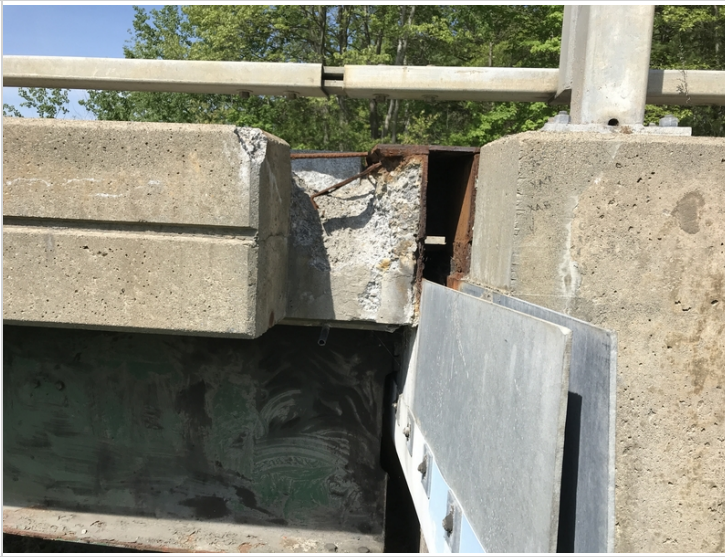
Eastern Curb at Abutment #2

Concrete curbing with granite block facing is in fair condition having areas of moderate to heavy concrete scaling and cracking behind granite blocks. A few of the granite blocks have slight translation pushing away from concrete curbing. Heavy spalling exposing steel reinforcing is present at each joint area along fascia's.

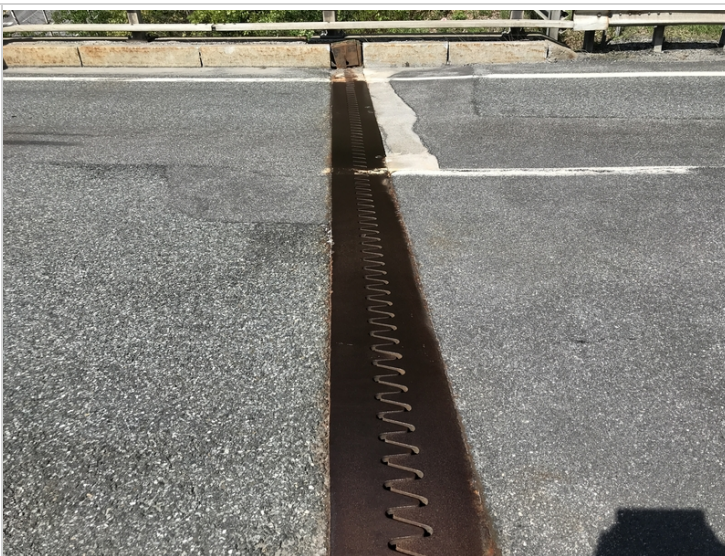
Steel Finger Plate Joint over Abutment #2

Steel finger plate joints are present over both abutments with steel plates having minor pitting and rusting along the outer portions and with gouges and scrapes in travel lanes. Steel plate spacing has roughly 1/2" at both joints. Steel housing below has heavy rusting. Areas along the western side of both steel finger plates have been previously patched. Asphaltic plug joint is present over pier #2 is in fairly good condition.

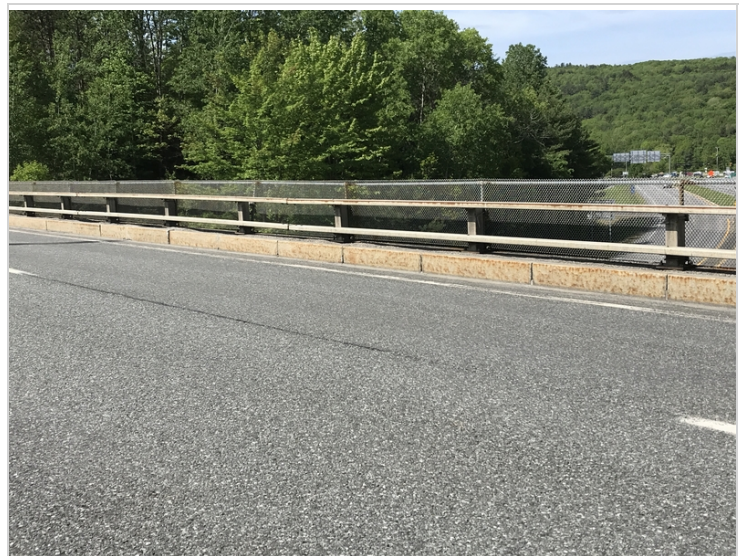
Galvanized two (2) tier box beam rail is in fair condition having some minor scrapes, gouges and dents with scrapes starting to rust. Impact damage is present along the northwest corner of structure with rail being bent and twisted. Western side of rail is missing six (6) connection bolts along the top section of rail. Snow fence has heavy rusting around connections with some connections missing over US-5

Sheared Connections Bolts along Snow Fence on West Side

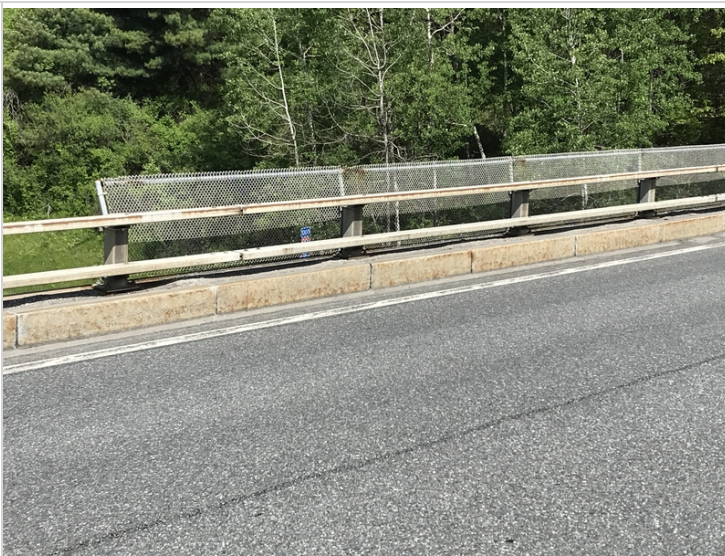
Western Snow Fence with Rusted Brackets and Frame

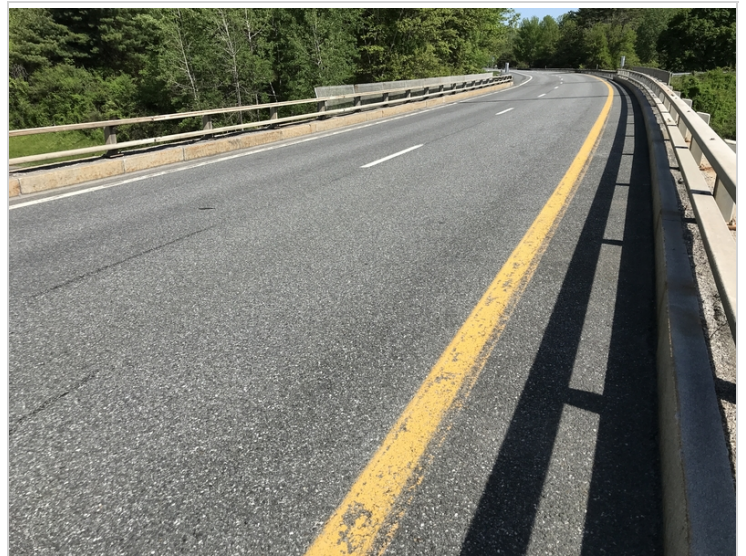
Wearing Surface

Asphalt is in satisfactory condition with minor wearing in travel lanes and some very small cracks. Patches are present around abutment joints. Large area of distress is present along the abutment #1 joint on the western side with asphalt having heavy break up and full depth hole beneath curb

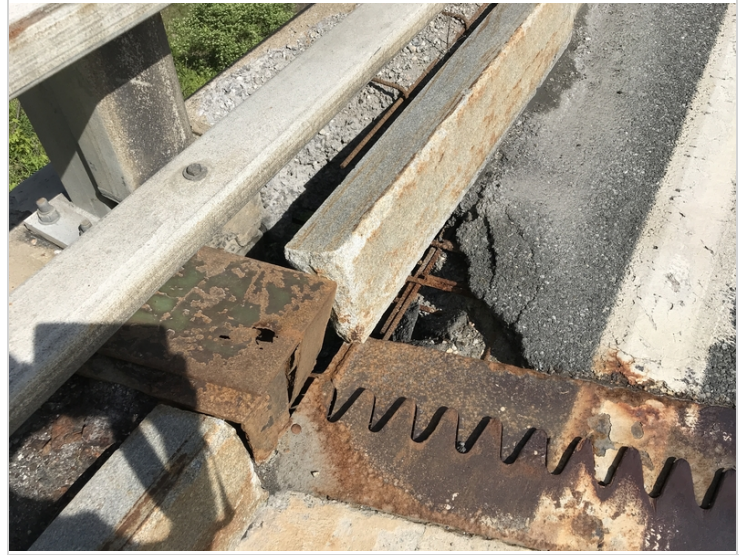
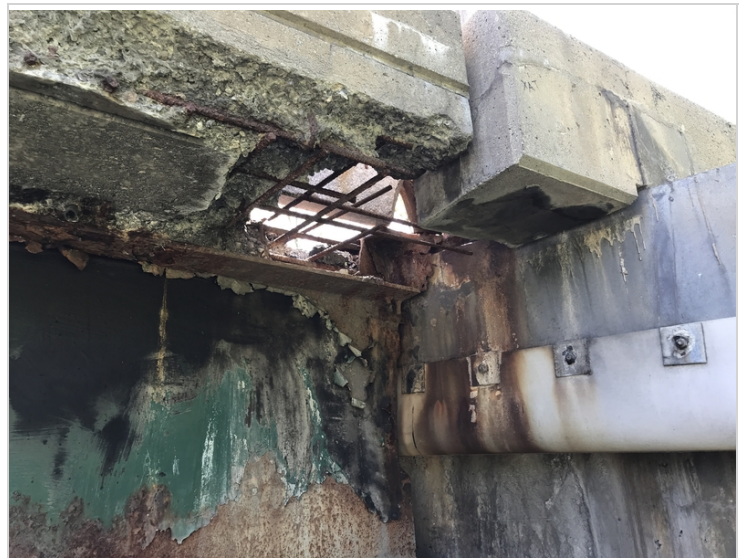
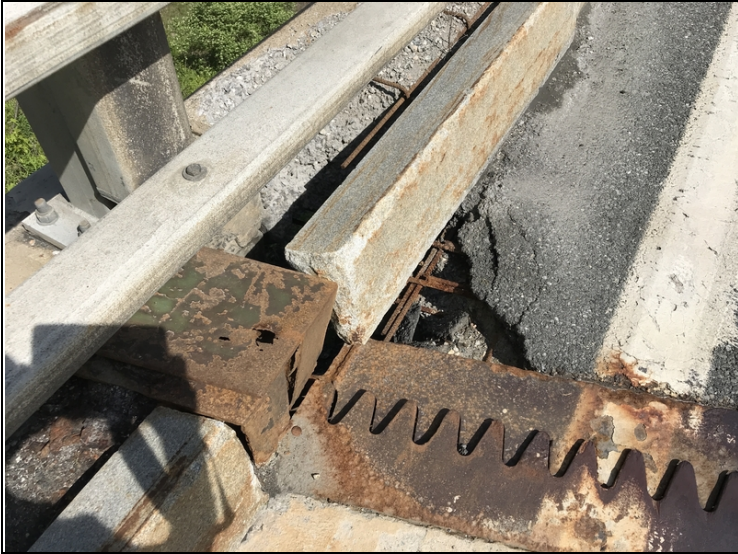
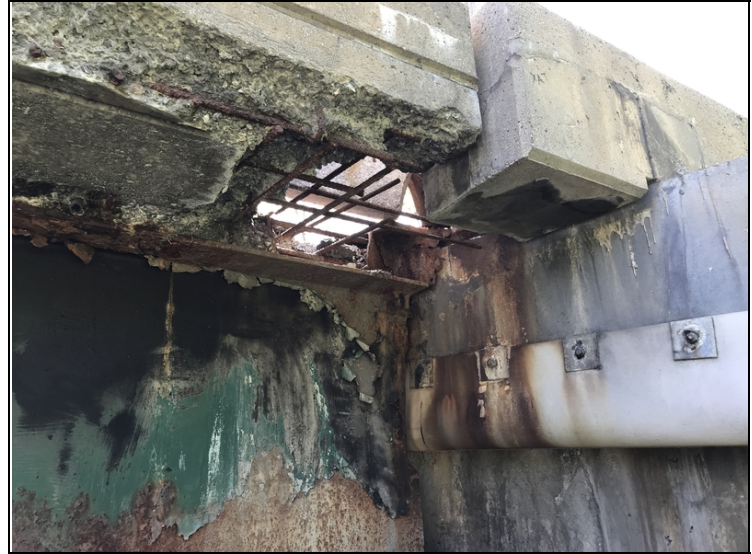
Southwest Corner of Deck at Abutment #1

Reinforced concrete deck is in fair condition having multiple scattered concrete patches present throughout the bays and spans. Other scattered areas of transverse cracking with efflorescence leakage, small delaminations and spalls are present. Large area of severe spalling is present along the southwest corner of structure that has penetrated from fascia of structure past top flange of beam #1. Area surrounding joint over pier #2 along the West side also has severe spalling present that has also penetrated over the top flange of beam ends.

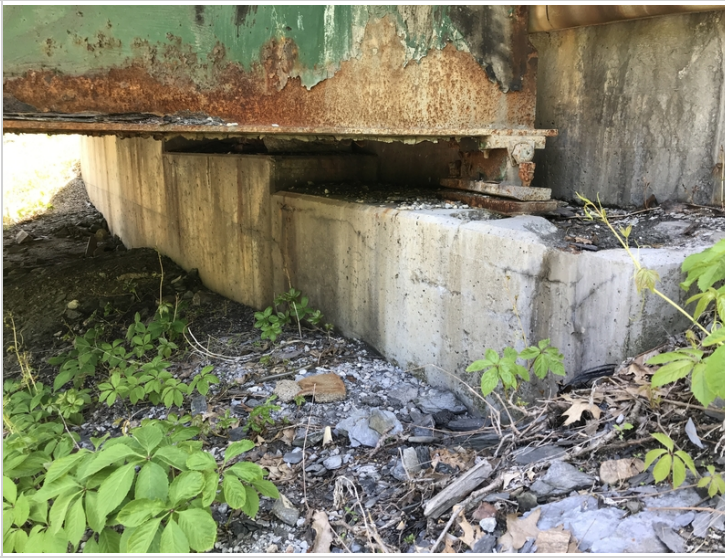
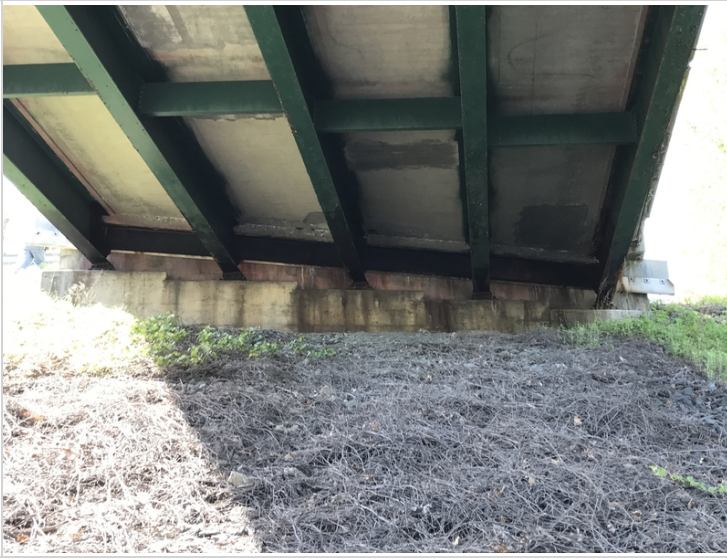
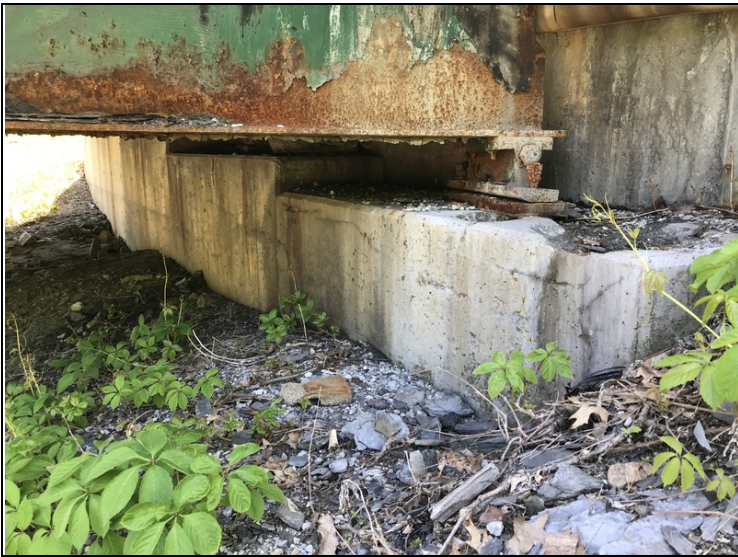
Abutment #1

Reinforced concrete abutment #1 is in satisfactory condition having minor cracking with rust stains scattered throughout the stem face. Outer portions of abutment stem / bridge seat have areas of concrete scaling / spalling. Minor sediment build up is present along bridge seat.

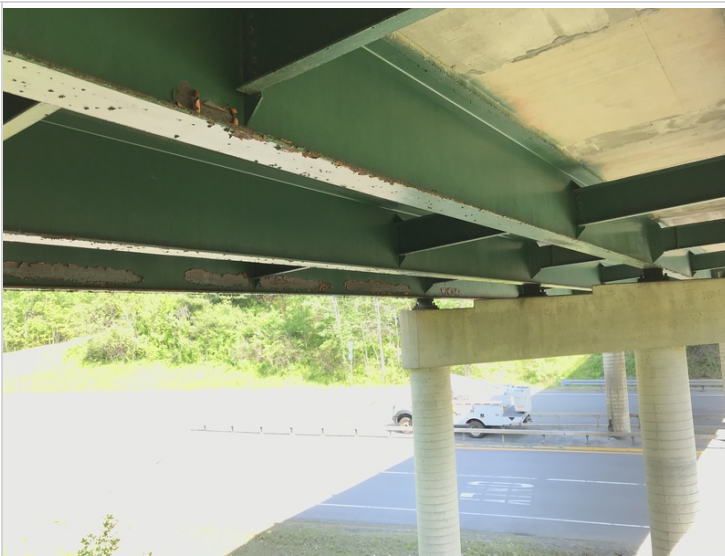
Span #1 Protective Coating

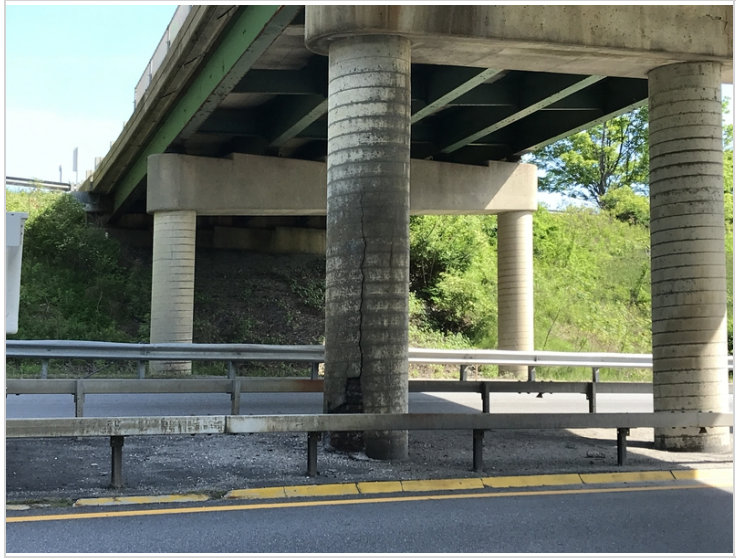
Pier #2 Column #1

All three (3) piers have three (3) columns a piece. Pier #1 columns are in good condition. Pier #2 column #1 and #2 have delaminations and spalls present along the lower portions with column #3 in good condition. Pier #3 column #1 has small delamination along the lower portion with remaining columns in good condition.

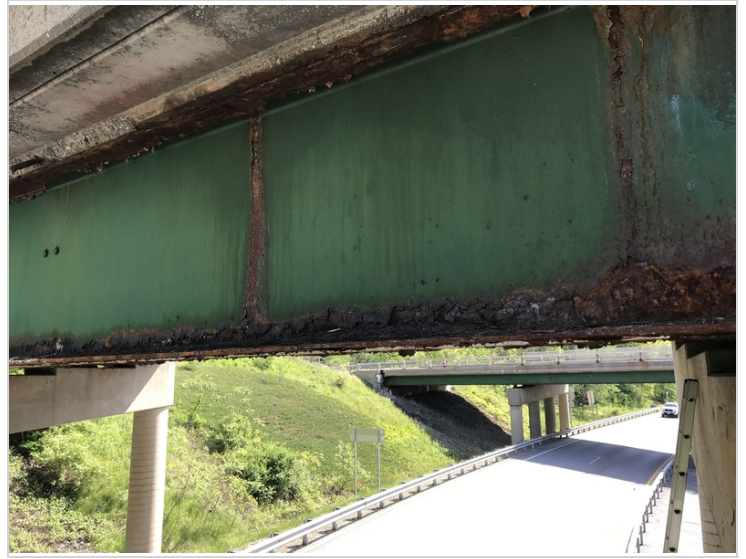
Five (5) painted steel rolled beams are present per span are in fair condition having areas of heavy rust scaling and thinning with beam #1 in spans #2 and #3 having heaviest corrosion and section loss at pier #2. Beam #1 at Pier #2 in Span #3 has section loss along the lower portion of web with large perforation that continues to corrode causing lower flange to bend upwards. Fascia beams have lighter corrosion from weathering. Beams have neutral to slightly positive camber. Protective layer has failed at both abutments and at pier #2 along the beam ends below deck joints that continually allow leakage to structure below causing progressive corrosion.

Beam #1 in Span #2 with Heavy Rust Scaling

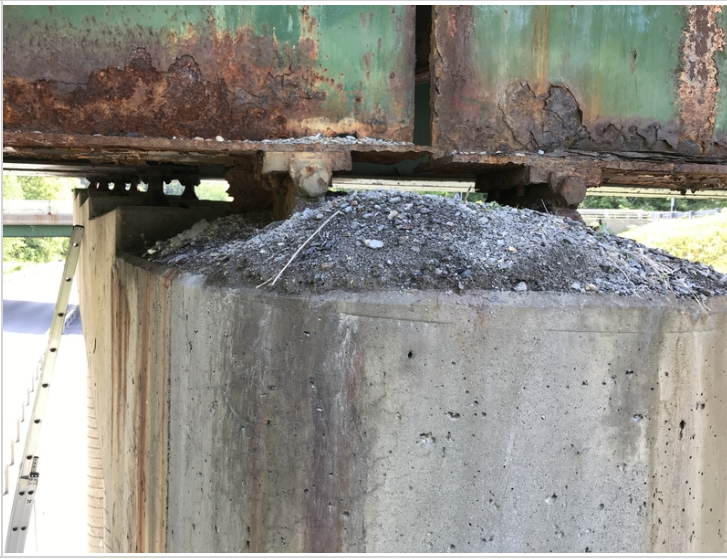
Heavy Debris on Pier #2 West End

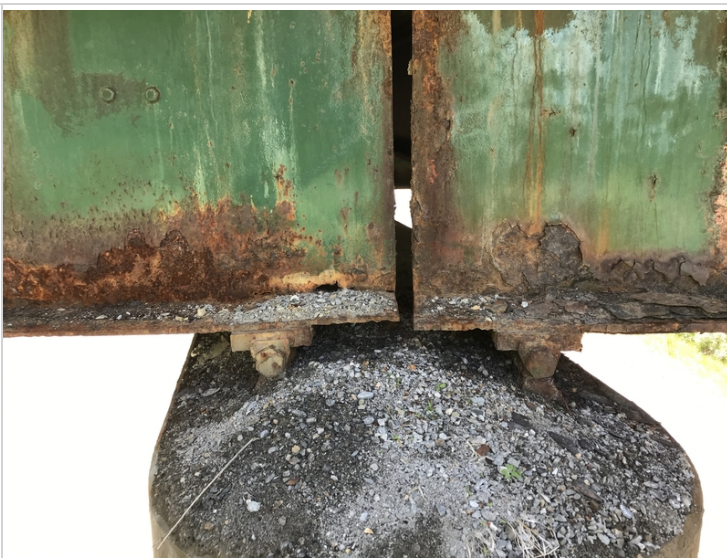
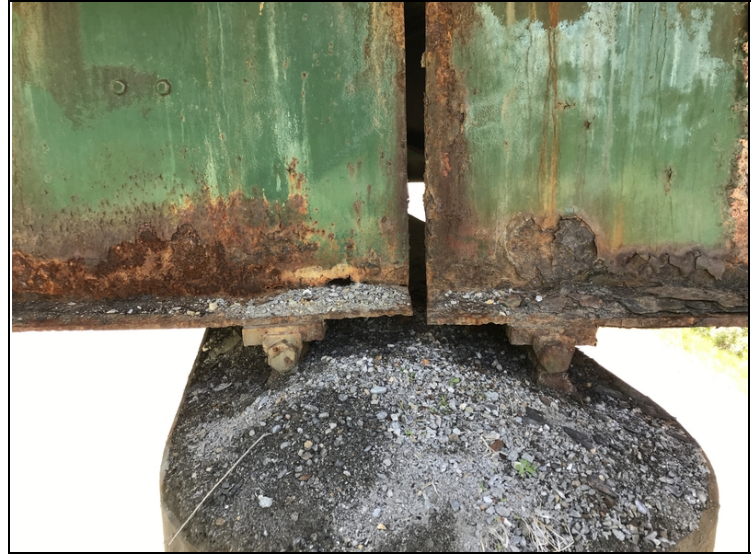
Span #2 Beams #1 Section Loss
