**STATE OF VERMONT
AGENCY OF TRANSPORTATION**

Structure Type Study

Readsboro BF 0102(16)

VT ROUTE 100, BRIDGE 25 OVER THE DEERFIELD RIVER

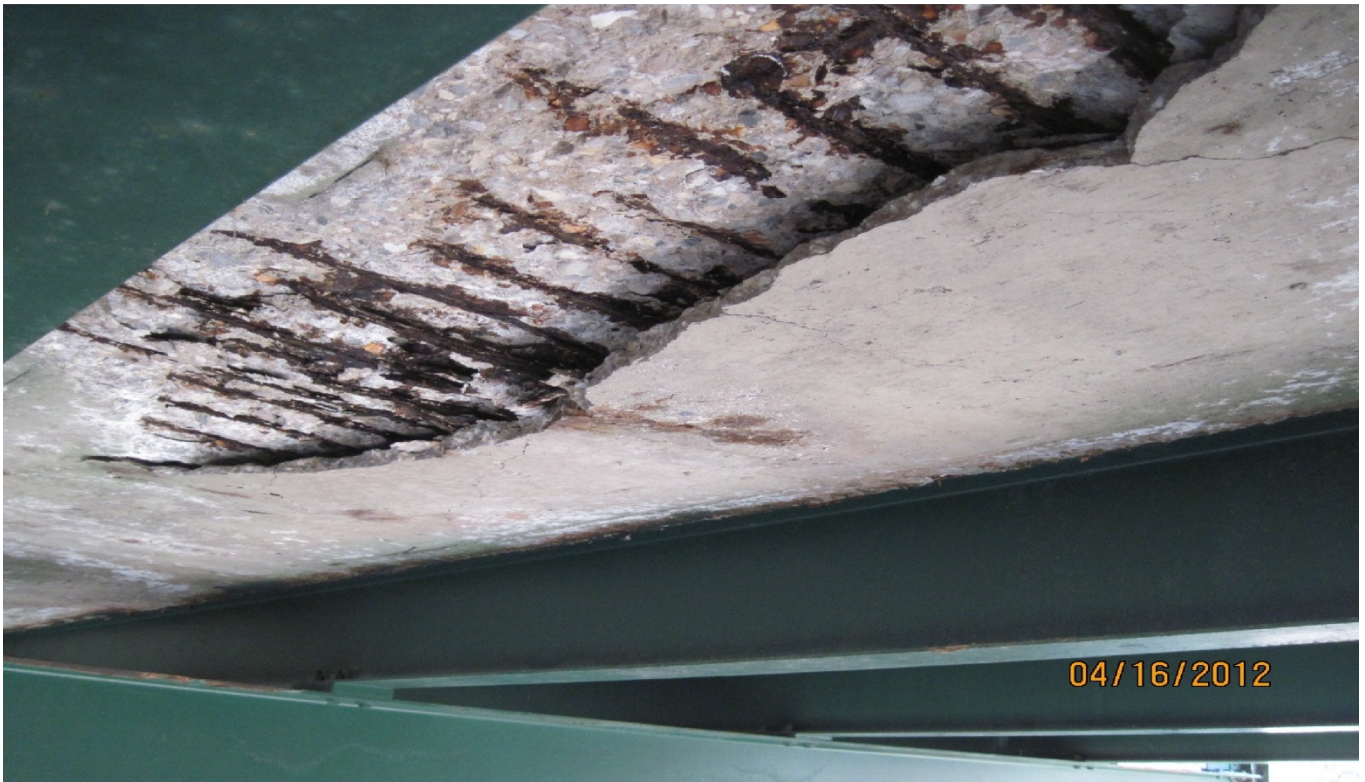
Delaminating Deck

1. The bridge is rated as structurally deficient.
2. The deck rating is 3 (Serious) and the Superstructure rating is 4 (Poor). A critical maintenance report has been made for this bridge, identifying the poor condition of the deck and superstructure (see Appendix).
3. The existing bridge railing and transitions are rated as 0 (Does Not Meet Current Standard).
4. The roadway alignment east of the bridge is substandard due to K value, sight distance, and horizontal geometry. On the west side, K value on the approach is substandard.

4/17/2014 The structure needs to have a rehabilitation project in the near future. There needs to be a full deck replacement with new joints installed that provide a drainage system to protect the beam ends. The beams need to be cleaned and painted. The guardrail system needs to be replaced. And the abutments should have patching repairs to the backwalls and bridge seats. ~JWW/JDM

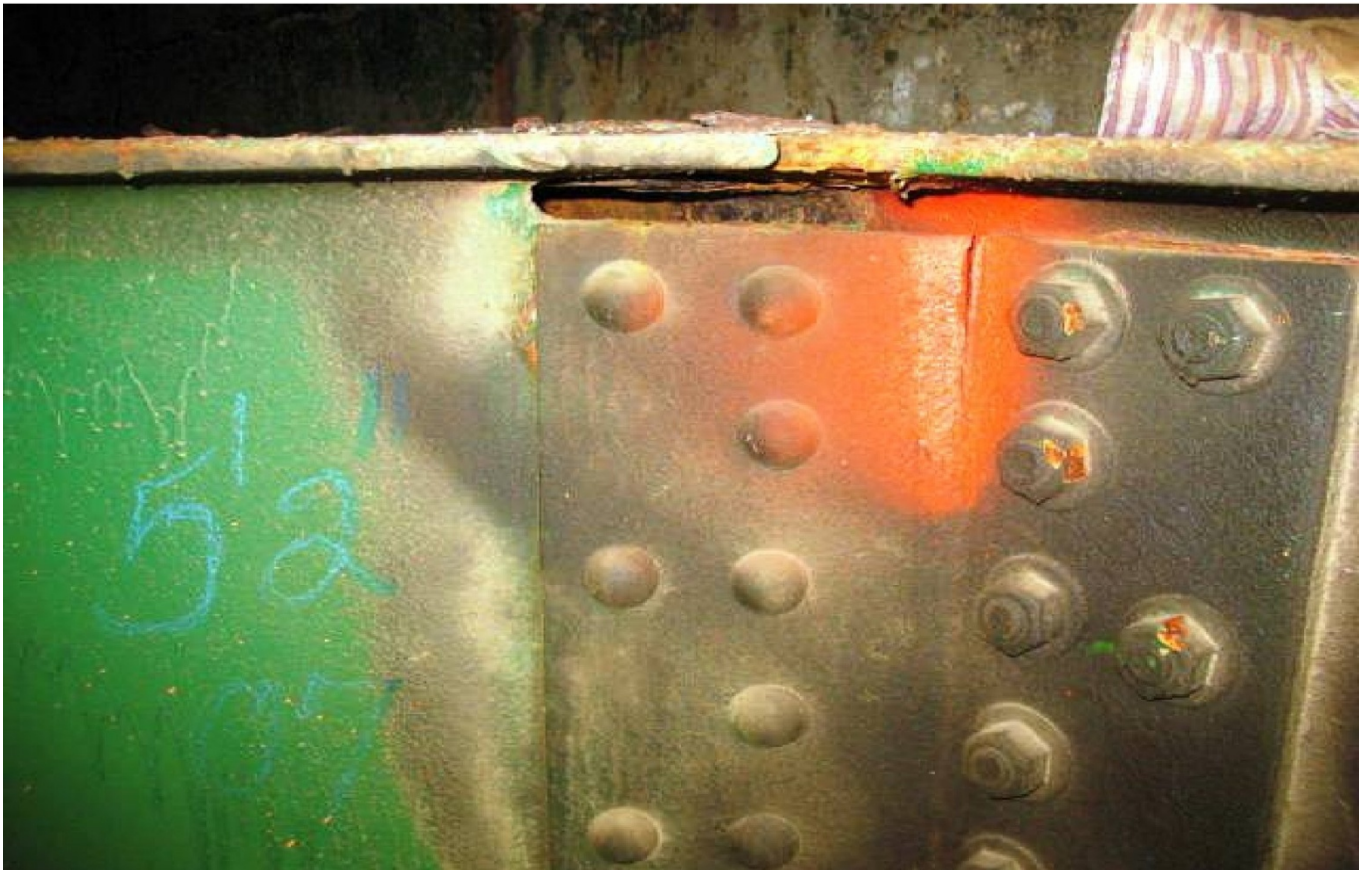
Secondary Member Crack

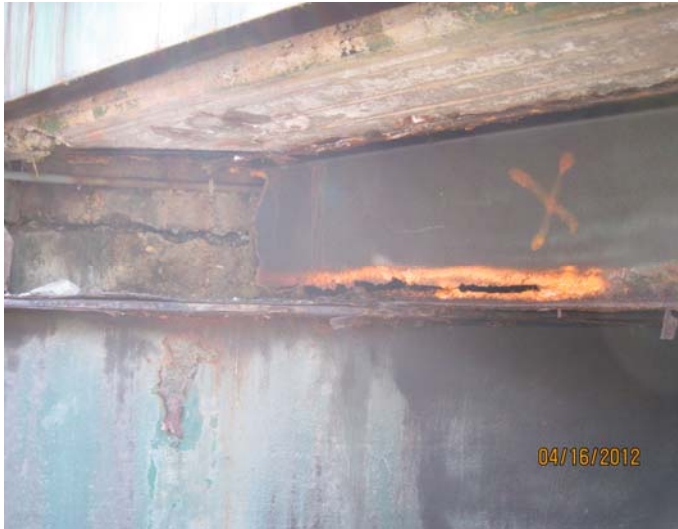
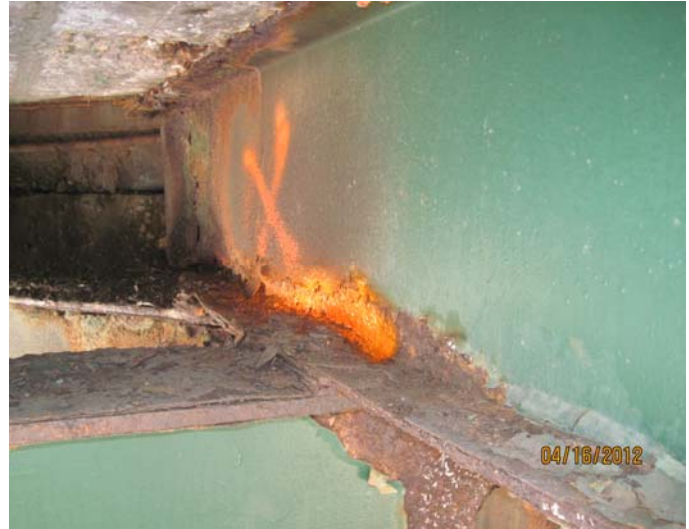
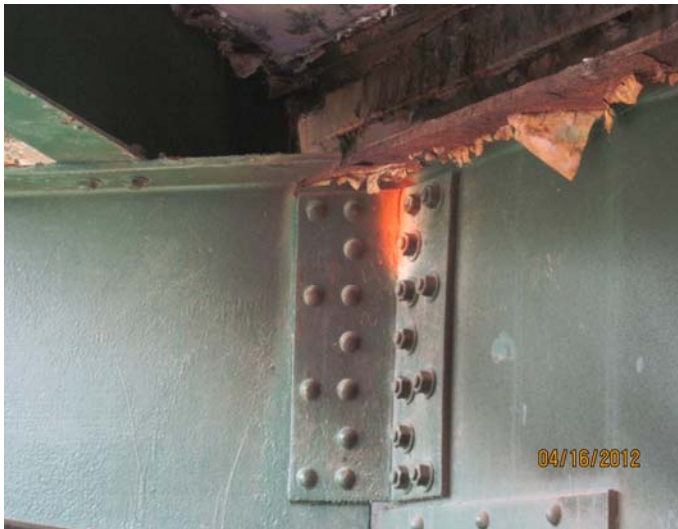
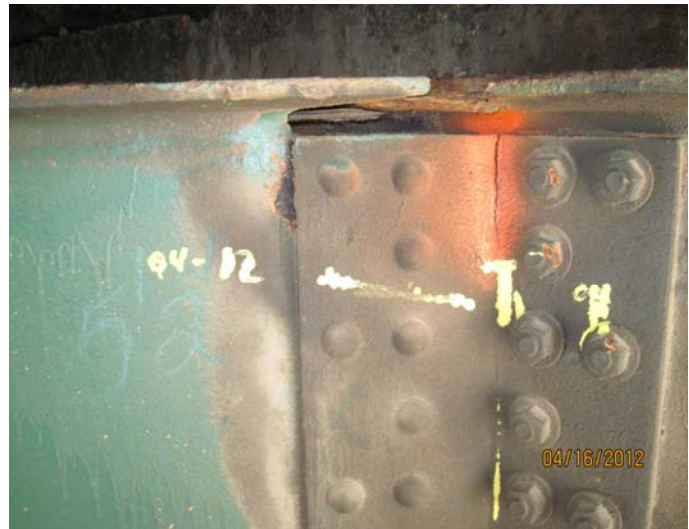
BRIDGE INSPECTION - CRITICAL MAINTENANCE REPORT

| 1. Deck Repair Needed | Large and thick delams w/ broken rebar |

| 1. Repair Stringer Beam | Holes in lower web. |
| 2. Repair | Connection plates |

Inspector(s) Comments : Large delaminations in bays 2 or 3 of spans 2 and 3 are in need of added support to prevent local break through. Stringer beams 1 thru 3 of span 3 are in need of reinforcement along the lower web areas. Connection plates on the south side of the both end floor beams are in need of repairs.

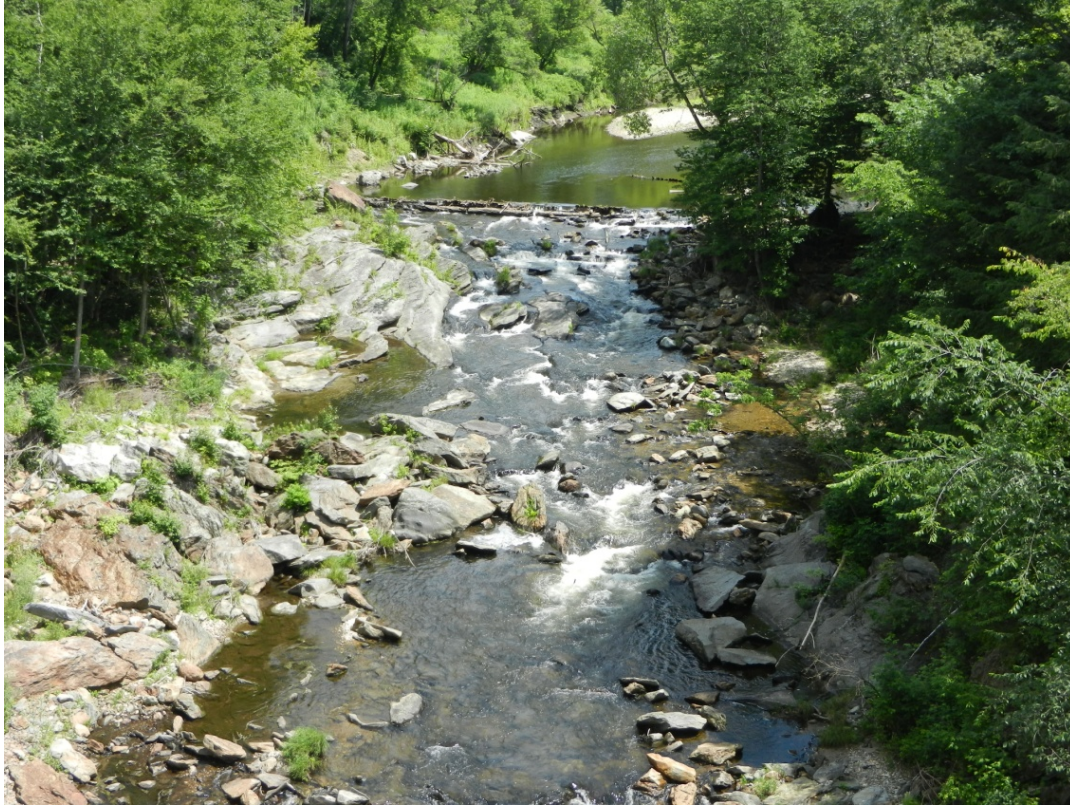
Figure 2 shows visible bedrock upstream of the bridge; however it should be noted the bedrock elevation at this site is variable. Based on the existing plans, and nearby borings, although bedrock is visible up and downstream of the bridge, it could be vary significantly across the width of the bridge. Additionally, large boulders in the area can be misleading as to the presence of bedrock.

Figure 2. Bedrock visible upstream
