Scoping Report

FOR
Hartford (Quechee) NH 020-2(45)

US Route 4, BRIDGE 61 OVER OTTAUQUECHEE RIVER

January 22, 2018

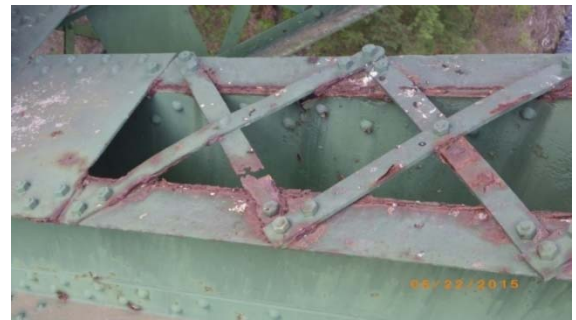
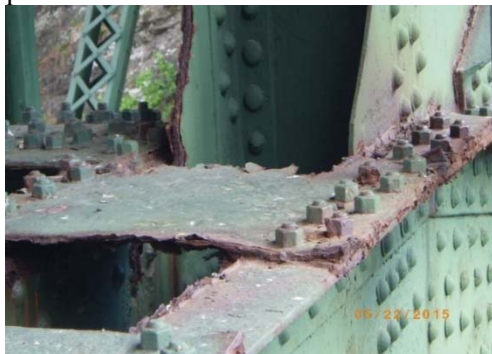
Corrosion: 32% of the steel arch members have been determined to be in a fair condition state. This indicates that the members were observed to have freckled rust. The corrosion of the steel has initiated in these areas, and would benefit from a protective paint coating as described in the previous section. 30% of the steel arch members were observed to be in a poor condition state. This indicates that section loss is evident or pack rust is present but does not warrant a structural review. These

members should be evaluated for potential replacement in order to extend the life of this structure. 3% of the steel arch members have corrosion that is in a severe condition state. This condition state warrants a structural review to determine the effect on strength or serviceability of the element. It is recommended that any members found to be in severe condition should be replaced to extend the service life of this structure. For estimating purposes, it will be assumed that all

members in a severe or poor condition state will be replaced.

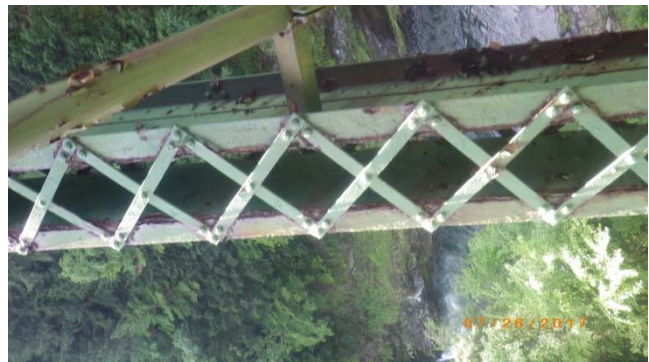
Cracking: No Cracking has been observed in 98% of members. 2% of members have a condition state of poor for cracking. This indicates Cracks that are not arrested but do not warrant structural review.

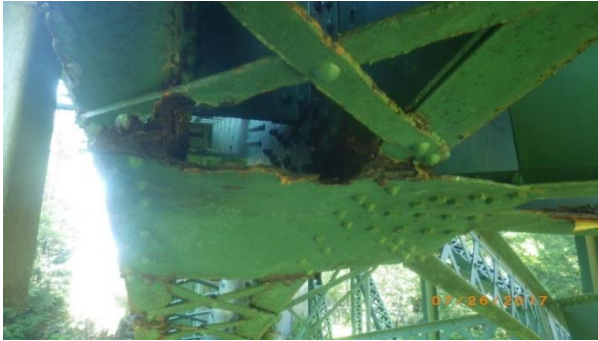
Connection: 50% of the connections are in place and functioning as intended. 40% of the connections have loose fasteners or pack rust without distortion but the connections are in place and functioning as intended. 10% of the connections are in a poor condition state. This indicated missing bolts, rivets, or fasteners; broken welds; or pack rust with distortion but does not warrant a structural review.

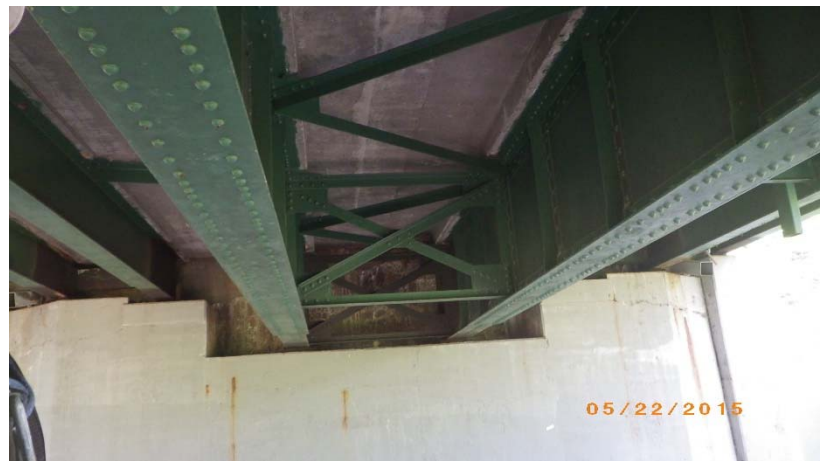
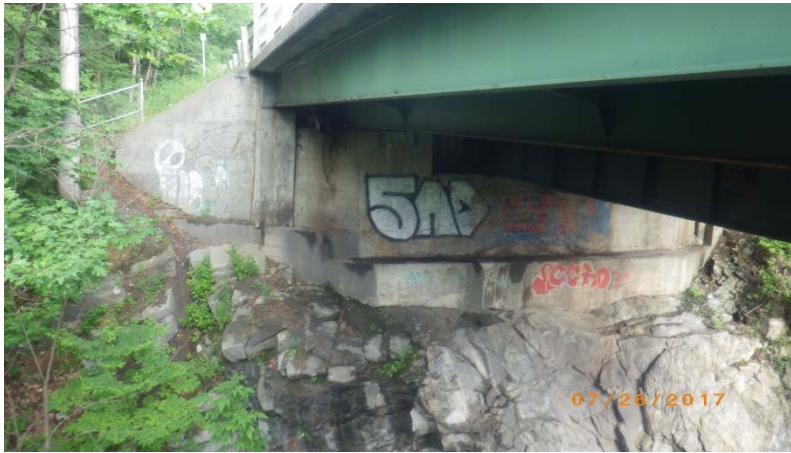
Corrosion: 30% of the girder elements have been determined to be in a fair condition state. This indicates that freckled rust was observed. The corrosion of the steel has initiated in these areas, and would benefit from a protective paint coating as described in the previous section. 30% of the girders were observed to be in a poor condition state. This indicates that section loss is evident or pack rust is present but does not warrant a structural review. These members should be evaluated for potential rehabilitation or replacement in order to extend the life of this structure.

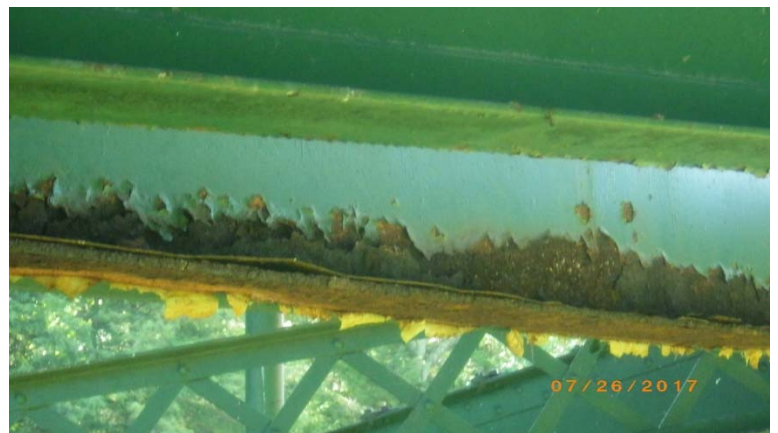
Corrosion: 30% of the stringers have been determined to be in a fair condition state. This indicates that freckled rust was observed. The corrosion of the steel has initiated in these areas, and would benefit from a protective paint coating as described in the previous section. 10% of the stringers were observed to be in a poor condition state. This indicates that section loss is evident, or pack rust is present but does not warrant a structural review. For estimating purposes, it will be assumed that the stringers will be cleaned and painted

only. However, the members found to be in poor condition should be evaluated for potential rehabilitation or replacement in order to extend the life of this structure.

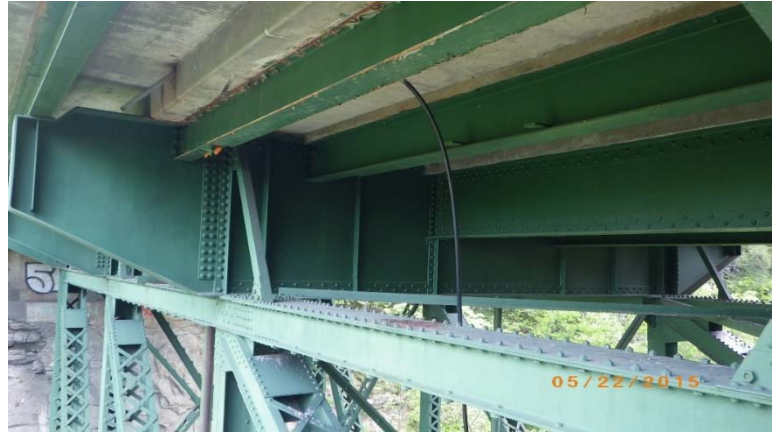
Corrosion: 20% of the floor beams have been determined to be in a fair condition state. This indicates that freckled rust was observed. The corrosion of the steel has initiated in these areas, and would benefit from a protective paint coating as described in the previous section. 10% of the floor beams were observed to be in a poor condition state. Based on these condition states, a protective paint coating as described in the above section is appropriate at the time.

Connection: 98% of the connections are in place and functioning as intended. 2% of the connections are in a poor condition state. This indicates missing bolts, rivets, or fasteners; broken welds; or pack rust with distortion but does not warrant a structural review.

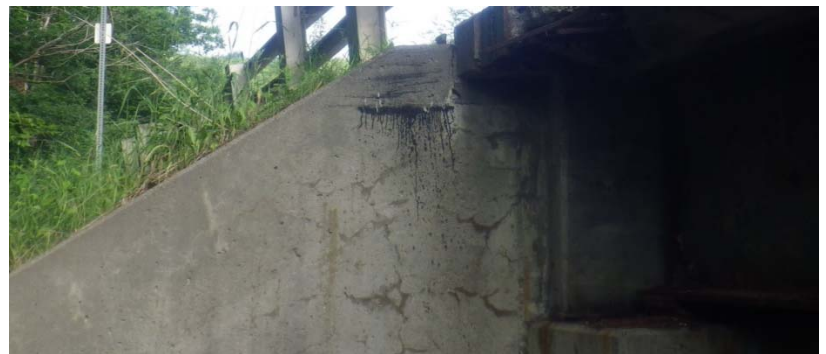
One of the major culprits of concrete degradation on bridges is moisture. There is a bridge joint located above each of the abutments at the begin bridge and end bridge locations. Leakage is evident along the backwalls with minor rust staining and efflorescence. All exposed concrete on the bridge should be sprayed with silane water

repellant to prevent moisture from penetrating the concrete. This is intended to protect the degrading concrete for several years against moisture damage.

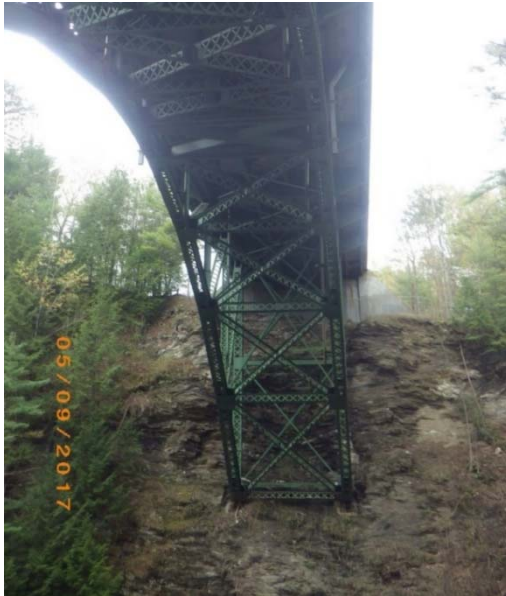
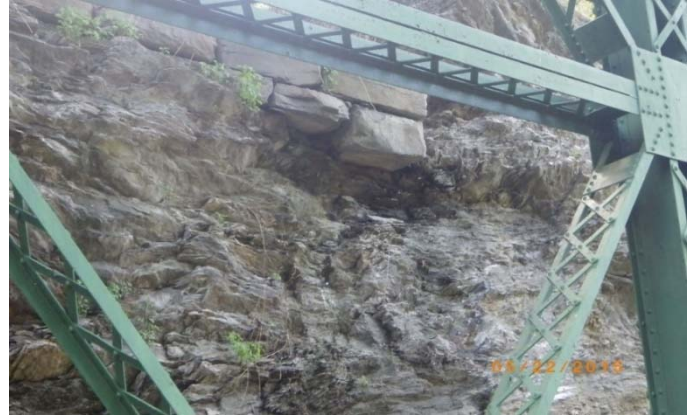
The eastern slope is comprised of shale and an old laid up stone wall. The shale is continuously eroding, causing stone to fall and build up on the bracing and hinge

bearings in that location. The shale should be stabilized to limit further erosion. There are several stabilization methods available, such as: protection of the face with shotcrete, rock bolts, or a tied-back wall.

Shotcrete: This option would involve applying a layer of shotcrete to seal the weathered shale rock

slope and prevent further degradation of the slope. This type of application can range in thickness from 0.75 inches to 4 inches. This stabilization technique has a design life of 50 years. In order to provide addition tensile and shear strength, reinforcement fibers will be added to the shotcrete mixture. This application would control progressive raveling that could eventually lead to unstable laid up stone overhangs. Drain holes in the shotcrete may be recommended by the geotechnical section to eliminate water pressure behind the shotcrete layer and extend the design life.

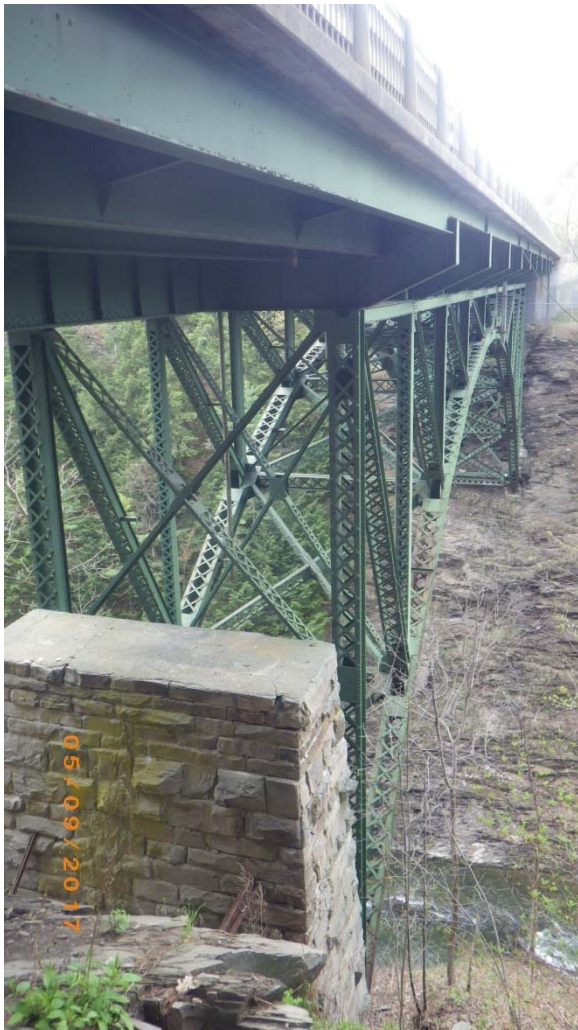
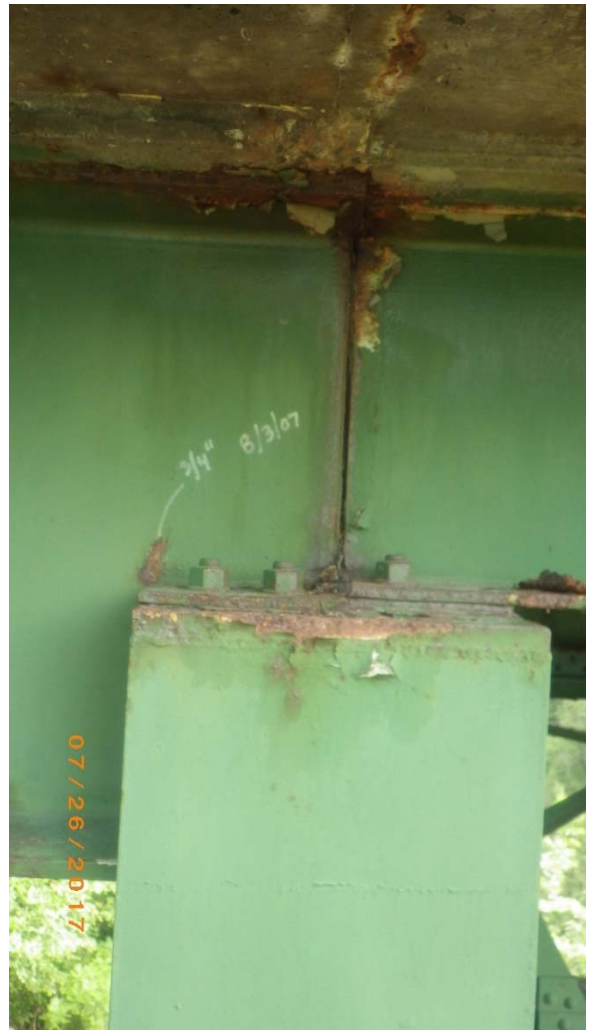
The pedestal rockers of the pinned deck arch have heavy rust scale and deep pitting surrounding the pinned connections, and slotted pitting along the gusset plate connections. These bearings should be rehabilitated as part of a preventative maintenance project.

Pedestal Rockers at the Arch
