STATE OF VERMONT
AGENCY OF TRANSPORTATION

Scoping Report

FOR
Springfield IM 091-1(74)

Interstate Route 91, Bridges 26 N/S over the Black River

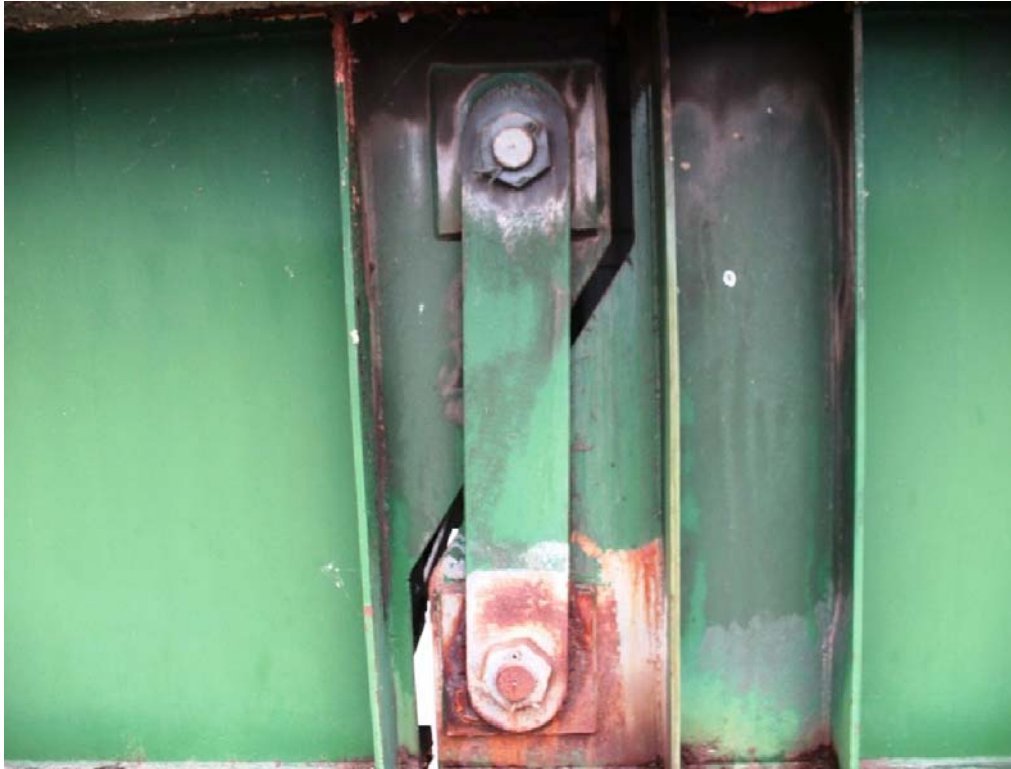
Bridge 26N Hinge
