STATE OF VERMONT  
AGENCY OF TRANSPORTATION

**Scoping Report**

**Springfield IM 091-1(83)**  
**I-91 Bridges 28 N&S over US Route 5**

August 25, 2020

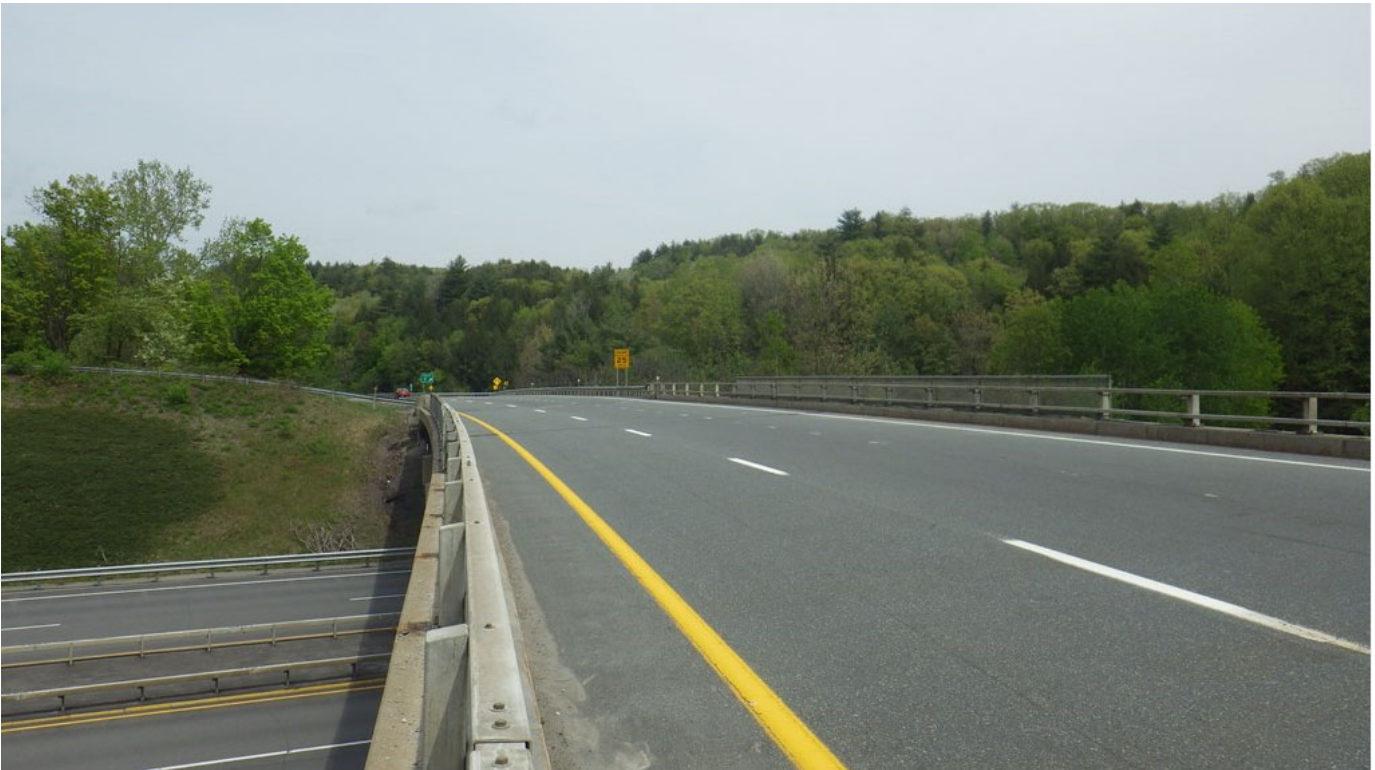
Looking north over Bridge 28N

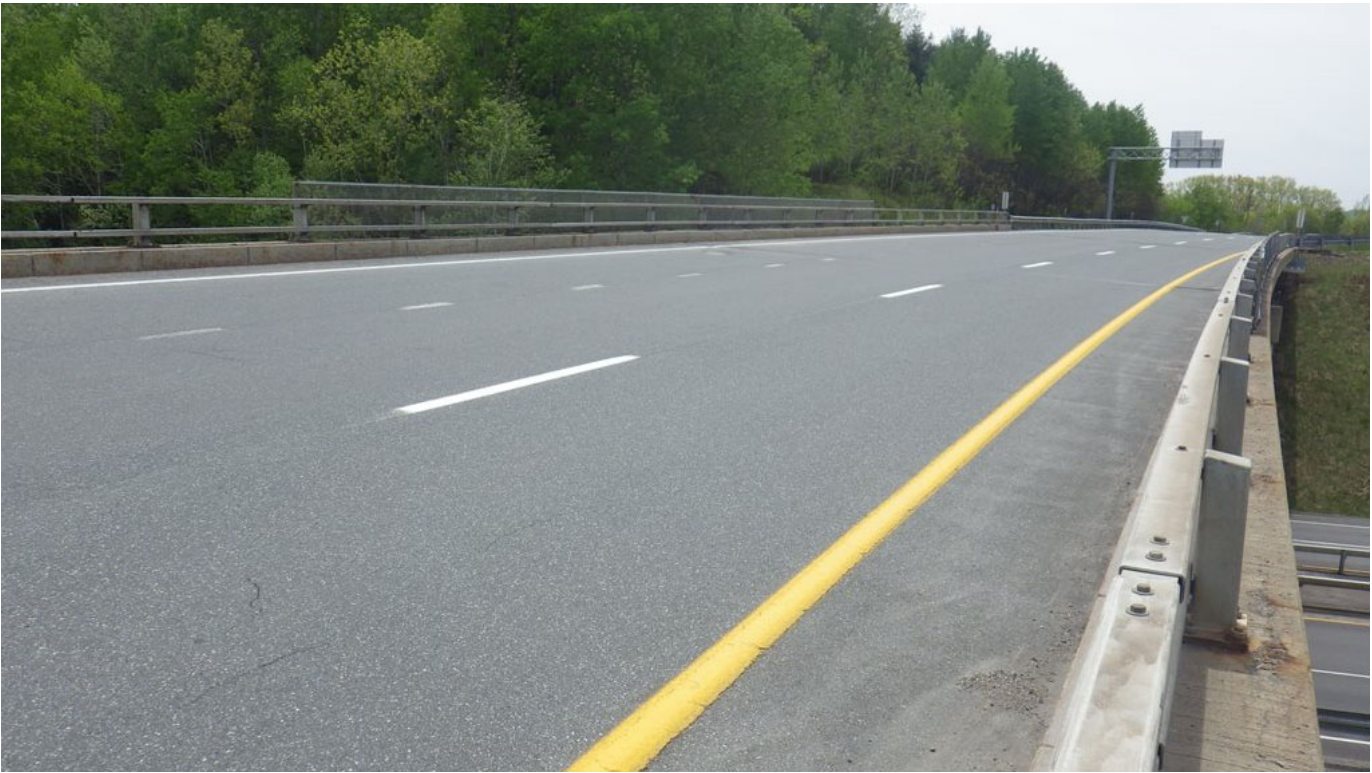
Looking South over Bridge 28N

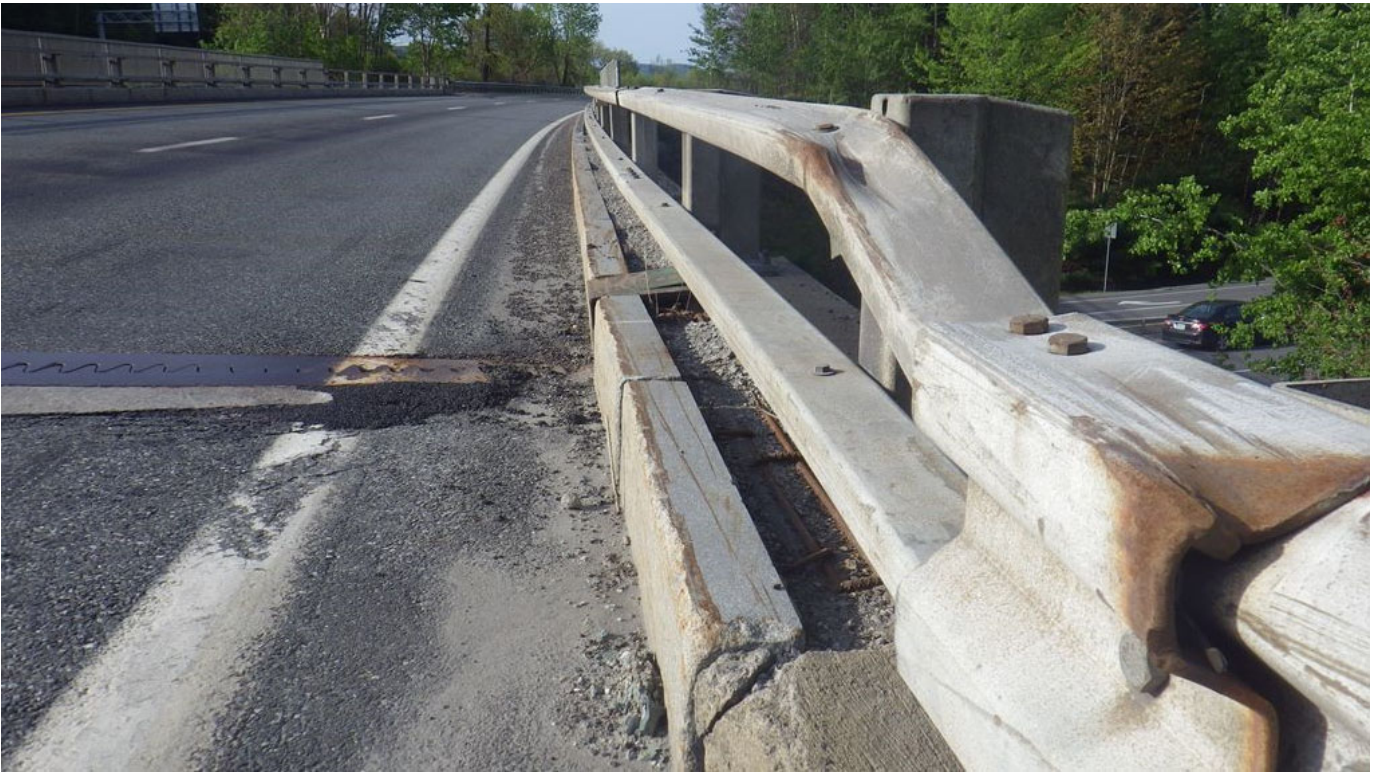
Looking South over Bridge 28S

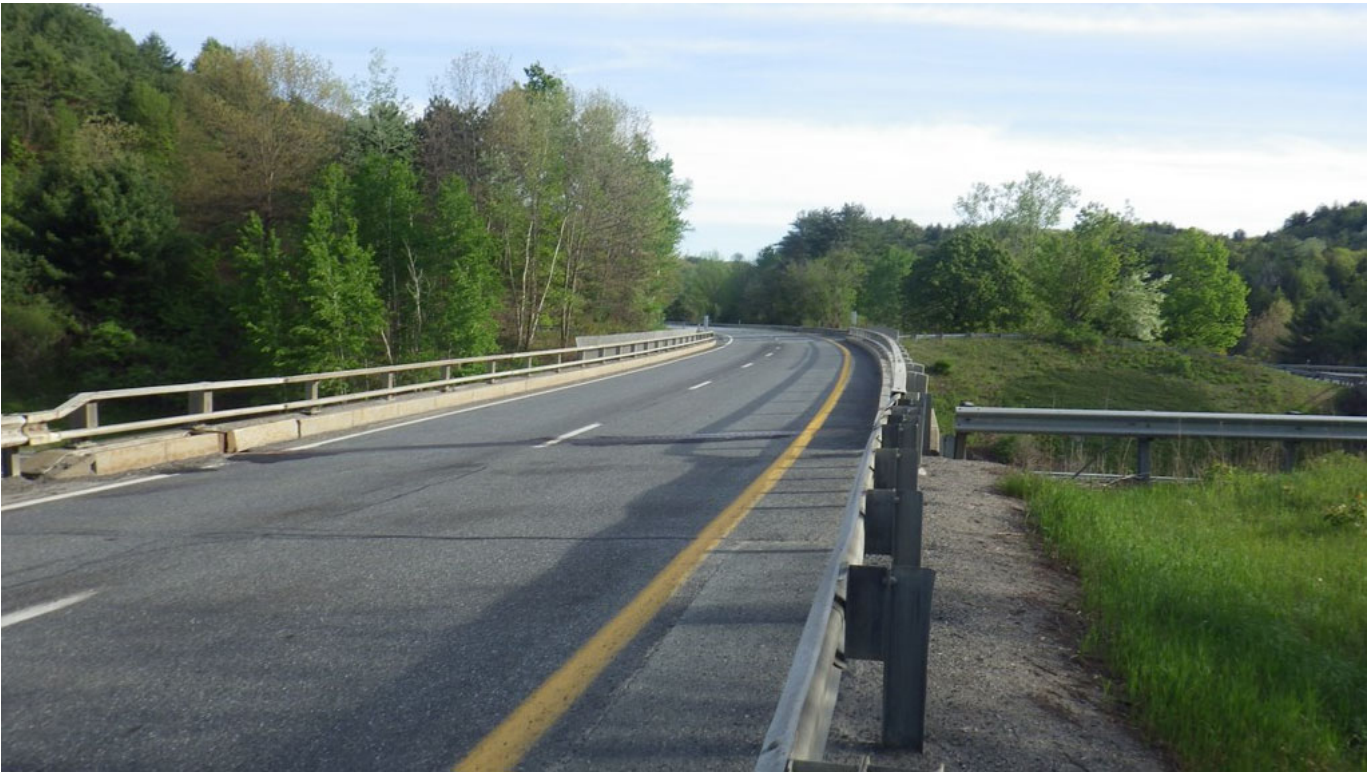
Looking north over bridge 28S

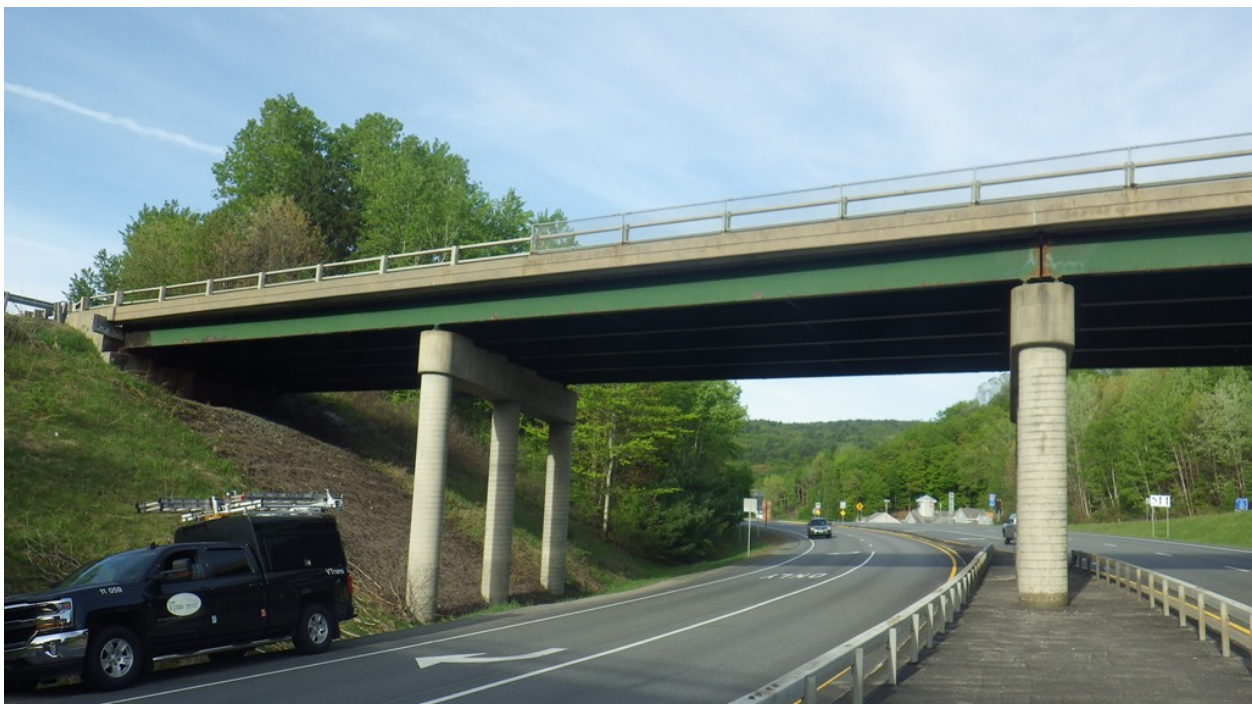
**Figure 3.2:** *Facing I-91 Bridge 28 Southbound south abutment; note limited overhead clearance for drilling operations under existing bridge. [Inspection photo dated 2018]*

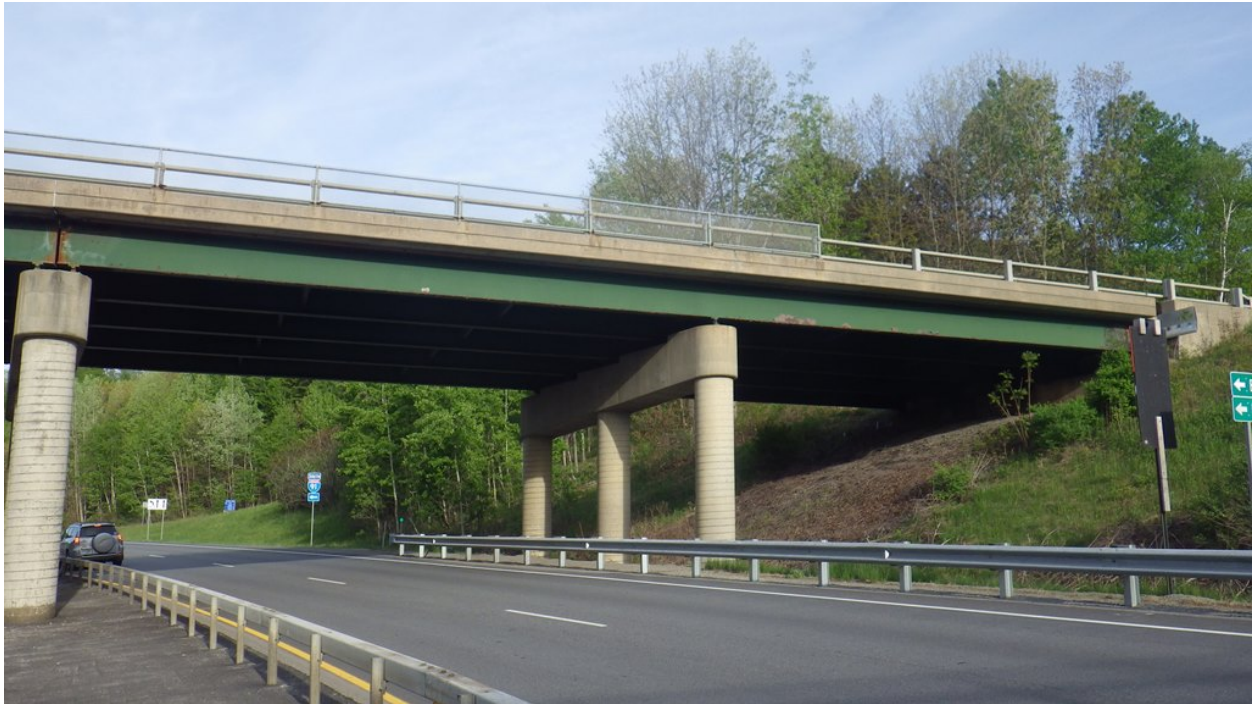
**Figure 3.3:** Facing I-91 Bridge 28 Southbound north abutment; note limited overhead clearance for drilling operations under existing bridge deck. [Inspection photo dated 2016]

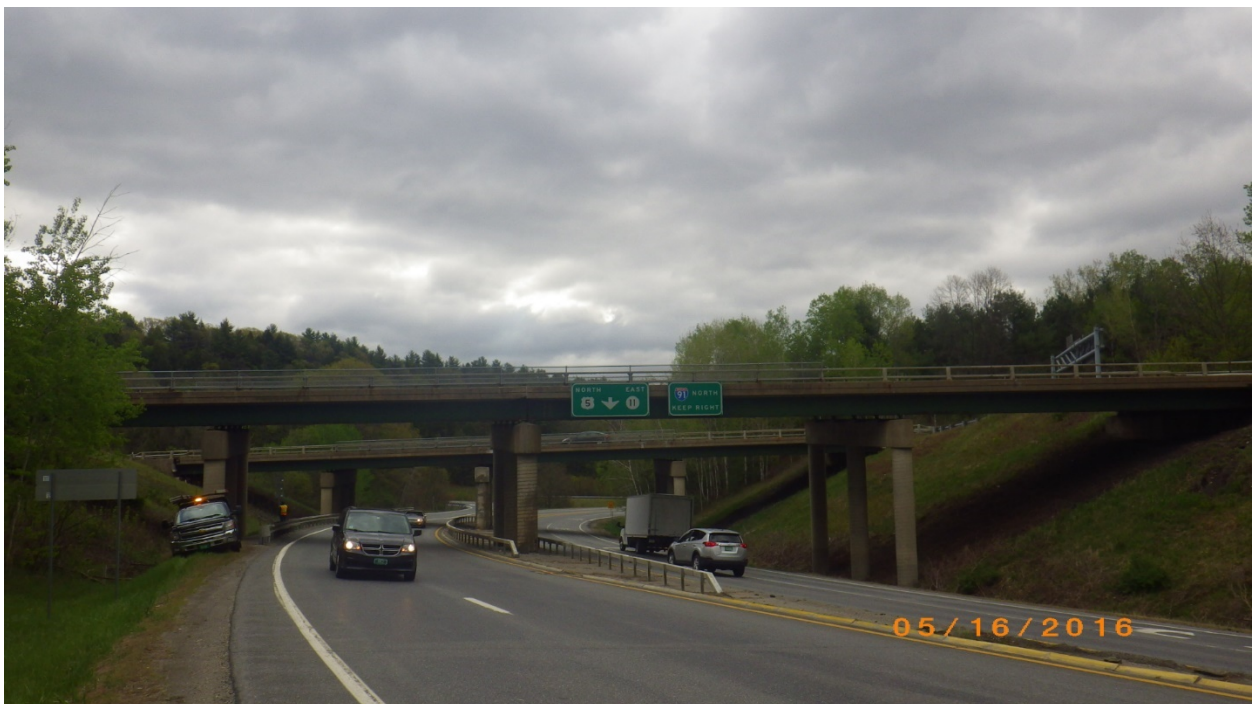
**Figure 3.4:** Facing east, Bridge 28 Southbound. [Inspection photo dated 2016]
