STATE OF VERMONT
AGENCY OF TRANSPORTATION

Scoping Report

FOR
Springfield IM 091-1(74)

Interstate Route 91, Bridges 26 N/S over the Black River

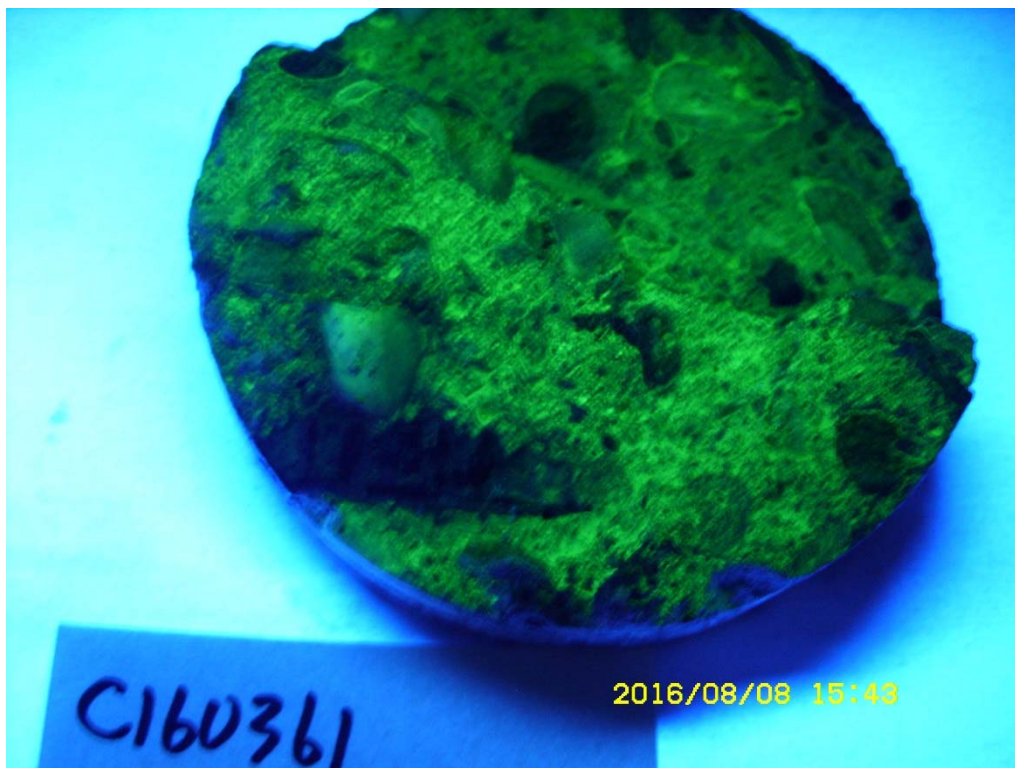
Core 1B from sample area 1, rated high ASR reactivity

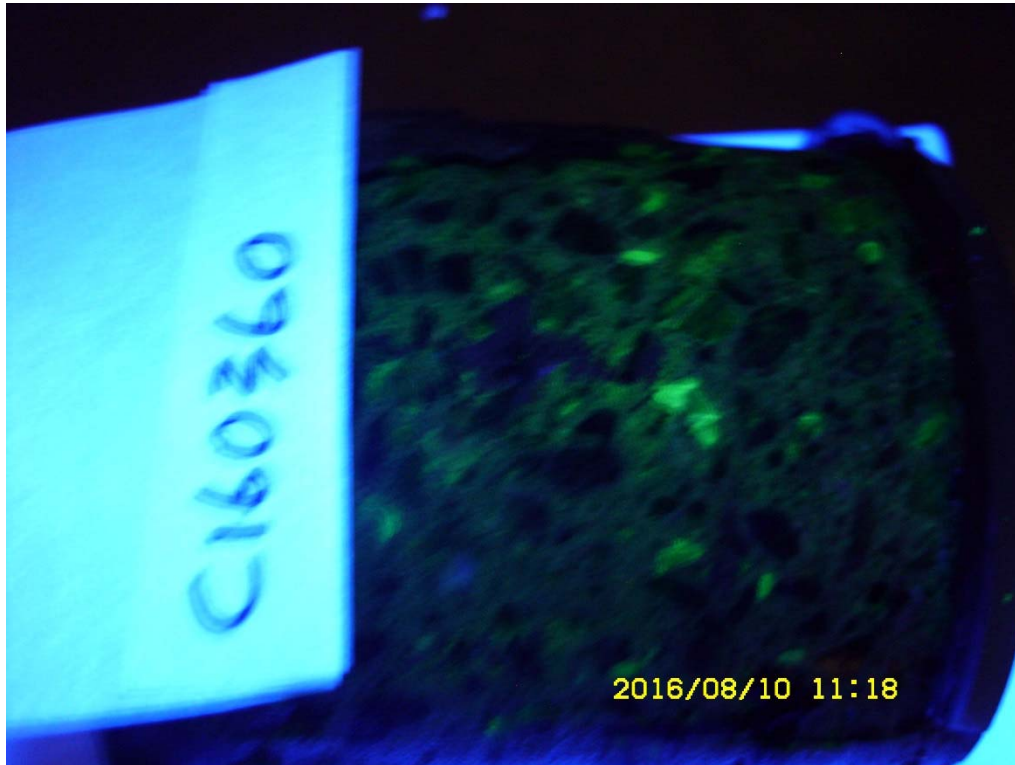
Core 1C from sample area 1, rated low ASR reactivity

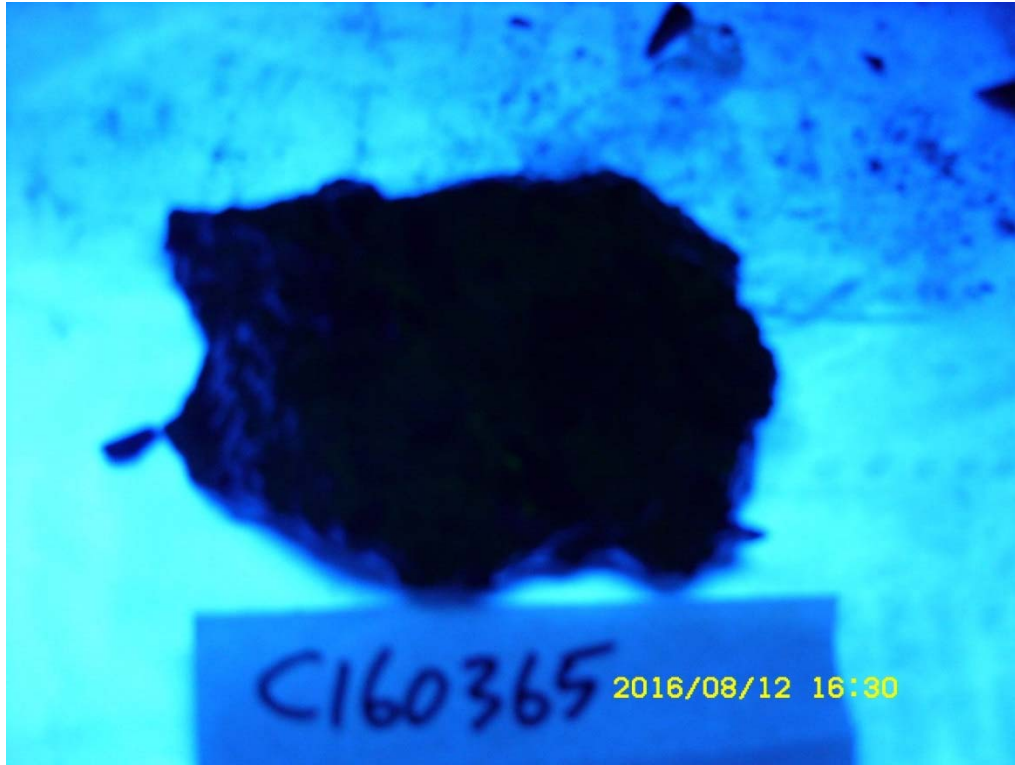
Core 2B from sample area 2, rated very low ASR reactivity

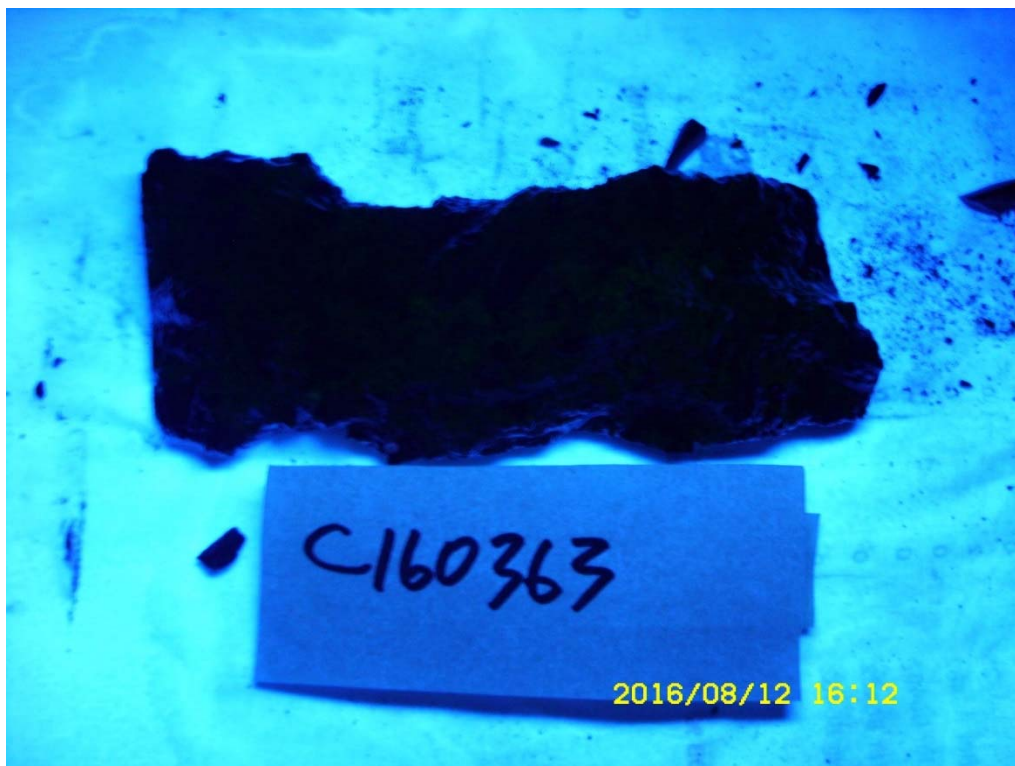
Core 2C from sample area 2, rated very low ASR reactivity

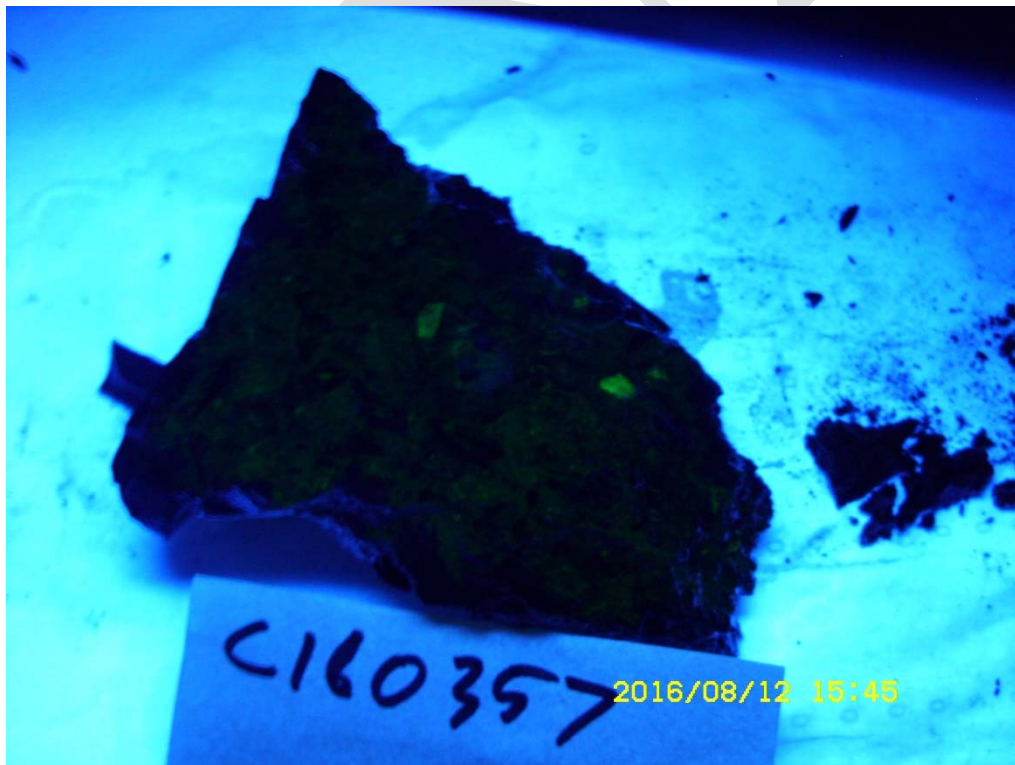
Core 2A from sample area 2, rated low ASR reactivity

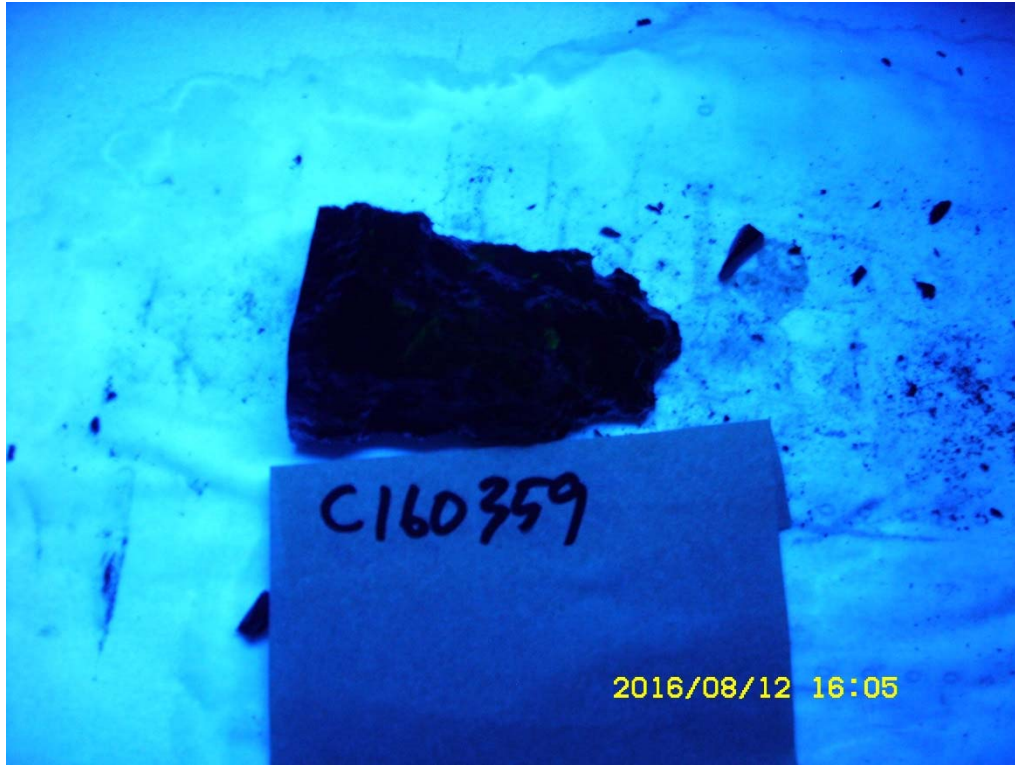
Core 2B from sample area 2, rated very low ASR reactivity
