STATE OF VERMONT  
AGENCY OF TRANSPORTATION

**Scoping Report**

**Springfield IM 091-1(83)**  
**I-91 Bridges 28 N&S over US Route 5**

August 25, 2020

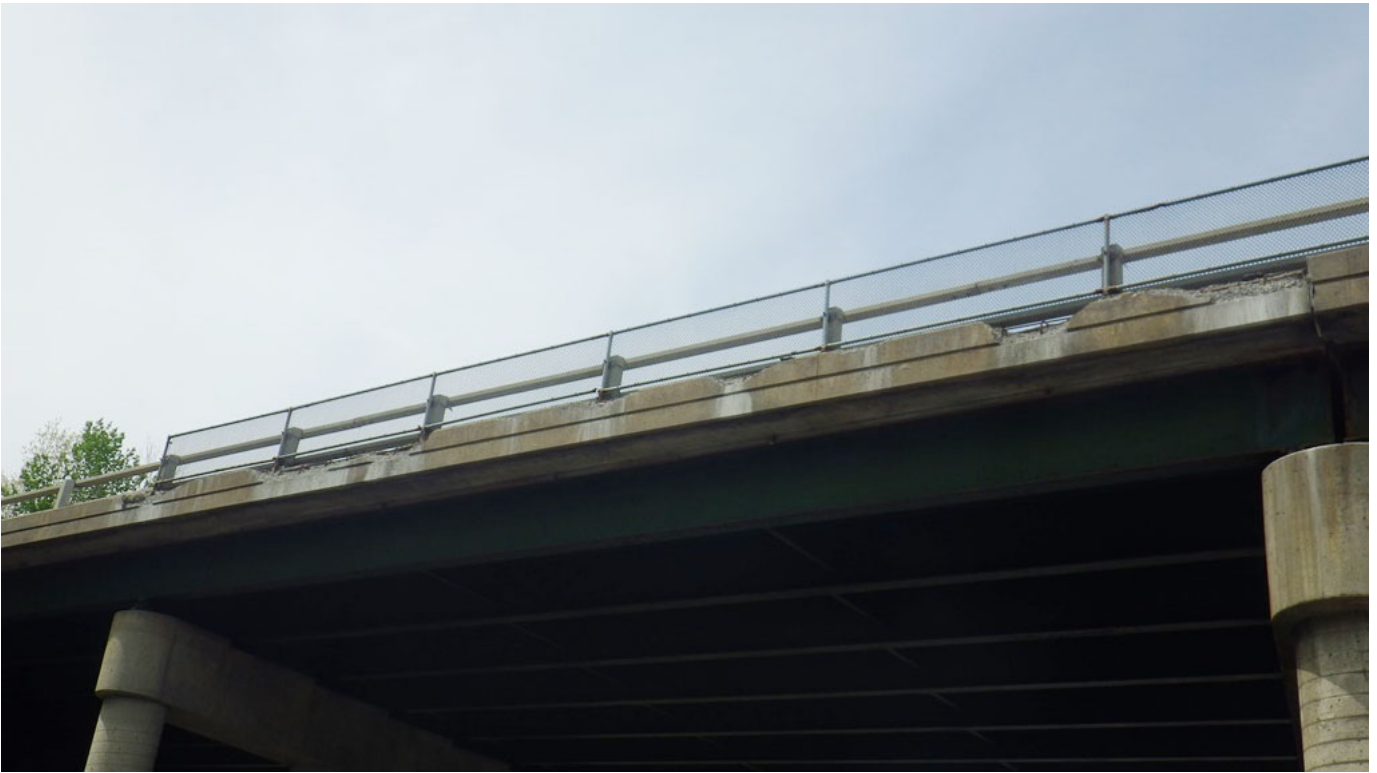
Bridge fascia
